Subject: Transmittal of Revision 1 to Service Bulletin No. V2500-ENG-71-0185

V2500-ENG-71-0185

POWER PLANT - GENERAL SERVICES HARNESS (LOOM D) - INTRODUCTION
OF REVISED CLIPPING

V2500-D5

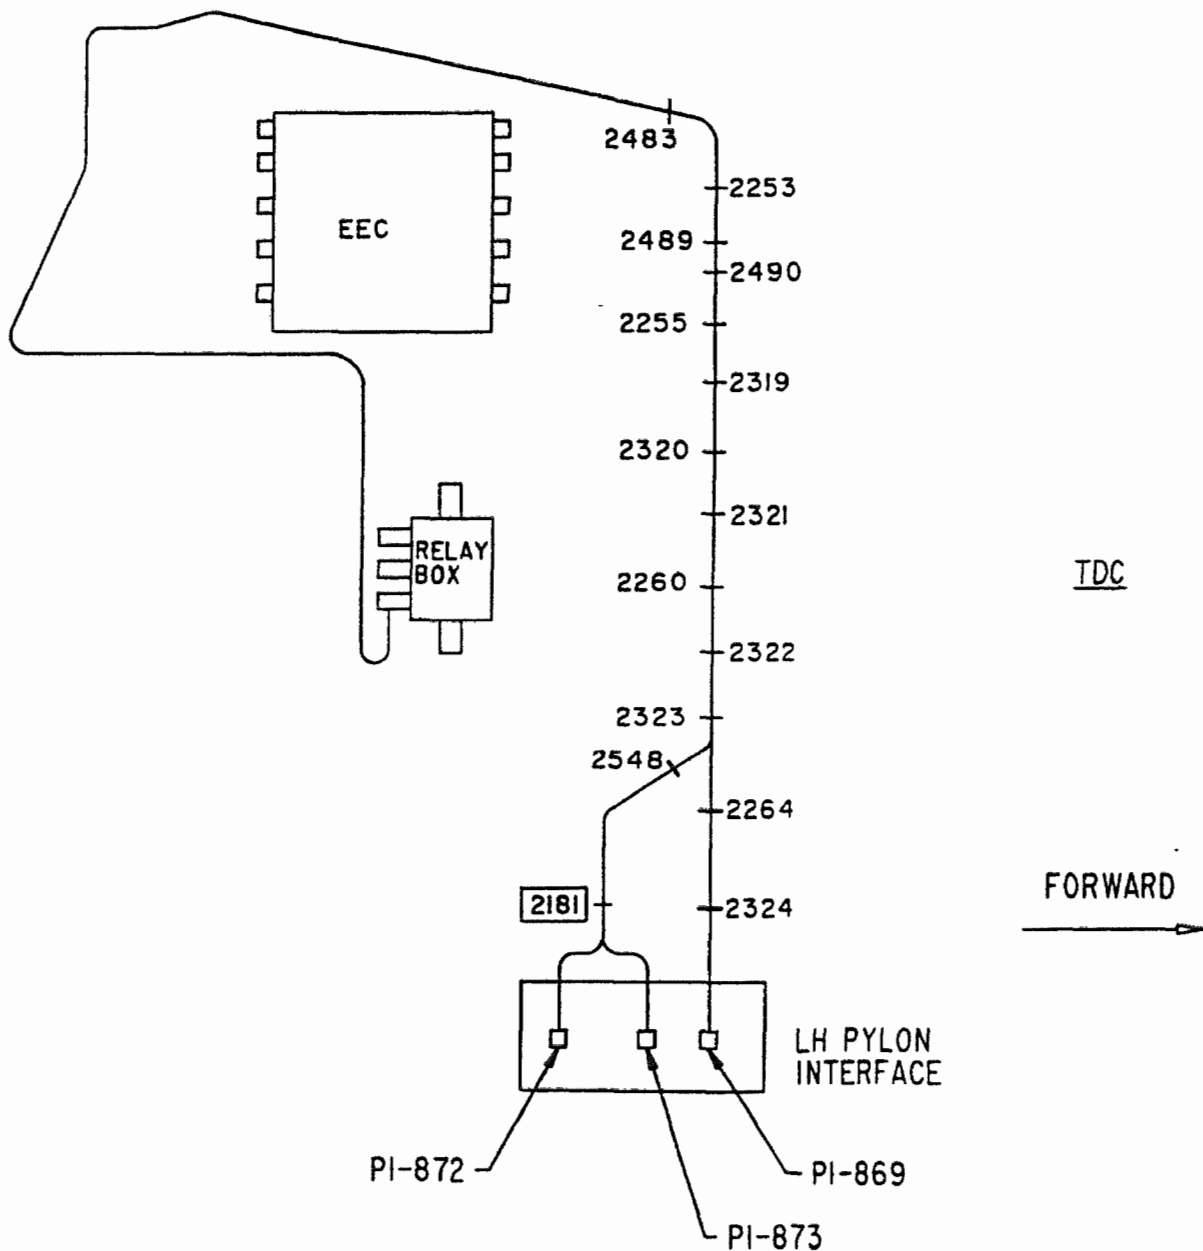
Schematic view of harness loom D
left hand installation before change
Fig 1

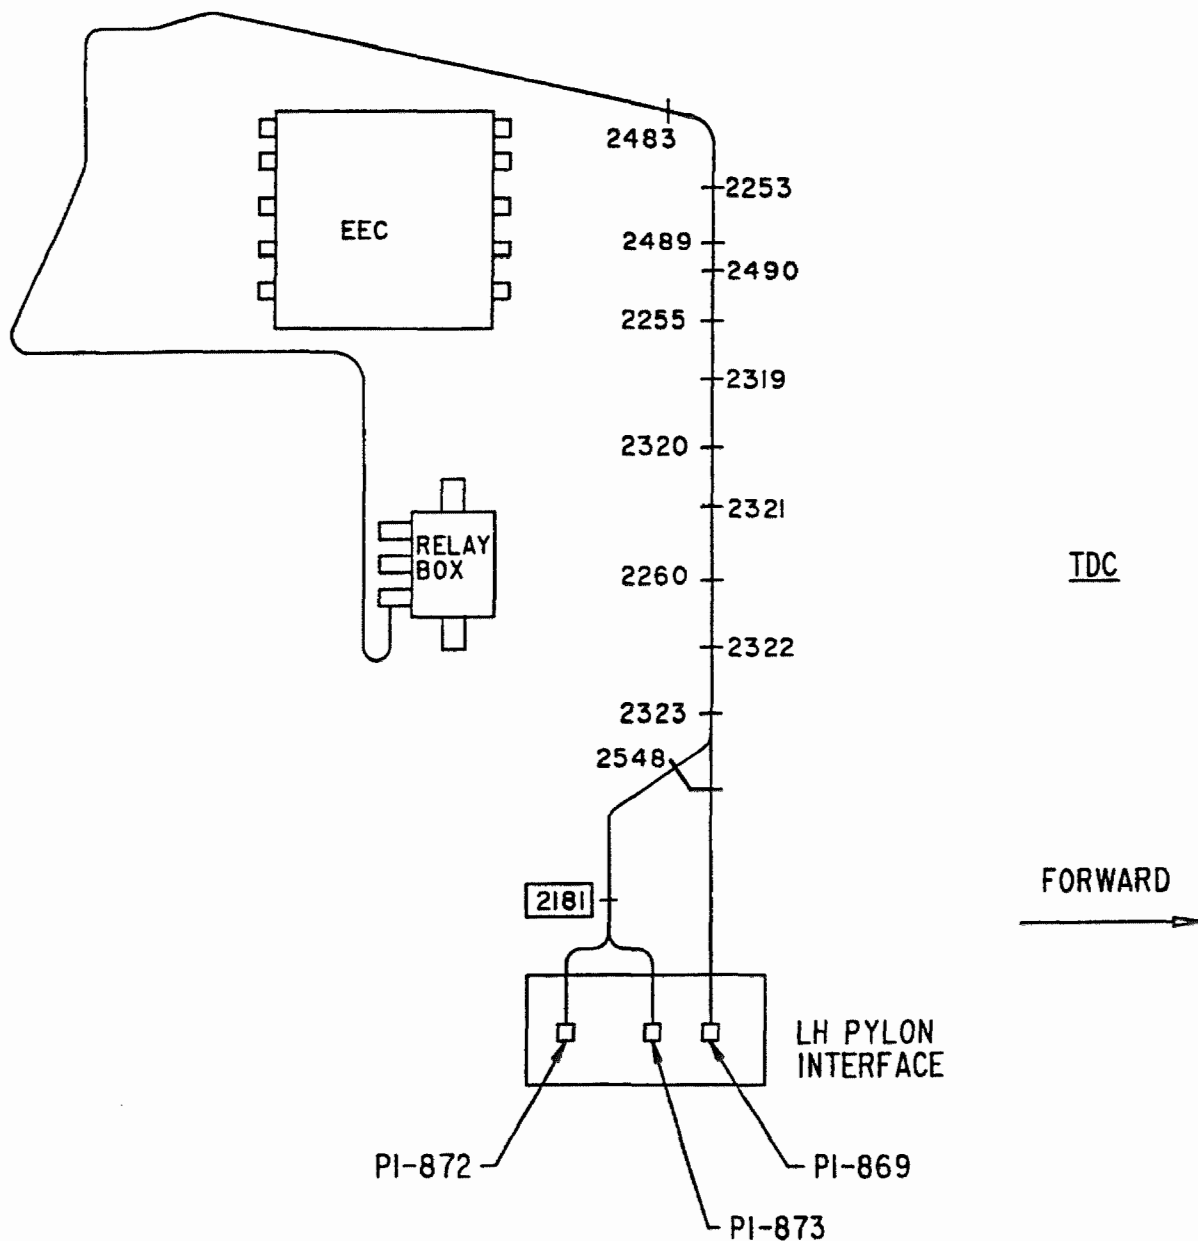
Fig 2

Schematic view of harness loom D
left hand installation after change

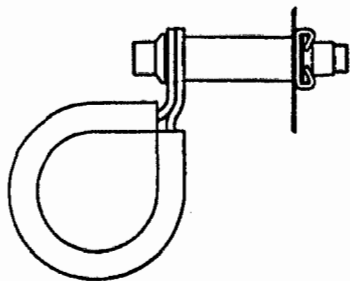
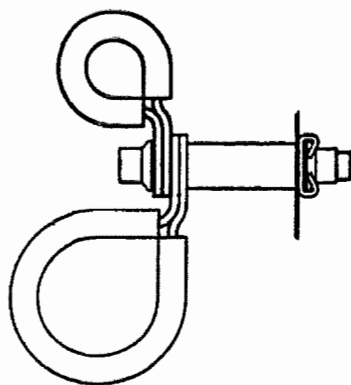
SCHEMATIC VIEW OF CLIP POINT 2548
LEFT HAND INSTALLATION BEFORE CHANGE

Clip point 2548 - Before and after alteration
Fig 3

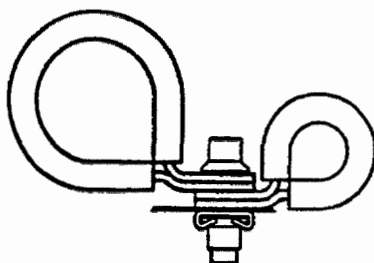
SCHEMATIC VIEW OF CLIP POINT 2264
LEFT HAND INSTALLATION BEFORE CHANGE

Clip point 2264 - Before and after alteration
Fig 4

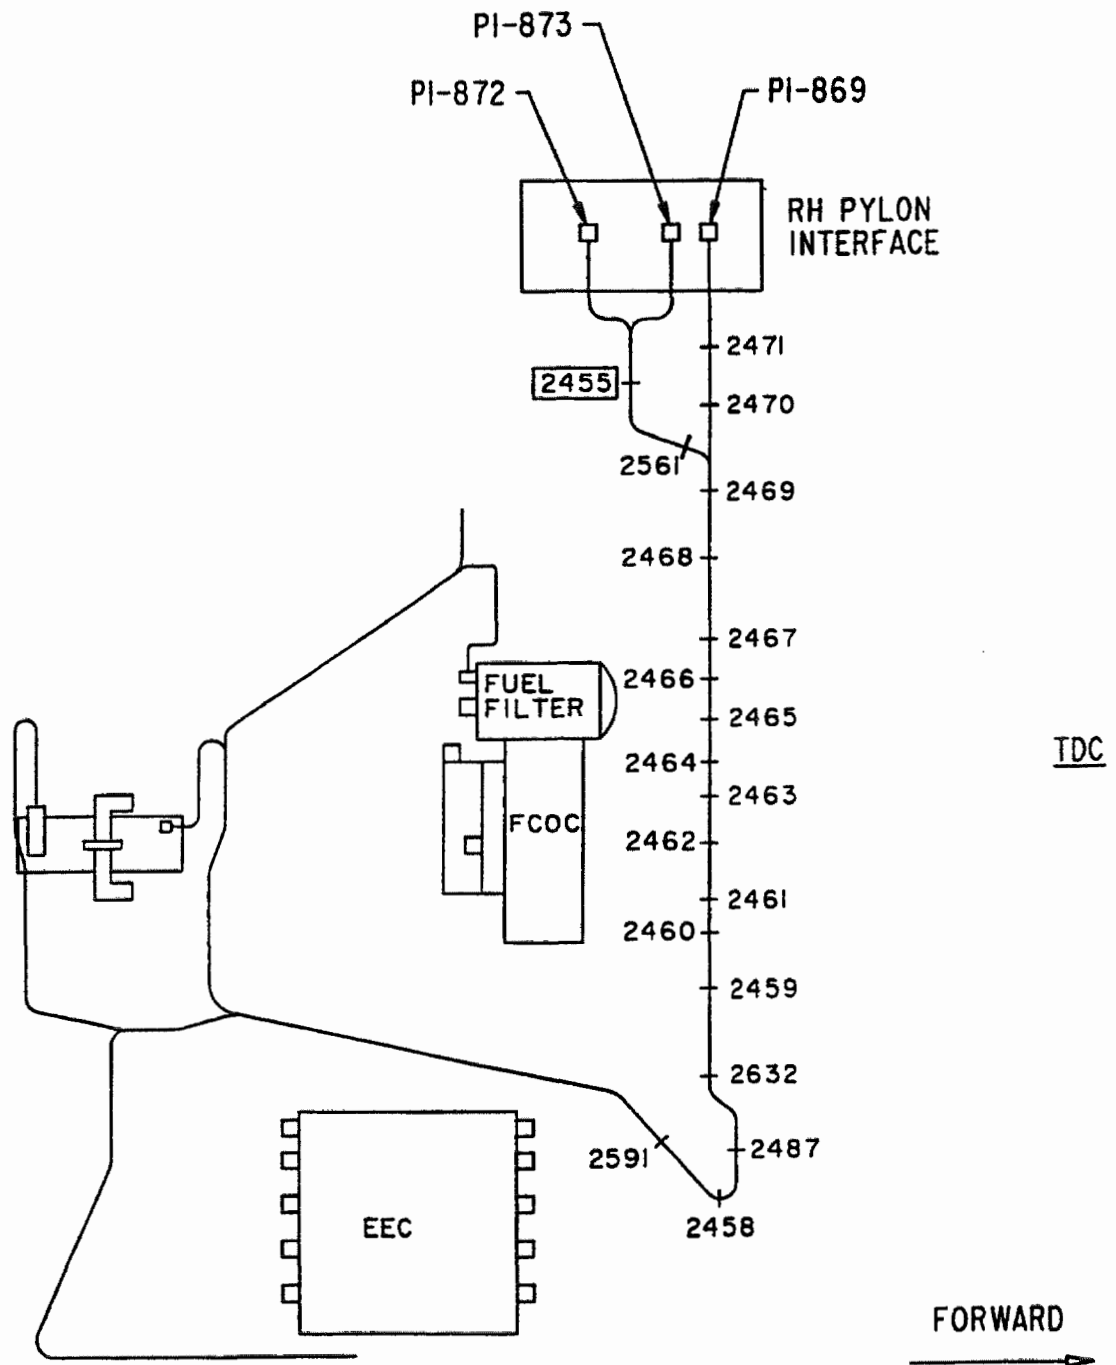
Schematic view of harness loom D
right hand installation before change
Fig 5

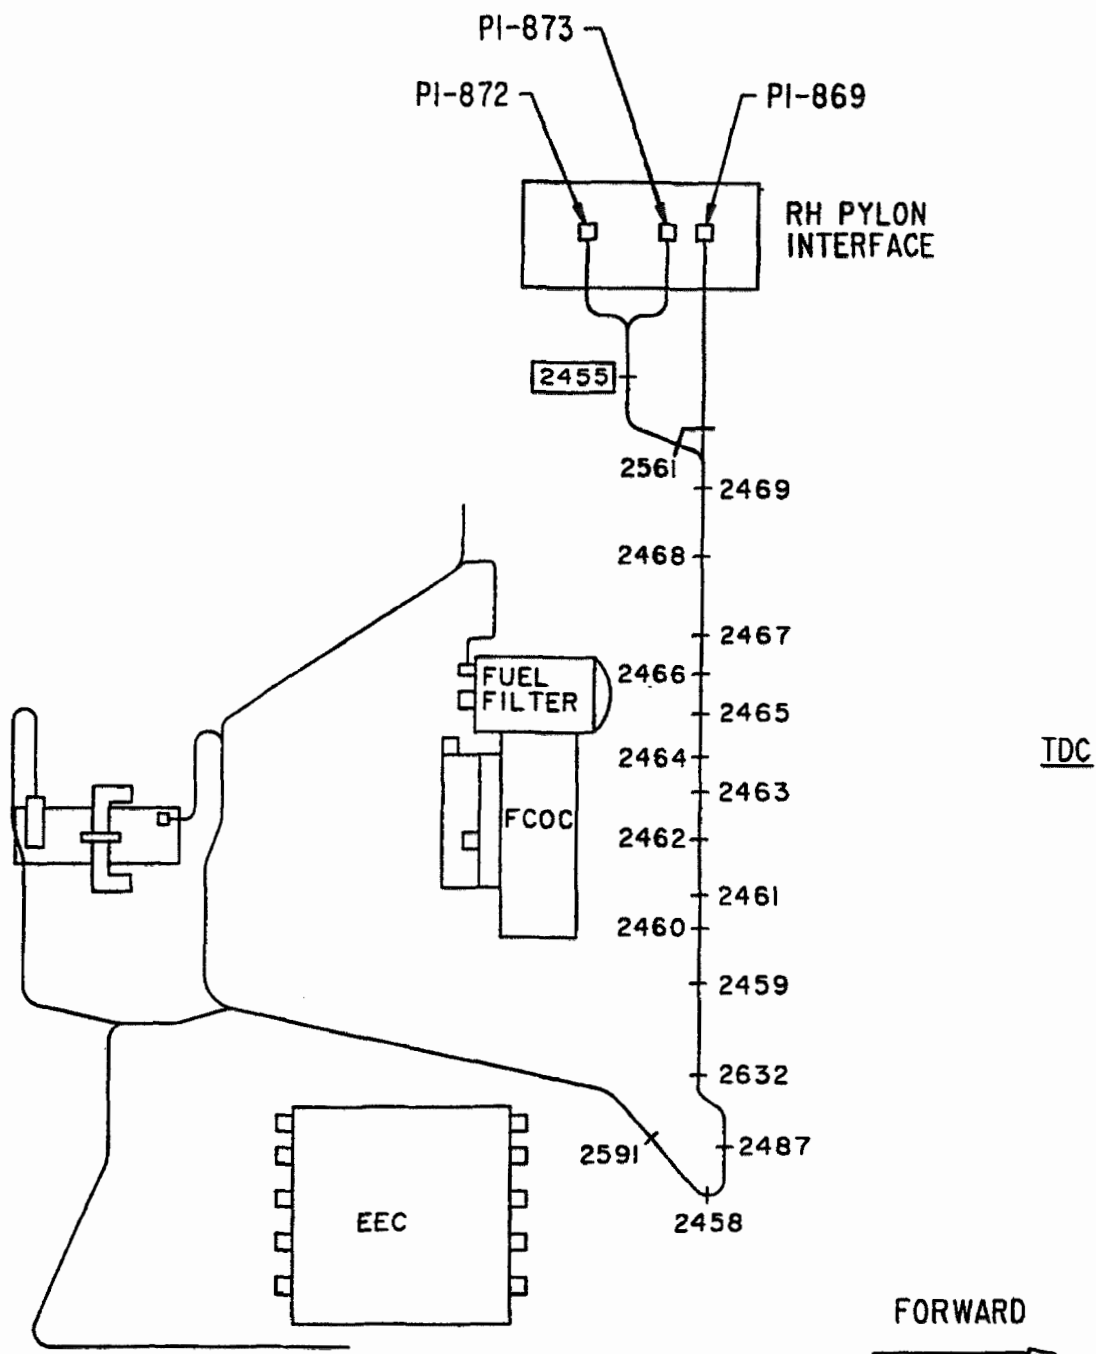
Schematic view of harness loom D
right hand installation after change
Fig 6

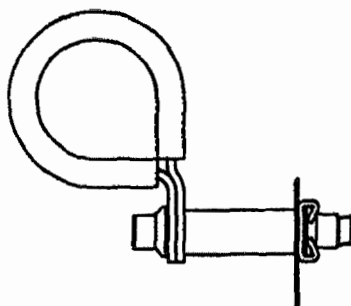
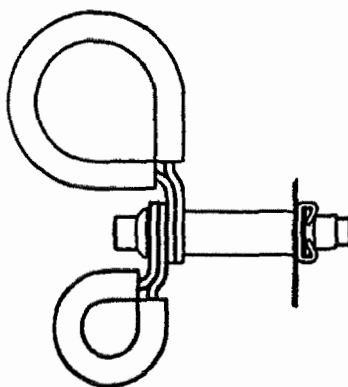
SCHEMATIC VIEW OF CLIP POINT 2561
RIGHT HAND INSTALLATION BEFORE CHANGE
LOOKING FORWARDS

Clip point 2561 - Before and after alteration
Fig 7

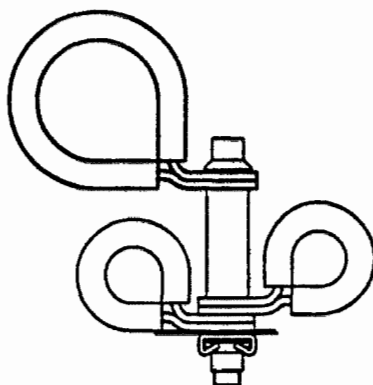
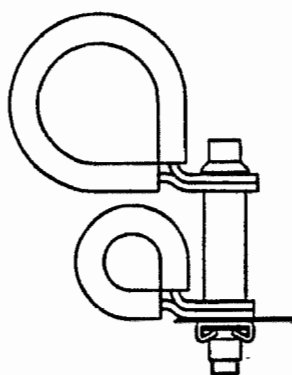
SCHEMATIC VIEW OF CLIP POINT 2470
RIGHT HAND INSTALLATION BEFORE CHANGE

SCHEMATIC VIEW OF CLIP POINT 2470
RIGHT HAND INSTALLATION AFTER CHANGE

Clip point 2470 - Before and after alteration
Fig 8
