POWER PLANT – EEC CHANNEL A AND B – INTRODUCTION OF REVISED ENGINE DEDICATED ALTERNATOR
CONNECTORS – NEW PRODUCTION – CATEGORY CODE 7 – MOD.ENG-71-0200

V2500-ENG-71-0200

SERVICE BULLETIN

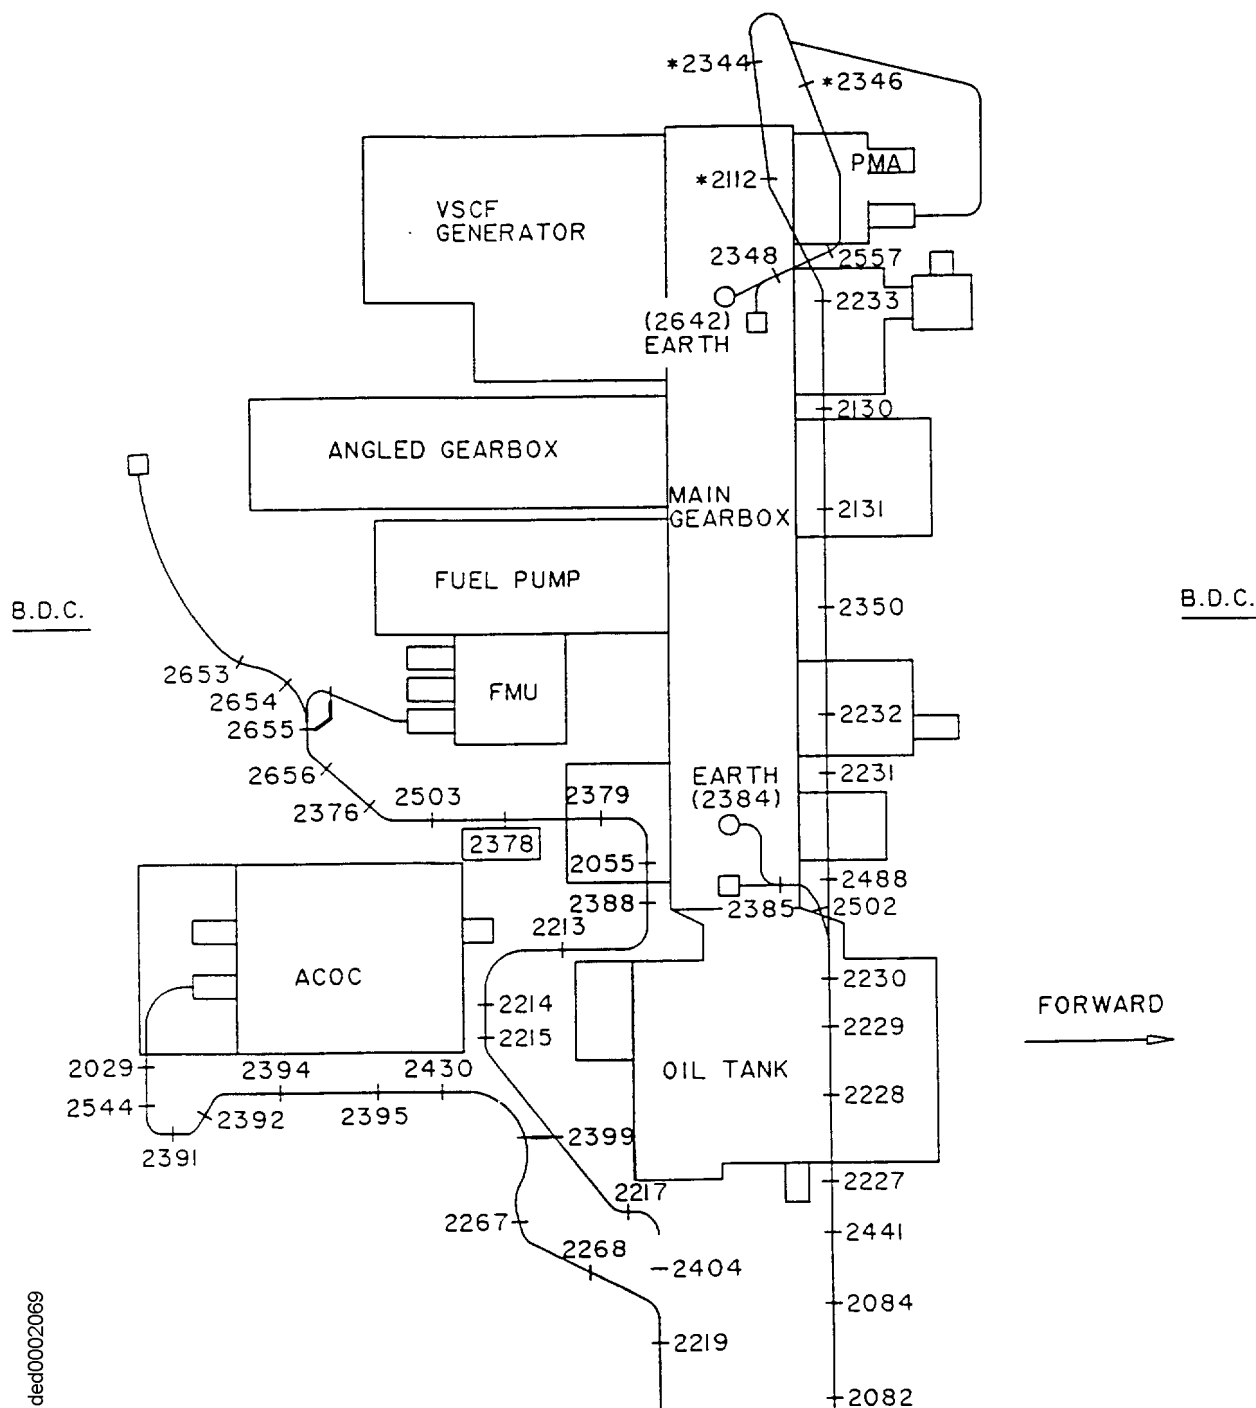
Schematic view of part of Loom B - Before change
Fig.1

The Engine Dedicated Alternator pin connectors can burn. The problem is caused by the locking of the stator connector for Looms A and B which is not sufficient.

Chaffing of the wire at the elbow of the 90 degree backshell can result in unwanted fault messages.

- (i) The connector at position P1-8024 (Loom A) and P1-8017 (Loom B) has changed. They have a finer locking mechanism to prevent "Backing-off". The quantity of the contact pins has increased from 10 to 12.
- (ii) The contact sockets have changed so that they connect correctly with pins of the new connector. The quantity of the sockets has increased from 10 to 12.
- (iii) The sealing plugs have changed to make the connector lock better. The quantity of the plugs has increased from two to four.
- (iv) The backshell of connectors P1-8024 (Loom A) and P1-8017 (Loom B) have changed from a straight standard to a right-angle standard.
- (v) The length of the EDA limb of the Loom A has increased to give a better radius and "drip-loop" of cable.
- (vi) The length of the EDA limb and the fire-wire limb (B20) of Loom B has decreased to give a better routing of the harness.
