POWER PLANT - GENERAL SERVICES HARNESS (LOOM E) - DELETION OF CLIP NUT AT CP7847 -
CATEGORY CODE 7 - MOD.ENG-71-0205

V2500-ENG-71-0205

SERVICE BULLETIN

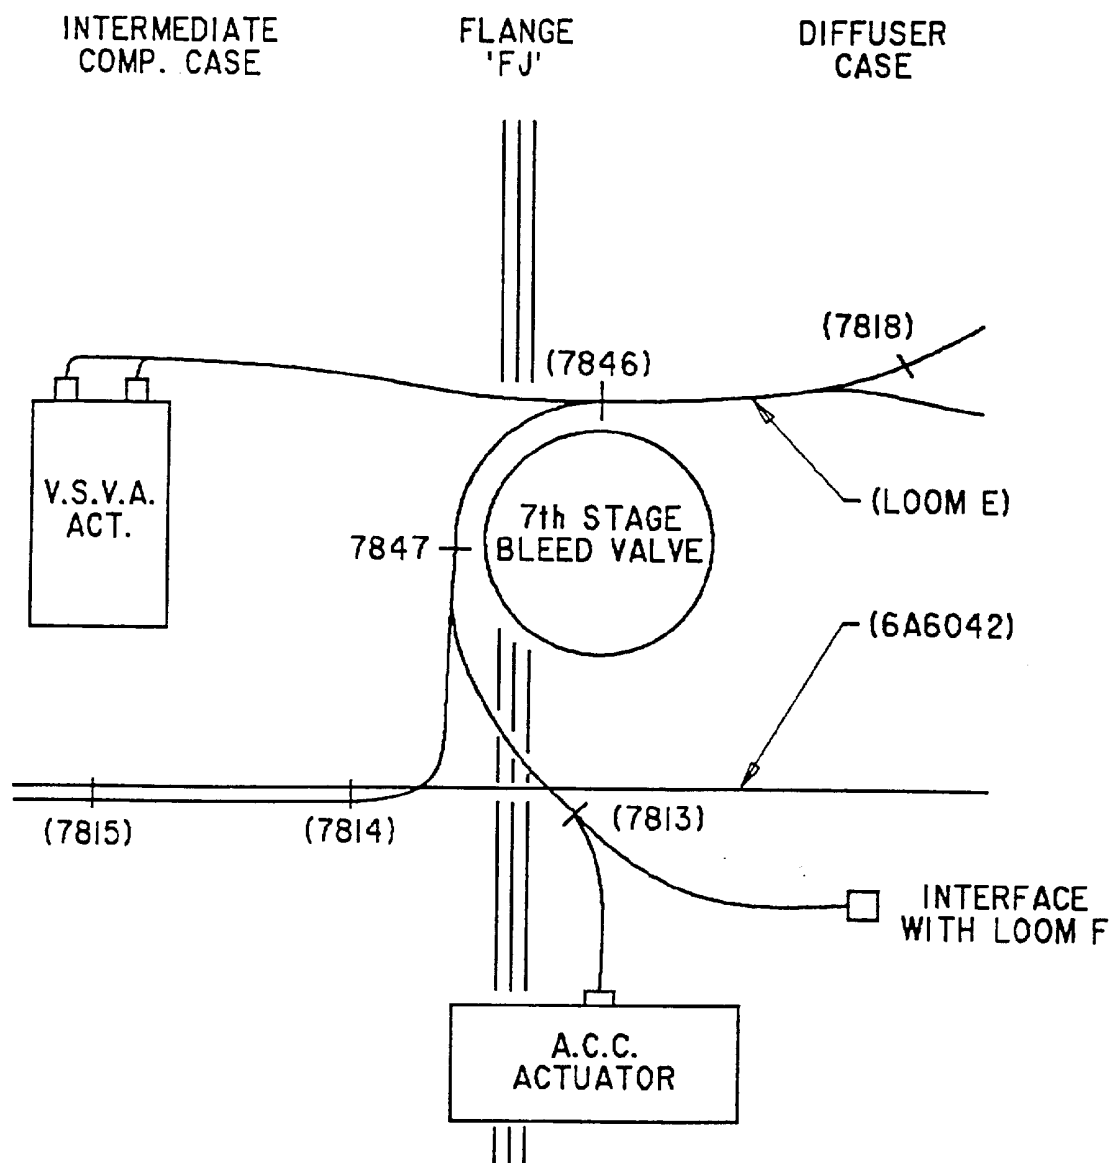
Diagrammatic view on loom E showing position of clip point 7847
Fig.1

Assembly of the clipping point CP7847 of the harness loom 'E' can be difficult.

The problem is caused by unsatisfactory access to the bolt head in this area.

- (a) Clipping point CP7847 has been changed. The clip nut has been replaced with a standard nut. In addition, the position of the bolt and nut has been moved through 180 degrees.
