IAE Propulsion System NON-MODIFICATION SERVICE BULLETIN

Subject: Transmittal of Revision 1 to Service Bulletin Number V2500-ENG-71-0230

NACELLE - PYLON - UPPER FITTING, OPENING ACTUATOR, THRUST REVERSER
(NON-MODIFICATION).

V2500-ENG-71-0230

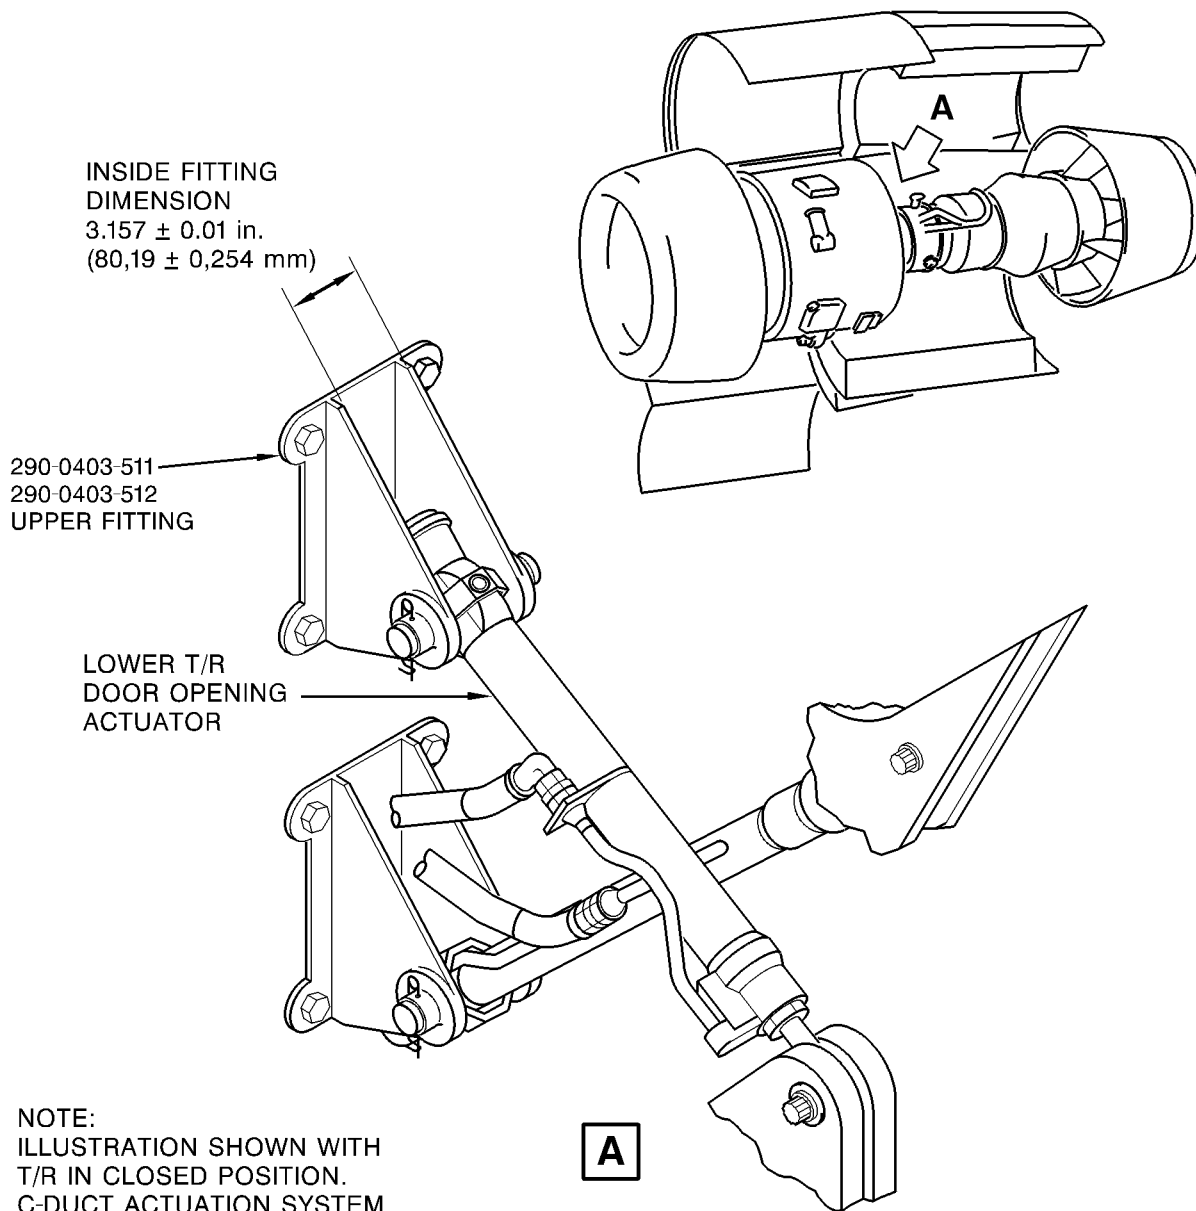
Lower Thrust Reverser Half Opening Actuator Pylon Upper Fitting Inspection
Figure 1

An MD-90 operator has reported two incidents in which the lower thrust reverser opening actuator upper fitting on the pylon has become wider (spread) in service. This allows the opening actuator pins to become disengaged from the actuator gimbal. Disengagement of the pivot pins could allow the lower thrust reverser half to swing unrestrained toward the fuselage when you open the lower thrust reverser half.

- (1) Open the lower thrust reverser half. Refer to the MD-90 Aircraft Maintenance Manual, Chapter 78-32-00, page block 201. Make sure you engage the thrust reverser hold open rods.
- (2) Examine the lower thrust reverser opening actuator upper fitting.
 - (a) If the inside fitting dimensions are larger than in Figure 1, you must replace the fitting. Report the results of the inspection to your local IAE or BFGoodrich representative. They will help you get a replacement fitting.
 - (b) If the inside fitting dimensions are within the range shown in Figure 1.
