DATE ~~R~~ Jun.30/03**V2500-A1/A5 SERIES PROPULSION SYSTEMS SERVICE BULLETIN**

ENGINE - ENGINE VIBRATION MONITOR (E.V.M.) HARNESS - RE-ROUTING OF THE E.V.M. HARNESS
AT CLIPPING POINTS CP0876 AND CP1210

V2500-ENG-71-0271

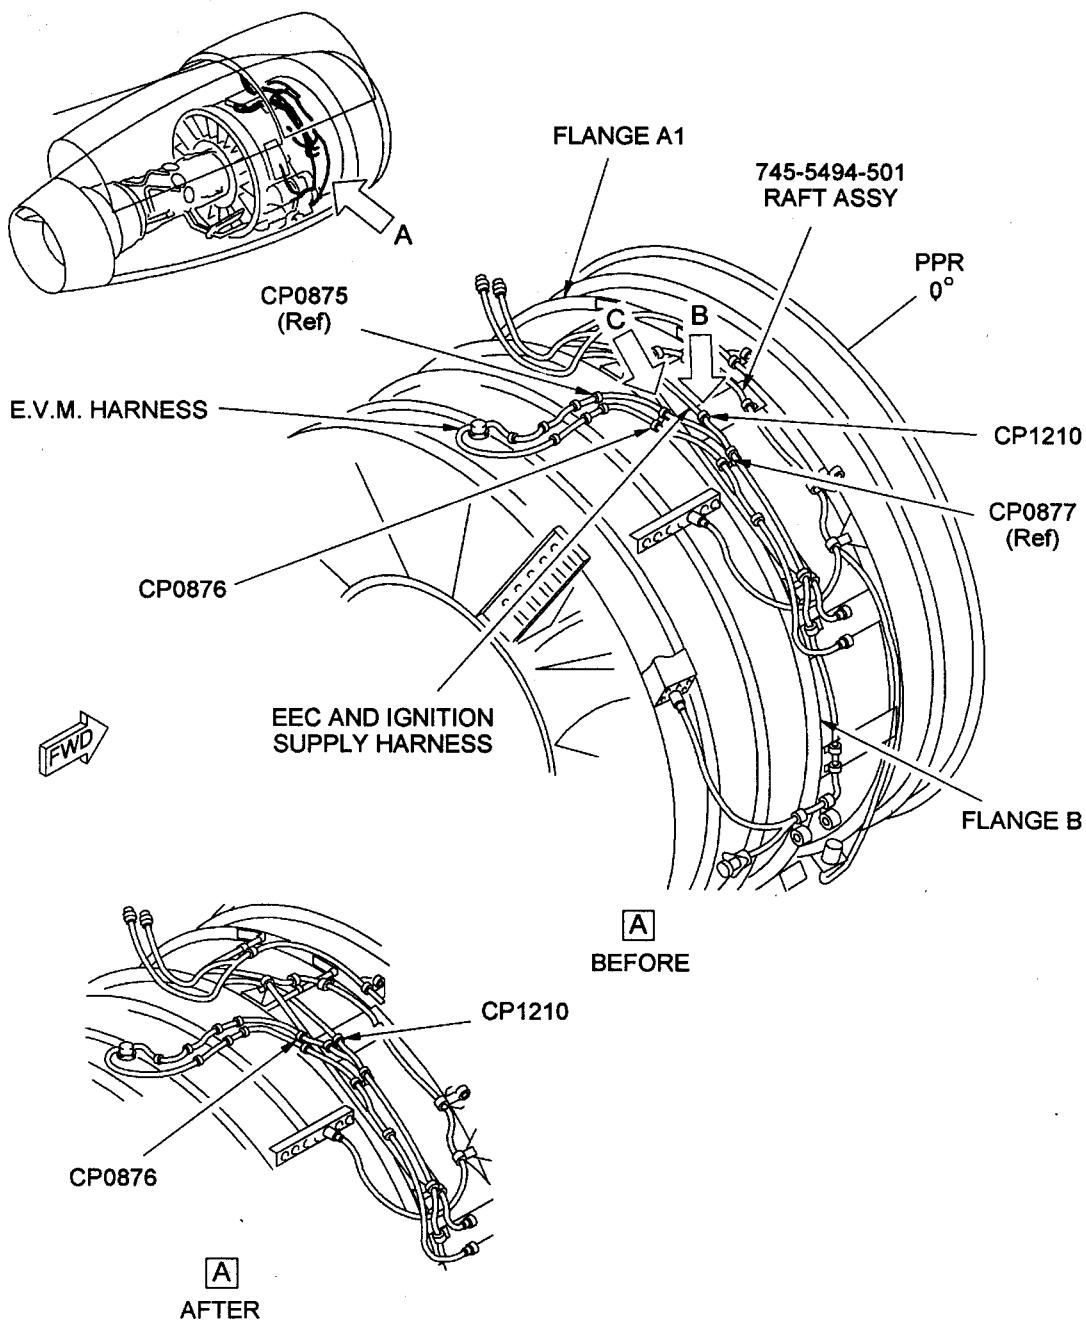
Rerouting of the E.V.M. Harness
Figure 1 (Sheet 1 of 3)

There may be a foul condition between the E.V.M. Harness and the Fire Extinguishing Nozzles, which can cause chafing to the outer sheath of the Harness.

Re-routing the E.V.M. Harness through Clipping Point CP1210 on the EEC and Ignition Supply Harness routing can remove the foul condition. A new 'P' Clip is installed on Clipping Point CP1210 to accommodate the Harness and the stack-up at E.V.M. Harness Clipping Point CP0876 is modified.

- (1) Remove the AS21408 Bolt and the SP154D Washer to disassemble Clipping Point CP1210. Refer to Figure 1 view B - before.
- (2) Remove the AS21410 Bolt, the SP154D Washer and the AS20624 Nut to disassemble Clipping Point CP0876. Refer to Figure 1 view C - before.

- (3) Remove the forward TA025074-02 'P' Clip from the E.V.M. Harness and fit to the Harness to suit the new stack-up of the Clipping Point CP0876. Refer to Figure 1 view C.

- (4) Locate the E.V.M. Harnesses to the Raceway at Clipping Point CP0876 and install with the AS21410 Bolt, the SP154D Washer and the AS20624 Nut. Refer to Figure 1 view C - after. Hand tighten the bolt.

- (5) Fit the TA025074-02 'P' Clip to the E.V.M. Harness and install to the 745-5494-501 Raft Assembly at Clipping Point CP1210 with the AS21409 Bolt and SP154D Washer. Refer to Figure 1 view B - after. Hand tighten the bolt.

- (6) Make sure the E.V.M. Harness has a minimum clearance of 0.250 in. (6,35 mm.) with adjacent structure/hardware between Clipping Points CP0877 and CP0875. Refer to the A320/V2500-A1, A320/A321/V2500-A5 Engine Manual (E-V2500-1IA) for details on harness clearances. Refer to Figure 1.

- (7) Torque the Bolts at Clipping Points CP0876 and CP1210 to 20 to 25 lbf in. (2 to 3 Nm.) as instructed in the SPP-V2500-1IA Standard Practices/Processes Manual, Chapter 70-41-00.

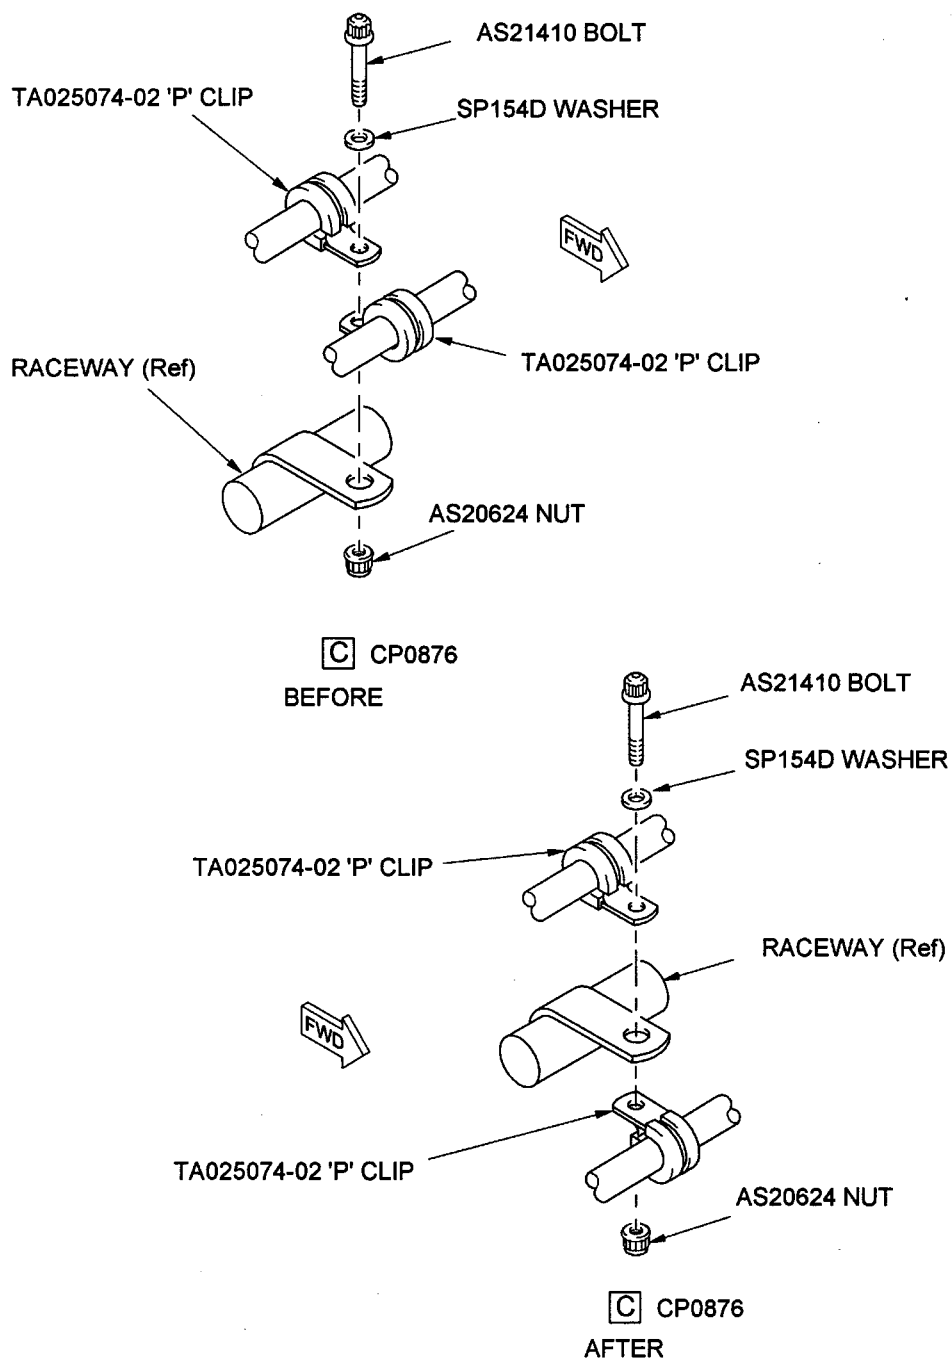
Rerouting of the E.V.M. Harness
Figure 1 (Sheet 3 of 3)

Reason for change
 Correction to P Clip part
 Number in Fig.1 Sheet 3 of
 3.
