ENGINE — ENGINE BUILD UNIT (EBU) — TERMINAL MODULE ASSEMBLY — REROUTING OF THE HARNESS

Turbojet Engine Service Bulletin No. V2500-ENG-71-0275 Revision No. 2 dated June 26, 2015.

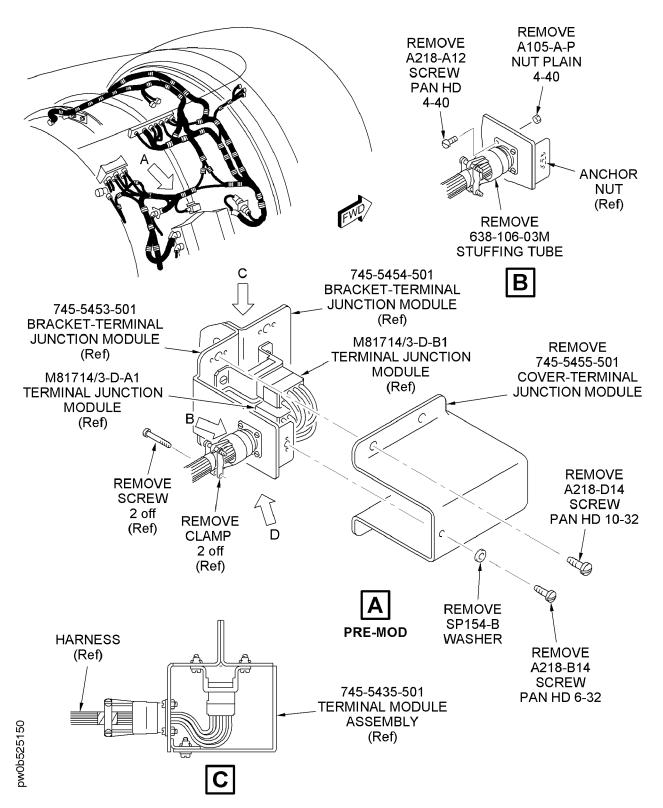
REROUTING OF THE TERMINAL MODULE ASSEMBLY — HARNESS CABLES FIGURE 1, SHEET 1 OF 3

- 1. Condition: Several operators have reported the possibility of part on part contact between the Harness Cables and the Terminal Module Assembly.
- 2. Background: Part on part contact between the Harness Cables and the Terminal Module Assembly may cause Cable damage resulting in incorrect cockpit warnings.
- Objective: To minimize the possibility of the Harness Cables from sustaining damage and prevent incorrect cockpit warnings.
- 4. Substantiation: All hardware changes have been successfully installed and substantiated on the IAE mock-up and has been the subject of satisfactory engineering analysis.
- 5. Effects of Bulletin on:

- A. Find the Terminal Module Assembly, PN 745-5435-501 looking forward on the engine, in the two o'clock position, at the termination of the Harness (ref). Refer to Figure 1.
- B. Remove the four Screws Pan Head 10-32, PN A218-D14 which attach the Cover, PN 745-5455-501 to the Bracket, PN 745-5453-501 and the Bracket, PN 745-5454-501.
- C. Remove the Screw Pan Head 6-32, PN A218-B14 and Washer, PN SP154-B which attach the Cover, PN 745-5455- 501 to the Bracket, PN 745-5453-501.

N. Locate the Harness (ref) in the new position making sure that it will not make contact with the Cover, PN 745-5455-501, the Anchor Nut (ref) or the through-hole in the Bracket, PN 745-5453-501.

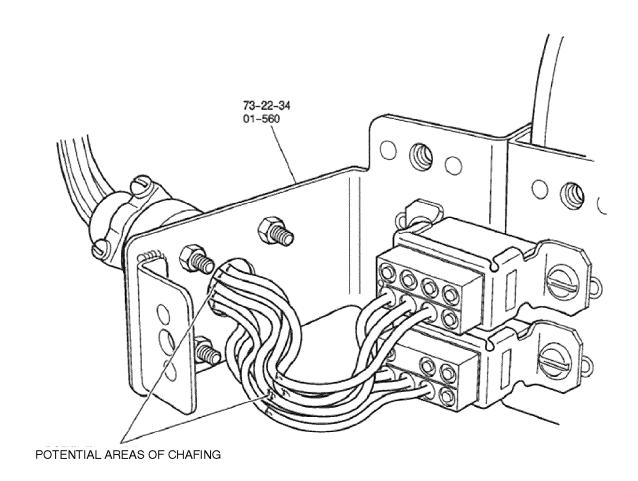
ADHESIVE TAPE APPLICATION VIEWS FIGURE 2, SHEET 1

VIEW OF THE HARNESS PRIOR TO INCORPORATION OF THIS SERVICE BULLETIN

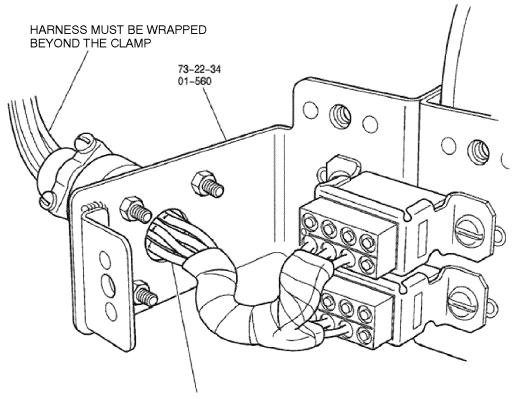
ADHESIVE TAPE APPLICATION VIEWS FIGURE 2, SHEET 2

Some operators did not correctly install the adhesive tape when incorporating this service bulletin. Incorrect installation of the adhesive tape may have caused the harness to chafe. The tape must begin at the terminal block and end beyond the clamp. The total length of wrapping is approximately 6.0 inches (152.4 mm). Several graphics have been added in Figure 2 to show correct and incorrect installation of the adhesive tape. Operators that have previously incorporated this service bulletin must perform an inspection to verify that the adhesive tape was installed correctly. This inspection of the adhesive tape must be completed the next time the engine is at a maintenance base that can do this service bulletin.

HARNESS MUST BE WRAPPED THROUGH THE BRACKET AND BEYOND THE CLAMP

INCORRECT APPLICATION OF ADHESIVE TAPE

If the adhesive tape was not installed correctly, and the harness is chafed on the insulation only, repair the insulation per Aircraft Maintenance Manual, Chapter/Section 70-71-22. Install the adhesive tape as specified in the Accomplishment Instructions.

If the adhesive tape was not installed correctly, and the harness is chafed below the wire insulation, replace the harness per Aircraft Maintenance Manual, Chapter/Section 71-51-42 and 71-51-43. Install the tape as specified in the Accomplishment Instructions.

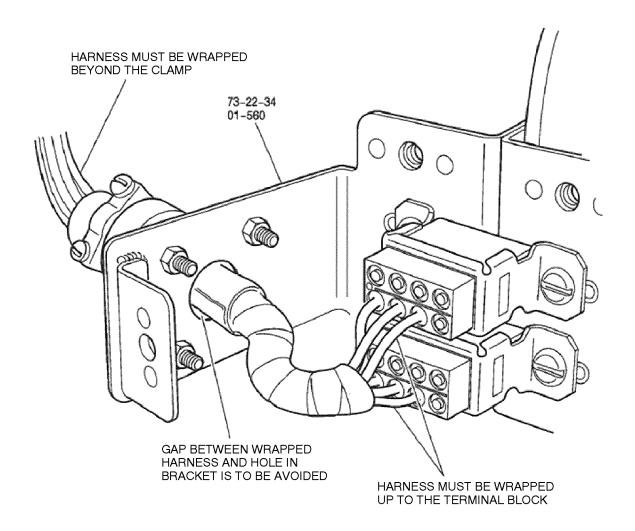
ADHESIVE TAPE APPLICATION VIEWS FIGURE 2, SHEET 3

INORRECT APPLICATION OF ADHESIVE TAPE

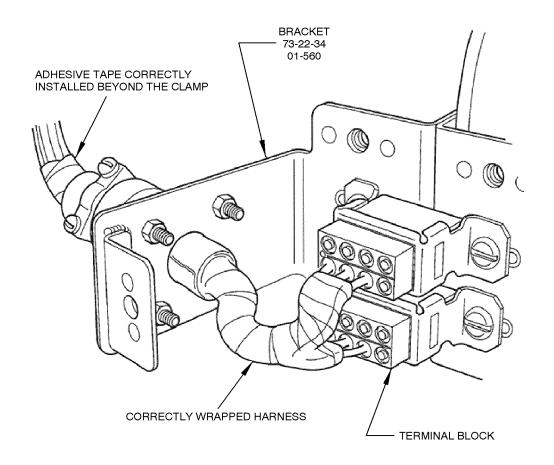
ADHESIVE TAPE APPLICATION VIEWS FIGURE 2, SHEET 4

VIEW OF CORRECT ADHESIVE TAPE INSTALLED ON THE HARNESS

M. Starting from the Terminal Junction Module, PN M81714/3-D-A1 and the Terminal Junction Module, PN M81714/3-D-B1, install three layers of Adhesive Tape (CoMat 02-148) along the length of the Harness (ref) for a distance of approximately 6.0 in. (152.4 mm).

NOTE: Confirm that the end of adhesive tape application is aft of the clamps (ref) .
