V2500-A5 SERIES PROPULSION SYSTEM SERVICE BULLETIN

V2500-ENG-71-0276

ENGINE – ENGINE BUILD UNIT (EBU) – REWORK OF ELECTRICAL HARNESS AND BRACKET ASSEMBLY
TO ACCOMMODATE THE REROUTING OF THE OIL SCAVENGE TUBES

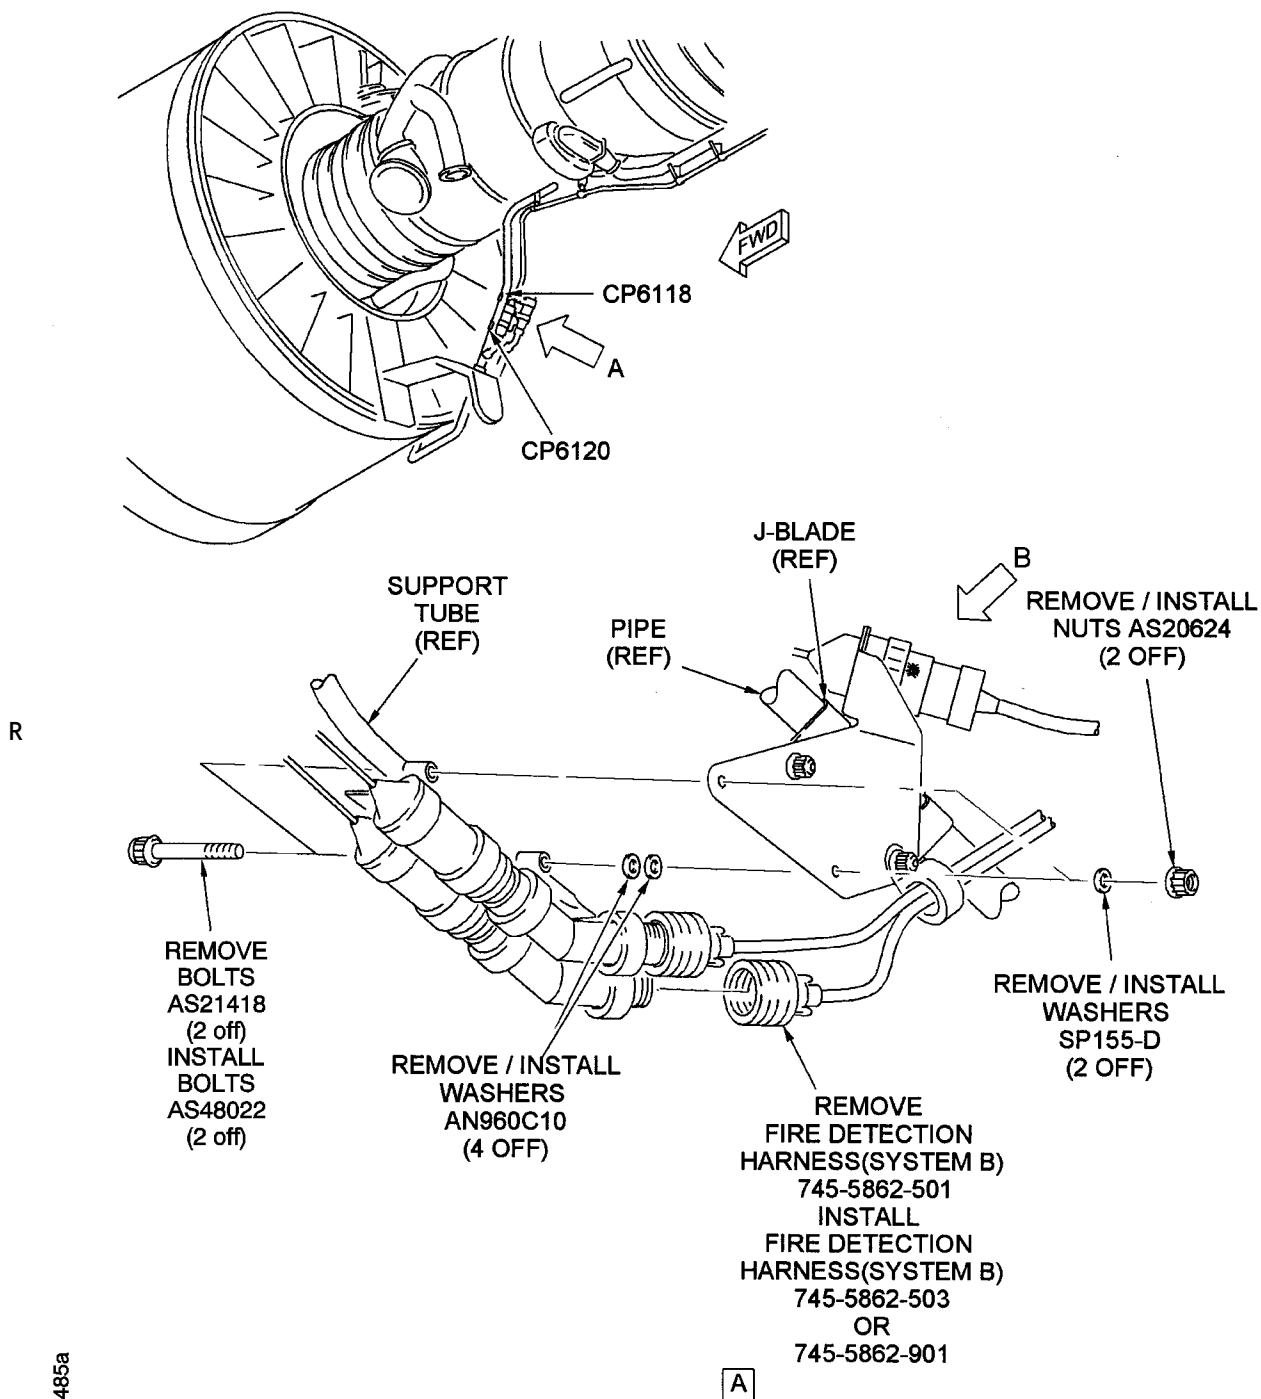
Rework of the Bracket and Fire Detection Harness (System B)
Figure 1, sheet 1 of 3

- (1) Find the 740-5290-501 Bracket which attaches to the 745-5862-501 Fire Detection Harness (System B) on the underside of the engine. Refer to Figure 1, Sheet 1 of 3.
- (2) Remove the 740-5290-501 Bracket from the aircraft using the steps that follow:

| (a) Clipping Point CP6118: Remove the upper, aft AS20624 Nut and AS21411 Bolt which attach the 740-5290-501 Bracket to the J-Blade (ref) and Pipe (ref). | Refer to Figure 1, Sheet 1 of 3 and Figure 1, Sheet 2 of 3. |
| (b) Clipping Point CP6118: Remove the lower, aft AS20624 Nut, SP155-D Washer, two AN960C10 Washers and AS21418 Bolt which attach the 740-5290-501 Bracket to the J-Blade (ref) and Pipe (ref). | Refer to Figure 1, Sheet 1 of 3 and Figure 1, Sheet 2 of 3. |
| (c) Clipping Point CP6120: Remove the upper, forward AS20624 Nut, P-Clip (ref) and AS21412 Bolt which attach the 740-5290-501 Bracket to the J-Blade (ref) and Pipe (ref). | Refer to Figure 1, Sheet 1 of 3 and Figure 1, Sheet 2 of 3. |
| (d) Clipping Point CP6120: Remove the lower, forward AS20624 Nut, SP155-D Washer, two AN960C10 Washers and AS21418 Bolt which attach the 740-5290-501 Bracket to the J-Blade (ref) and Pipe (ref). | Refer to Figure 1, Sheet 1 of 3 and Figure 1, Sheet 2 of 3. |
| (e) Remove the four AS8623A Nuts, four SP155-A Washers and four A117-1-A Bolts to detach the 740-5290-501 Bracket from the Overheat Detector (ref). | Refer to Figure 1, Sheet 1 of 3 and Figure 1, Sheet 2 of 3. |

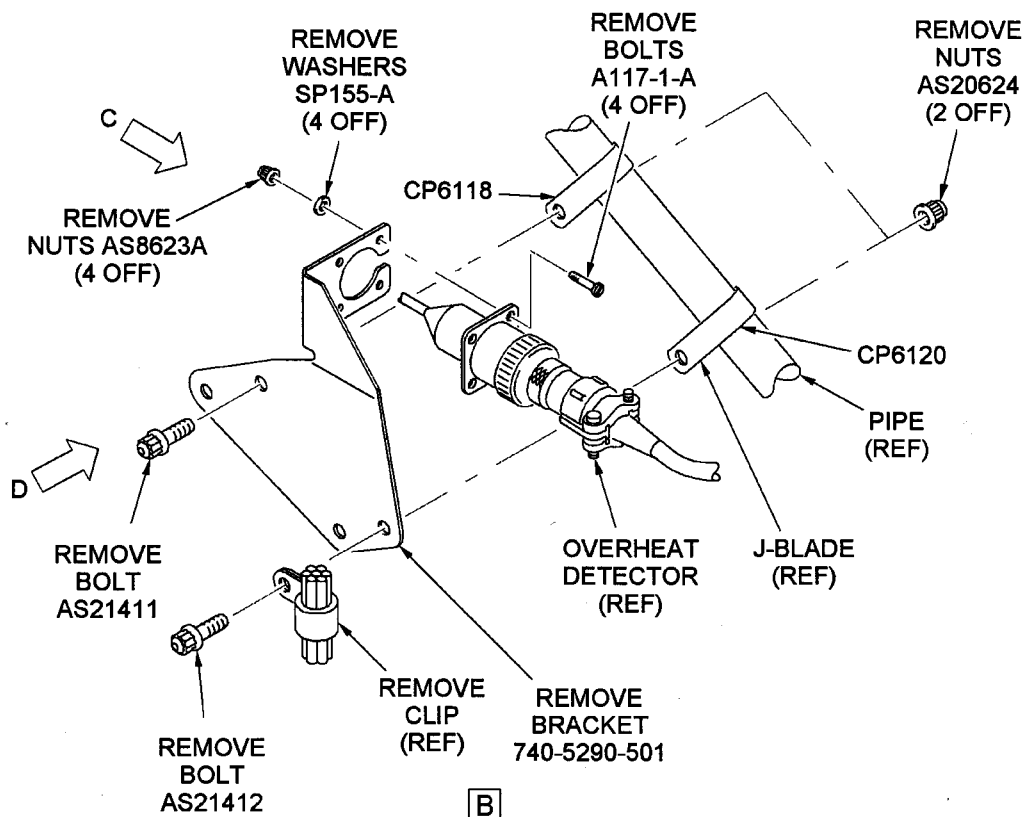
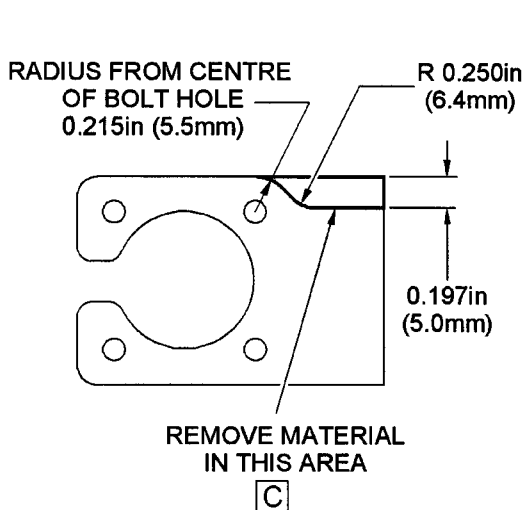
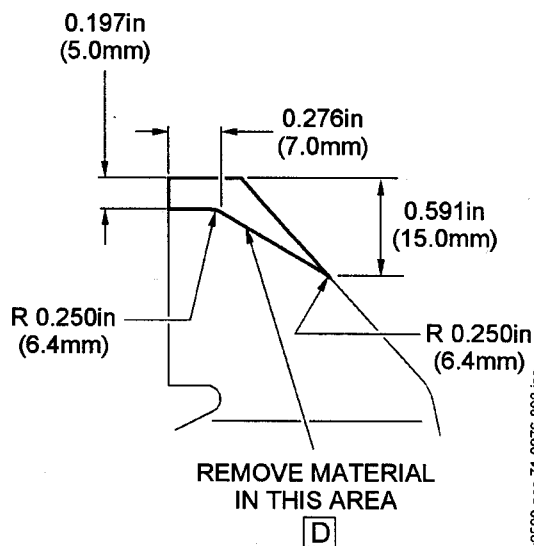
Rework of the Bracket and Fire Detection Harness (System B)
Figure 1, sheet 2 of 3

Re-routing of the No.4 Compartment Oil Scavenge Tube has led to the re-positioning of the Fire Detection Harness clipping points. This has necessitated an increase in the harness length to allow easier installation and to reduce tension in the harness assembly. The Overheat Detector Bracket has been found to be in close proximity to the TRU hold-open rod and hence requires modification/replacement to increase clearance.

- (a) Use indelible ink pen to mark off the area of the 740-5290-501 Bracket to be reworked. Refer to Figure 1, Sheet 2 of 3.
- (b) Carefully remove the area marked-off in the step above. Refer to Figure 1, Sheet 2 of 3.
- (c) Use vibro-etching to re-identify the Bracket from '740-5290-501' to '740-5290-503'. Refer to Figure 1, Sheet 2 of 3. Re-identify parts as instructed in the Standard Practices/Processes Manual, Task 70-09-00-400-501.
