This document transmits the Initial Issue of Service Bulletin EV2500-71-0278

**V2500-ENG-71-0278**

POWER PLANT – CORE HARNESSSES – INTRODUCTION OF EEC LOOMS G AND H WITH REVISED  
INSULATION SHIELDING

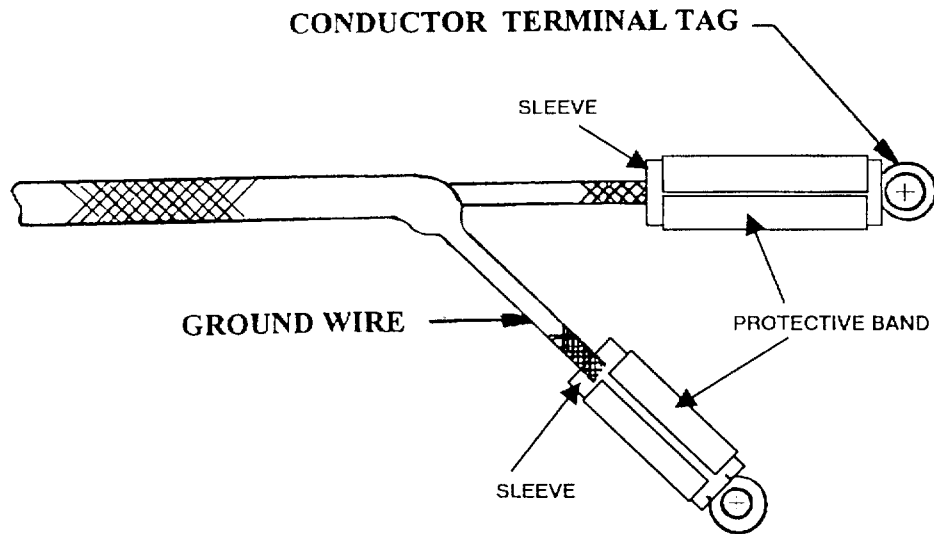
Pre SB71-0278

Thermal break down of the loom G and loom H (fire wire system harnesses) insulation shield can occur, which allows the rolled back end of the metal over-braid to creep forward and make contact with the terminal tags.

This results in a short circuit to ground, leading to false fire indicators with subsequent delays and maintenance carry-overs.

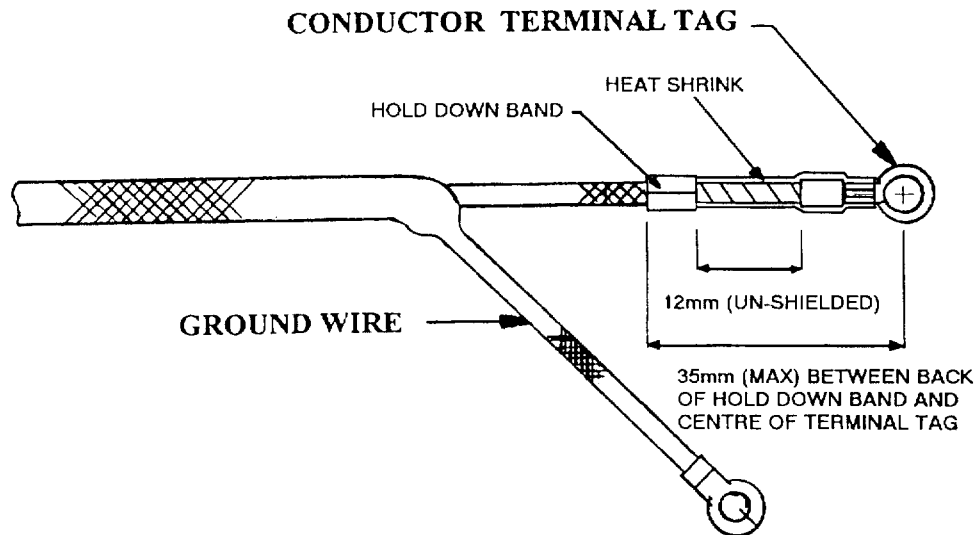
Post SB71-0278

(a) Revised Fire Detection Harnesses, EEC Looms G and H, are introduced similar to the existing items except for the following:-

- (i) There are two locations on the harness with terminal tags and ground wires arranged as shown in Fig.1. At one of these locations only layers of glass tape are introduced between the existing insulation and the inner wire braid, with the unshielded space being increased from 0.25in. to 0.47in. (6,35mm to 12,00mm.)
- (ii) The protective bands have been reduced in quantity from 4 off to 2 off per harness.
- (iii) The Sleeves have been reduced in quantity from 8 off to 4 off per harness.
- (iv) Existing insulation shields are replaced by heat shrink sleeving.
