V2500 A5 SERIES PROPULSION SYSTEM SERVICE BULLETIN

POWER PLANT – ELECTRICAL HARNESS – EEC HARNESS – FAN – DELETION OF LIGHTNING STRIKE
PROTECTION SLEEVES – MOD 71-0294

V2500-ENG-71-0294

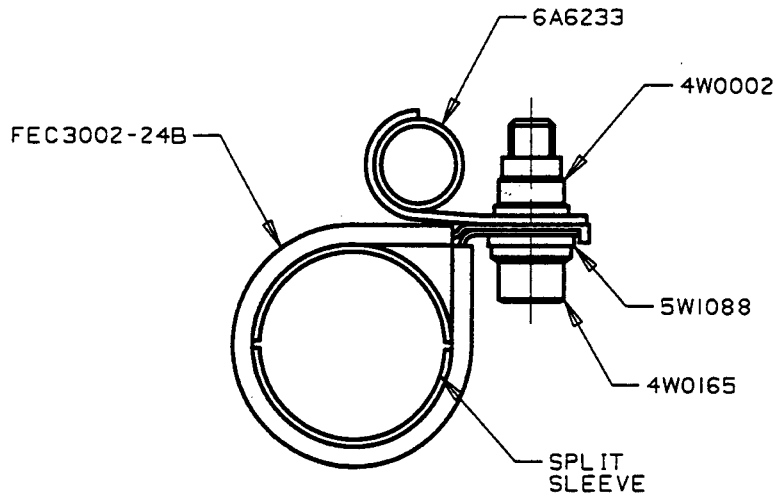
CLIPPING POINT 1447
PRIOR TO MODIFICATION

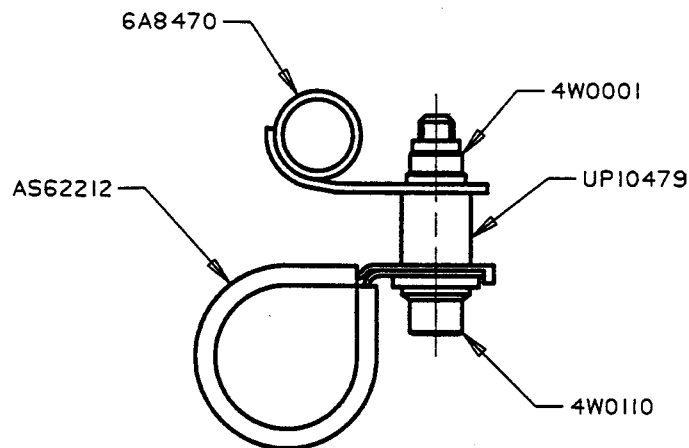
CLIPPING POINT 1447
AFTER MODIFICATION

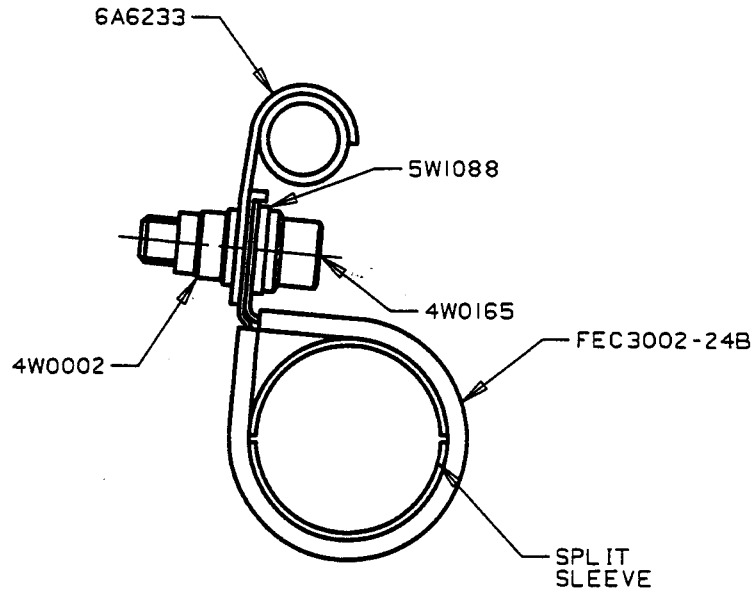
CLIPPING POINT 1448
PRIOR TO MODIFICATION

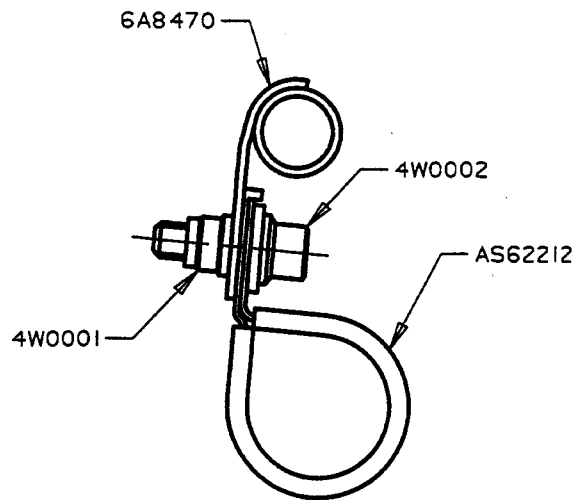
CLIPPING POINT 1448
AFTER MODIFICATION

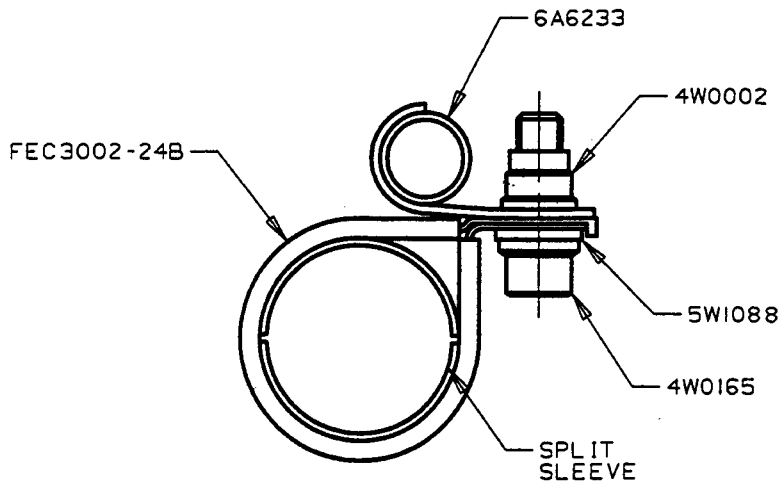
CLIPPING POINT 1449
PRIOR TO MODIFICATION

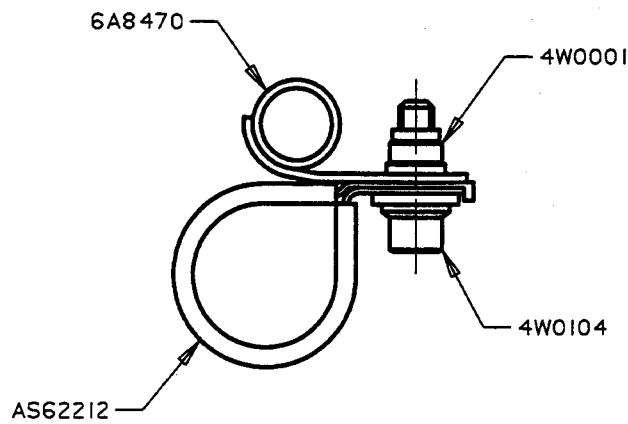
CLIPPING POINT 1449
AFTER MODIFICATION

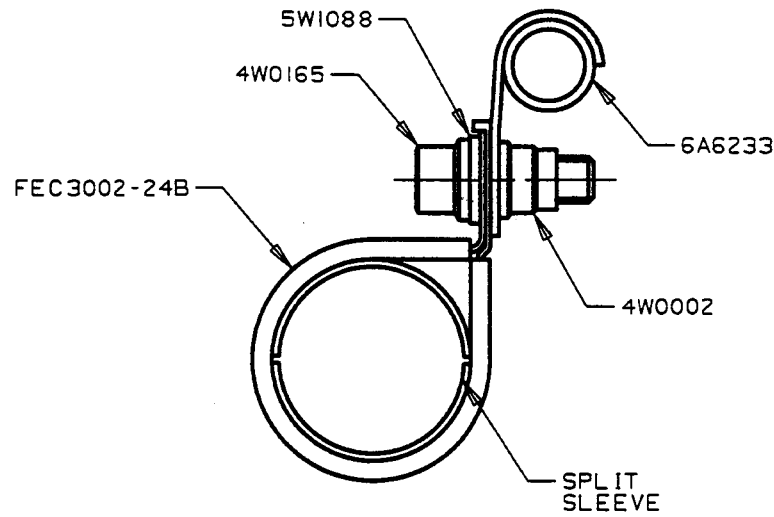
CLIPPING POINT 1450
PRIOR TO MODIFICATION

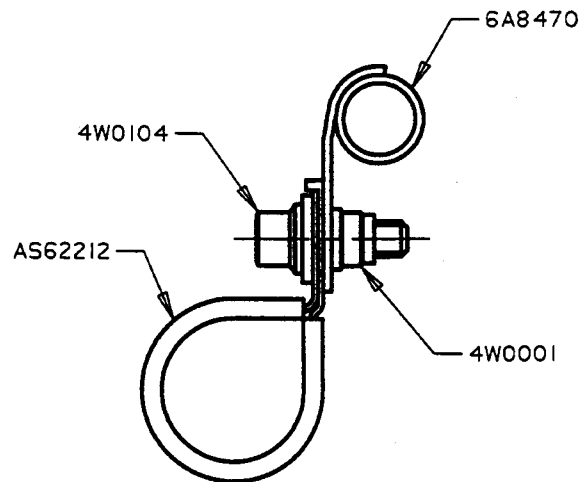
CLIPPING POINT 1450
AFTER MODIFICATION
