V2500-A5 SERIES PROPULSION SYSTEM SERVICE BULLETIN

V2500-ENG-71-0311
Transmittal - Page 1 of 1

ENGINE – INSTALLATION OF CABLE WRAP ON THE ENGINE SYSTEM DRAIN PIPES (FOR CONTROLLED
SERVICE USE)(BANGKOK AIRWAYS ONLY)

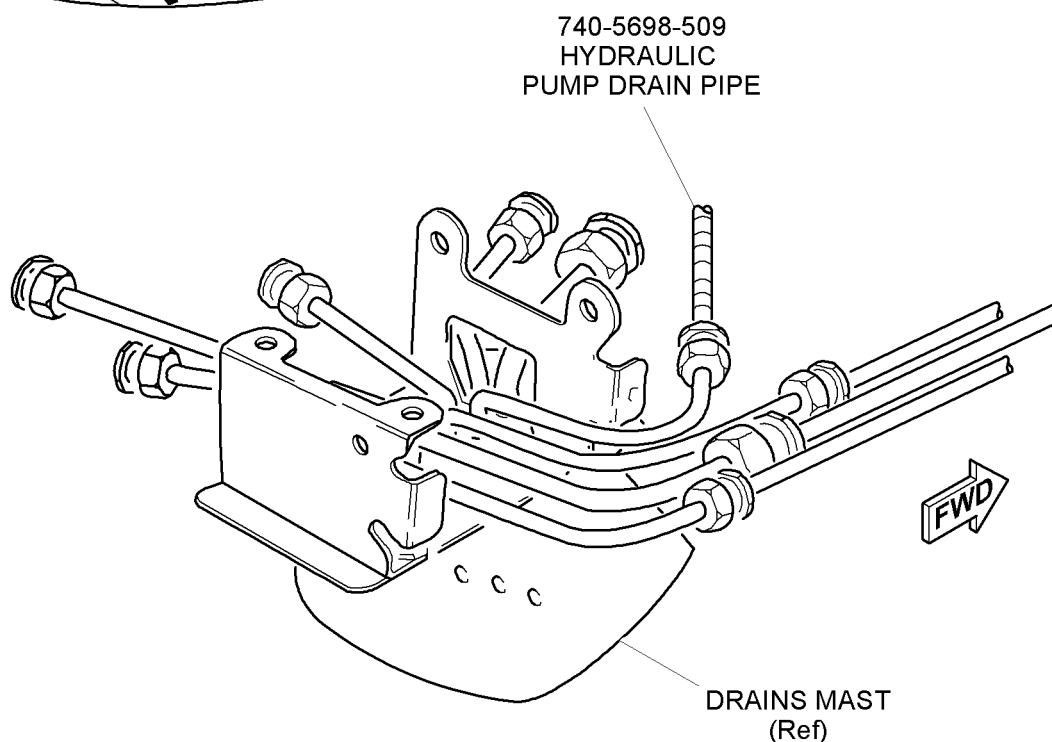
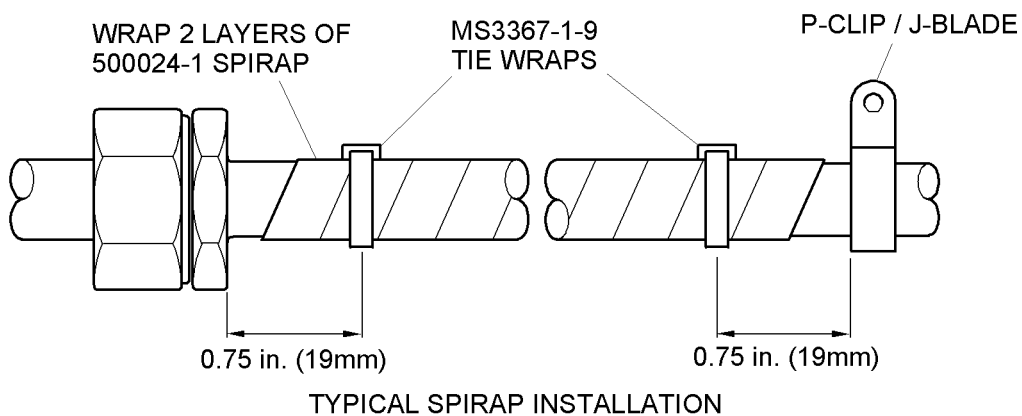
Installation of the Spirap to the Drain Tube
Figure 1

Some operators have experienced a hard foul between the #3 Latch on the Fan Cowl Door and the Hydraulic Pump Drains Line when the Door is being fully closed.

Airlines have experienced excessive wear of the Hydraulic Pump Drains Line in way of the #3 Latch on the Fan Cowl Door.

- (4) Use a clean lint free cloth (CoMat 02-099) made moist with solvent (CoMat 01-076 or CoMat 01-124) and remove dirt and grease from the surfaces of the drain pipes identified in Figure 1. Wipe the area dry before the solvent becomes dry.
- (5) Apply two layers of spirap, P/N 500024-1 around the pipe between the pipe union and the first clipping point.
- (6) Secure the spirap to the pipe with two tie wraps, P/N MS3367-1-9 fitted approximately 0.75in. (19,0 mm) from the Pipe Union and approximately 0.75in. (19,0 mm) from the first clipping point.
- (7) Close the Fan Cowl Doors as instructed in the A320/V2500-A1 A319/A320/A321/V2500-A5 Aircraft Maintenance Manual, Task 71-13-00-410-010.

Use a clean lint free cloth (CoMat 02-099) made moist with solvent (CoMat 01-076 or CoMat 01-124) and remove dirt and grease from the surfaces of the drain pipes identified in Figure 1. Wipe the area dry before the solvent becomes dry.
