## V2500-A5 SERIES PROPULSION SYSTEM NON-MODIFICATION SERVICE BULLETIN

# V2500-ENG-71-0315

NON-MODIFICATION SERVICE BULLETIN – POWERPLANT – EBU – HYDRAULIC SUCTION LINE AND  
FUEL RETURN LINE HOSES – INSPECTION FOR APPLICATION OF PROPER TORQUE

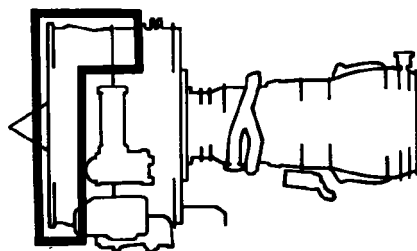
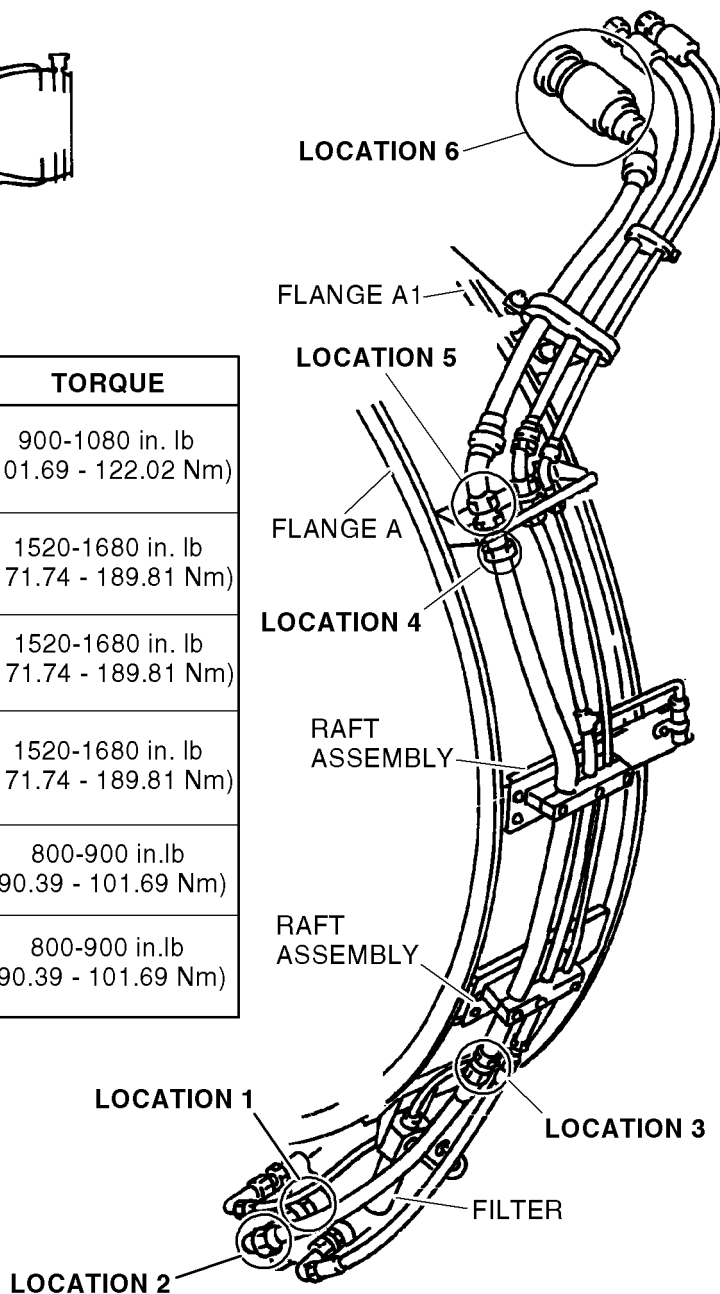
Inspection for proper torque of Hydraulic Suction Lines installation  
Figure 1

(a) Following a review of the Hydraulic Suction Lines installation torque and system operating requirements, and in the absence of a lockwire requirement, it was determined that an inspection for proper torque on the affected engines was the responsible course of action.

- (1) Using an appropriate torque wrench, verify the installation torque on the subject Hydraulic Suction Line connections, see Figure 1. Refer to the Airbus Aircraft Maintenance Manual, Chapter/Sections 29-11-49, Task 29-11-49-400-010, Subtask 29-11-49-420-050 for Engine No 1.
- (2) Using an appropriate torque wrench, verify the installation torque on the subject Hydraulic Suction Line connections, see Figure 1. Refer to the Airbus Aircraft Maintenance Manual, Chapter/Sections 29-13-49, Task 29-13-49-400-010, Subtask 29-13-49-420-050 for Engine No 2.
- (3) Using an appropriate torque wrench, verify the installation torque on the subject Fuel Line connections, see Figure 2. Refer to the Airbus Aircraft Maintenance Manual, Chapter/Sections 73-11-48, Task 73-11-48-400-010, Subtask 73-11-48-420-052.

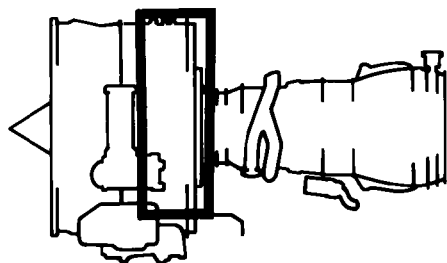
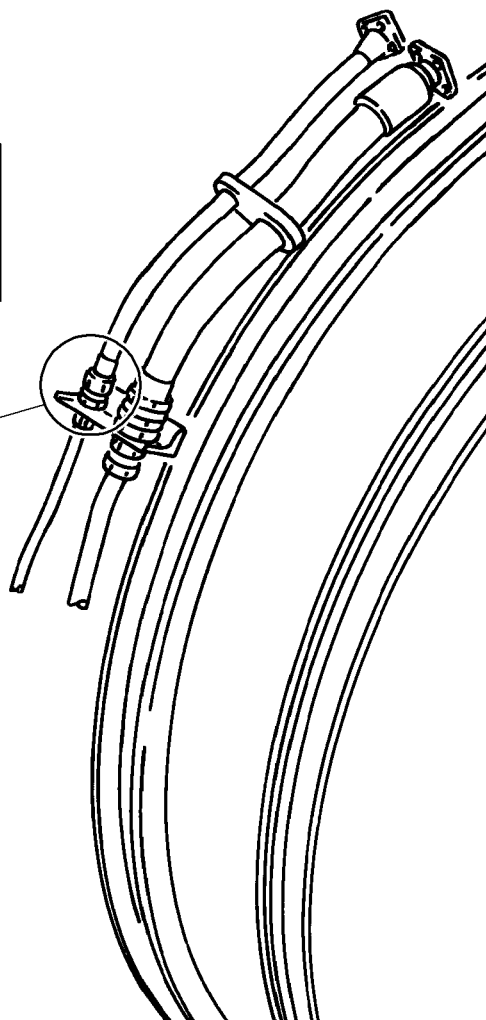
Inspection for proper torque of Fuel Return Line installation  
Figure 2

(b) Following a review of the Fuel Return Line installation torque and system operating requirements, and in the absence of a lockwire requirement, it was determined that an inspection for proper torque on the affected engines was the responsible course of action.
