# SERVICE BULLETIN

POWERPLANT — HARNESS CLAMP — REDUCTION OF HARNESS CLAMP  
SIZE REQUIREMENT AT CLIPPING POINT 2409

V2500 Series 71-0319

**V2500-ENG-71-0319**

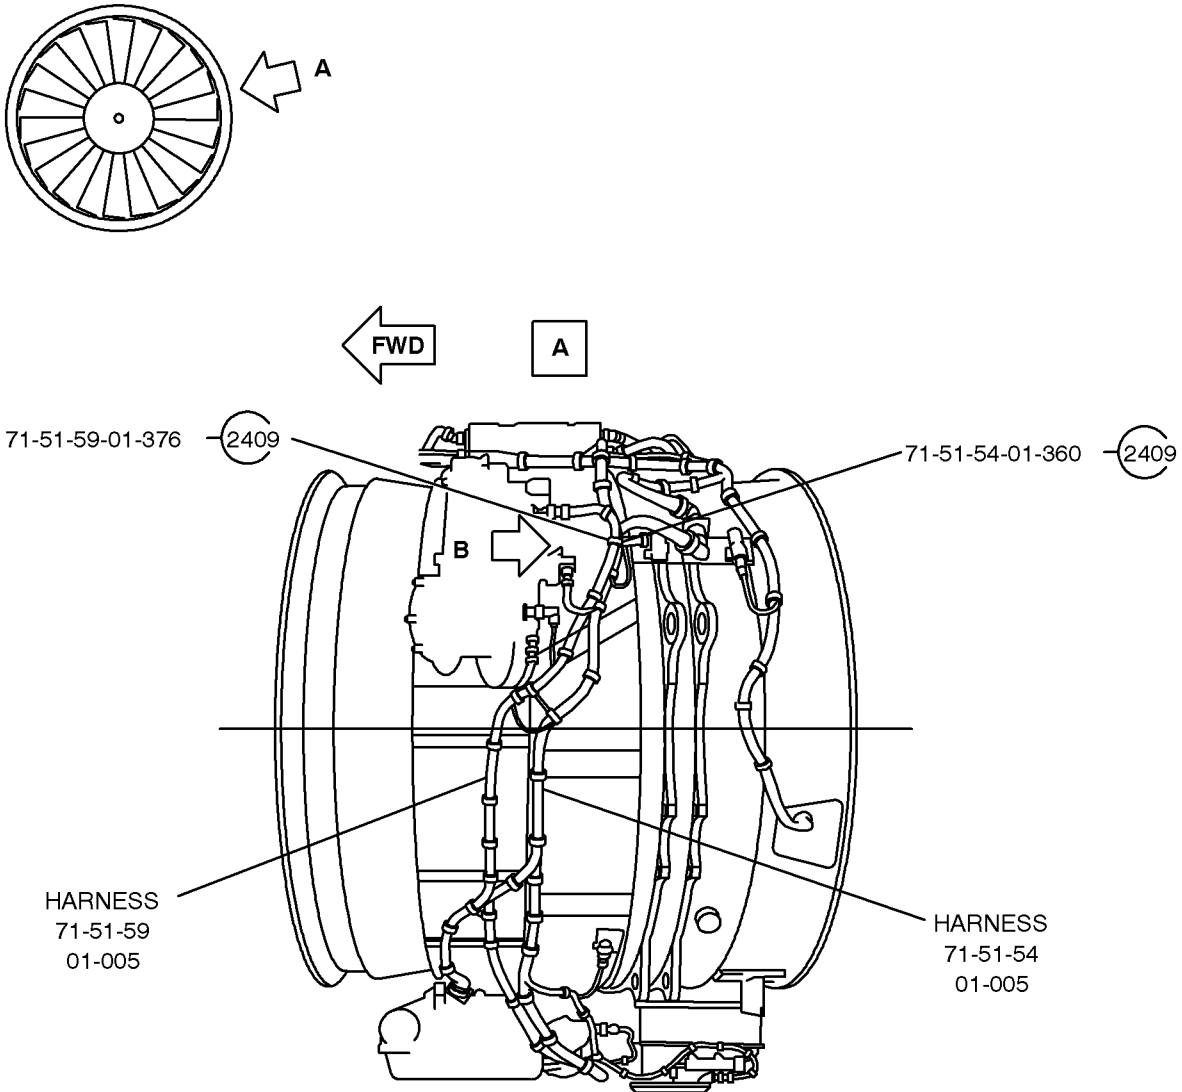
LOCATION OF CLIPPING POINT 2409  
FIGURE 1

1. Condition: Loss of oil and low oil pressure was attributed to a chafed Oil Scavenge Tube, PN 6A5089 adjacent to clipping point 2409. Chafing was caused by the bolt attached to clipping point 2409 when clamps moved along the harness.
2. Background: An In-Flight Shutdown (IFSD) occurred in service due to loss of oil quantity and low oil pressure. Loss of oil was due to chafing of a bolt causing a hole to the Oil Scavenge Tube, PN 6A5089 at clipping point 2409.
3. Objective: Provide instructions to replace the clamps.
4. Substantiation: Investigation showed that chafing of the oil tube can be avoided by installing smaller clamps.
5. Effects of Bulletin on:
  - Removal/Installation: Affected.
  - Disassembly/Assembly: Not Applicable.
  - Cleaning: Not Applicable.
  - Inspection/Check: Affected.
  - Repair: Not Applicable.
  - Testing: Not Applicable.
6. Supplemental Information
  - None.

1. Open thrust reverser halves in accordance with Reference 5, Aircraft Maintenance Manual (AMM), Task 78-32-00.
2. Remove the Nut, PN 4W0001 and the Bolt, PN AS20908 which attach the Clamp, PN AS62518 and PN AS62510 at clipping point 2409. See Figures 1 and 2 for location of the parts.

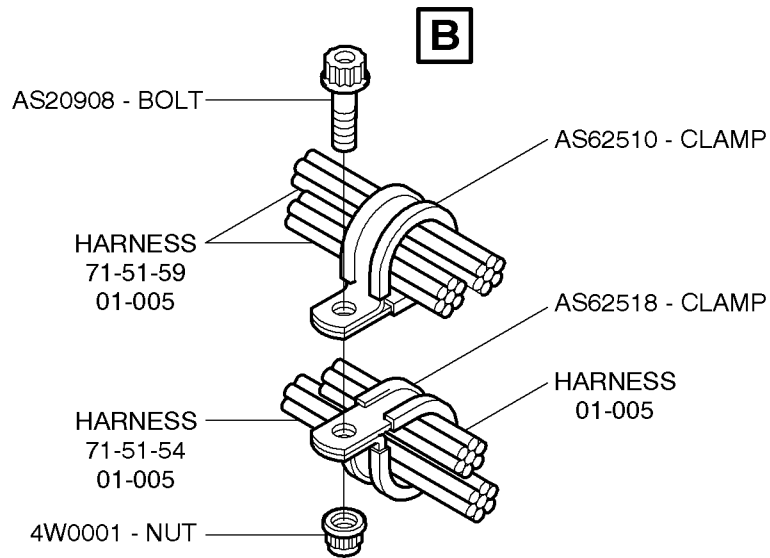
CLIP POSITION 2409

PRE SB

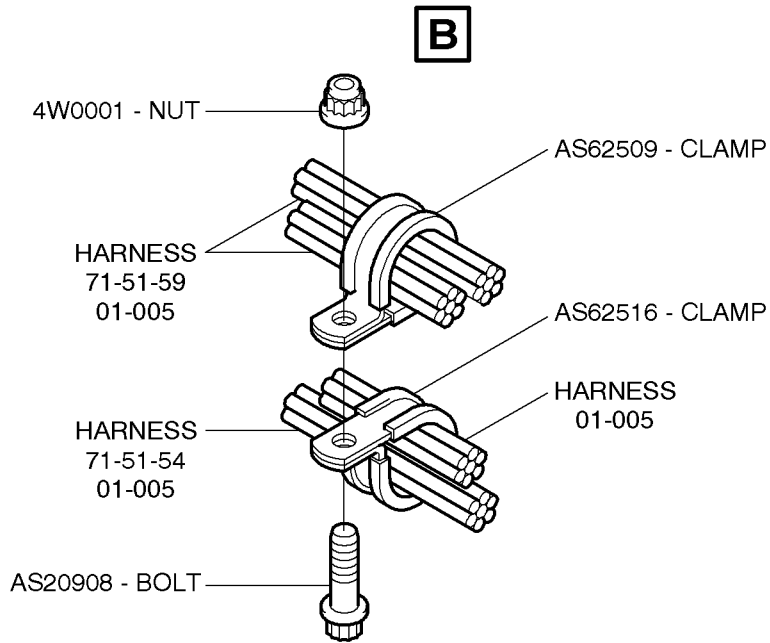
CLIP POSITION 2409

POST SB

- B. Replace Clamp, PN AS62510 with Clamp, PN AS62509.
5. Install the new Clamp, PN AS62516 and PN AS62509, Bolt, PN AS20908 with shaft showing upwards (see Figure 2) and Nut, PN 4W0001 at clipping point 2409 in accordance with Reference 2, Standard Practices Manual (SPM), Task 70-43-02-400-501. Torque the Nut, PN 4W0001 to 36 – 45 lbf-in. (4 – 5 N-m).
