# SERVICE BULLETIN

ENGINE - REMOVE MATERIAL FROM THE LEADING EDGE OF STAGE 2.0 COMPRESSOR BLADES TO IMPROVE CLEARANCE - CATEGORY CODE 6 - MOD.ENG-72-0001

V2500-ENG-72-0001

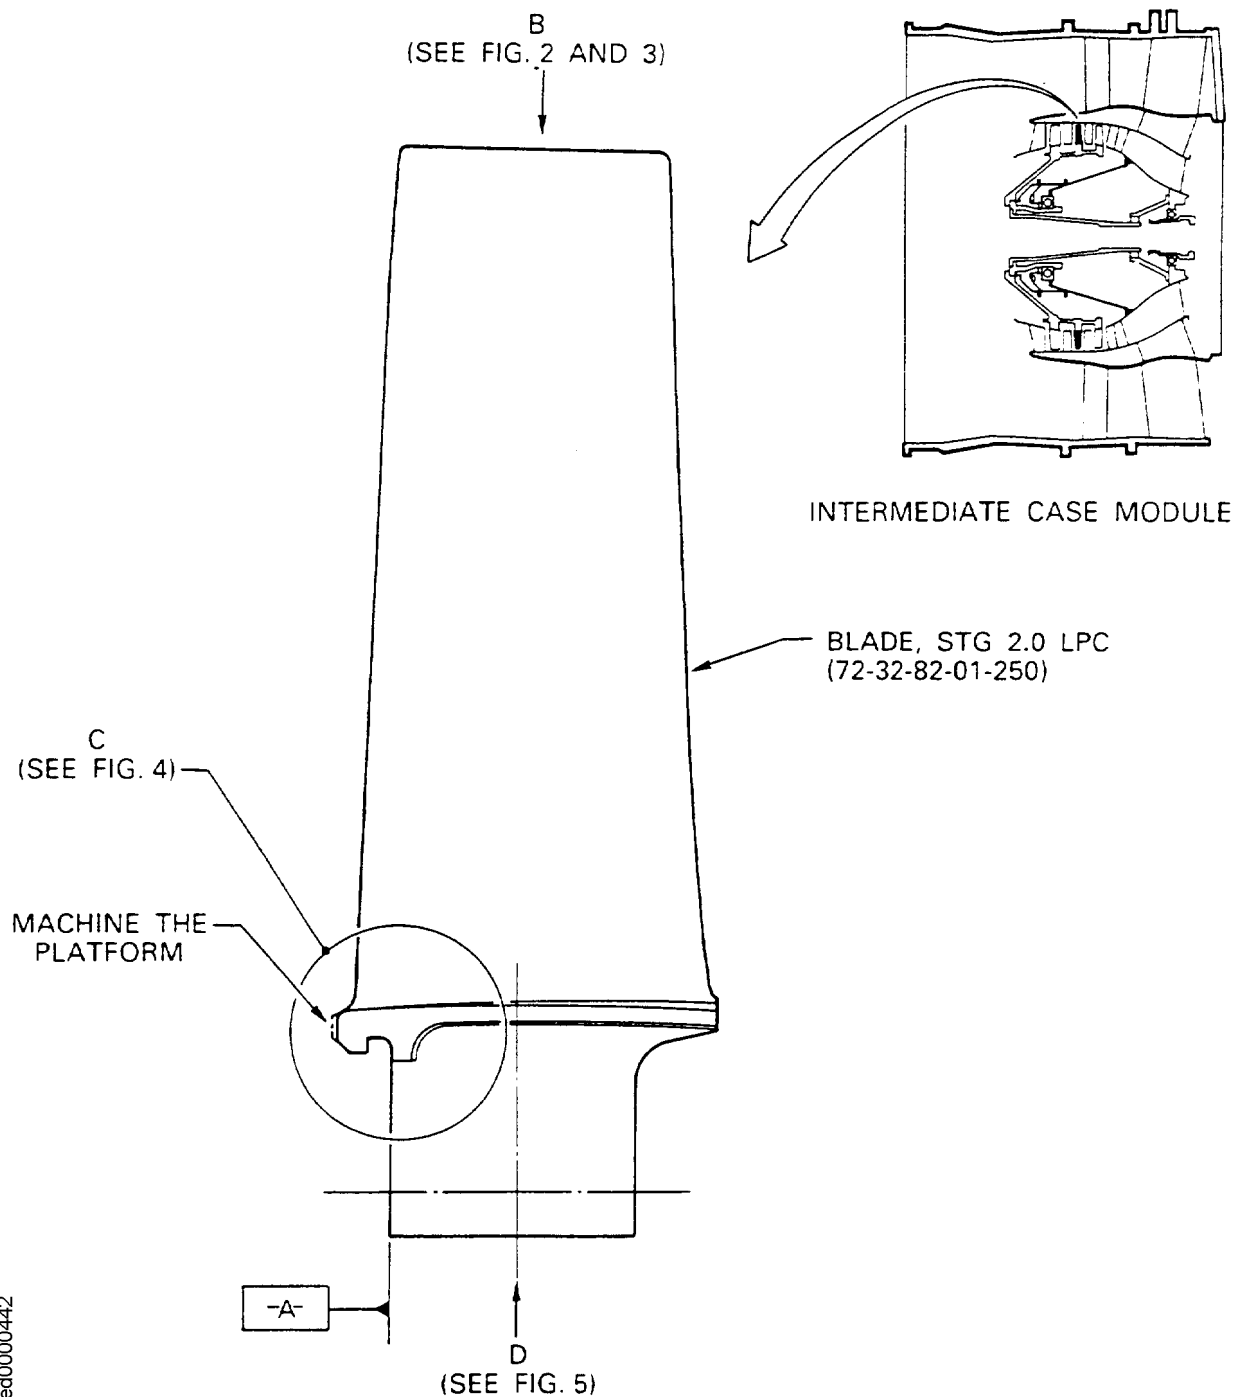
Outline of rework  
Fig.1

Insufficient clearance may exist between the Stage 2.0 LP Compressor Blades and the Stage 1.5 LP Compressor Vanes.

Current Blades must be replaced or reworked to satisfy the minimum axial clearance.

Procedure	Supplementary Information
(a) Set-up and machine the platform of Blade	Refer to Figure 1, 2 and 3
(b) Finish the machined area	Refer to Figure 3 and 4. Break sharp edges 0.004 to 0.011in. (0,1 to 0,3 mm). Tool: RB010, Grinder, hand held pneumatic or equivalent

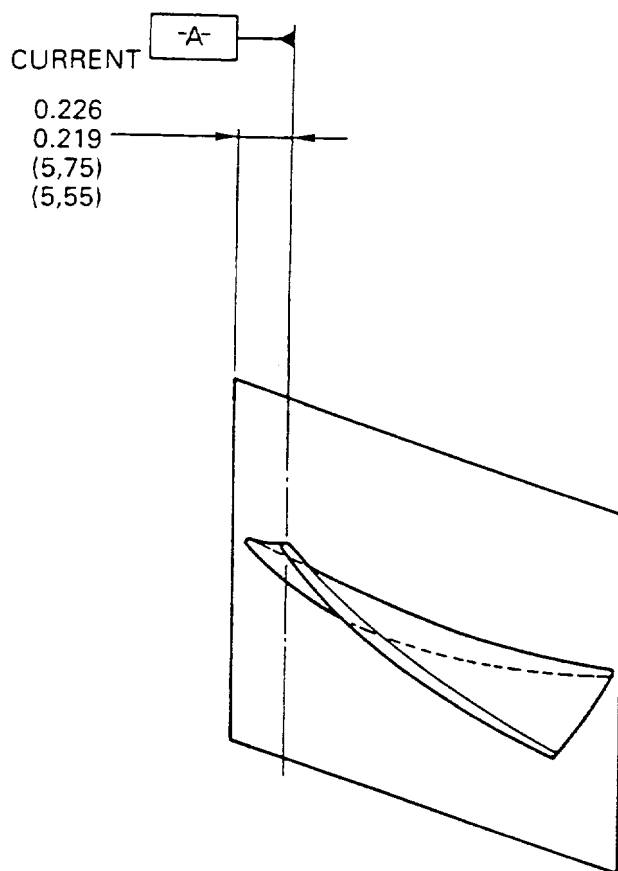
Before accomplishment of S.B.  
Fig.2

VIEW ON ARROW B (SEE FIG. 1)

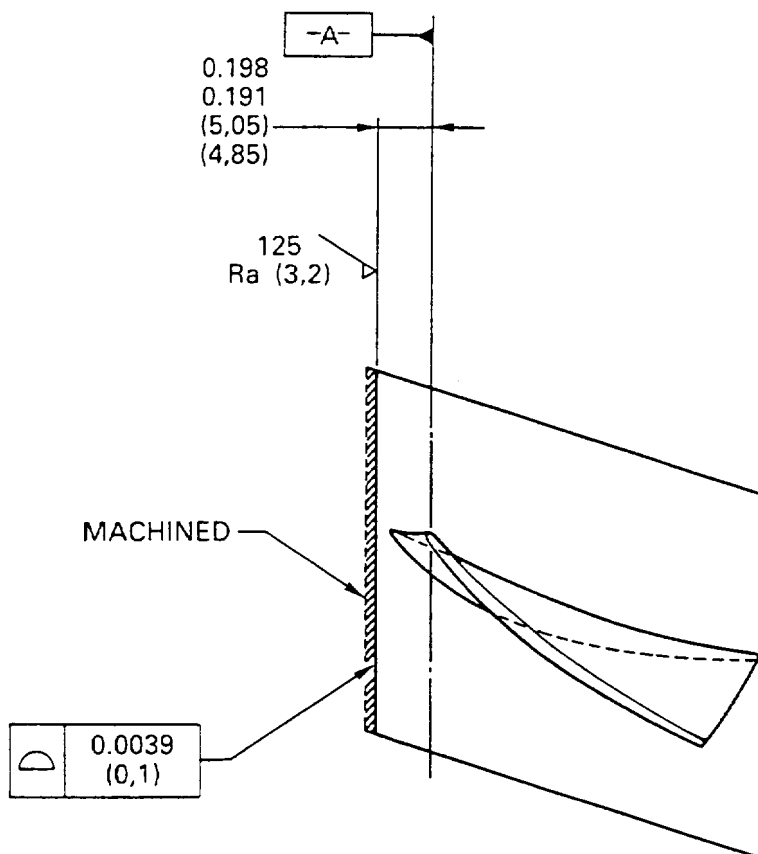
After accomplishment of S.B.  
Fig.3

REPEAT VIEW ON ARROW B (SEE FIG. 1)

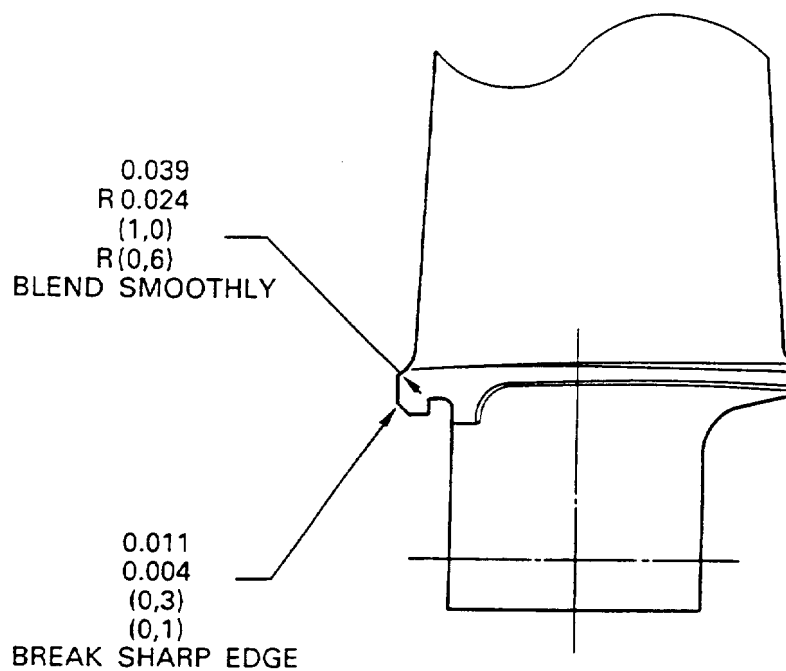
Fig.4

ENLARGED VIEW AT C (SEE FIG. 1)

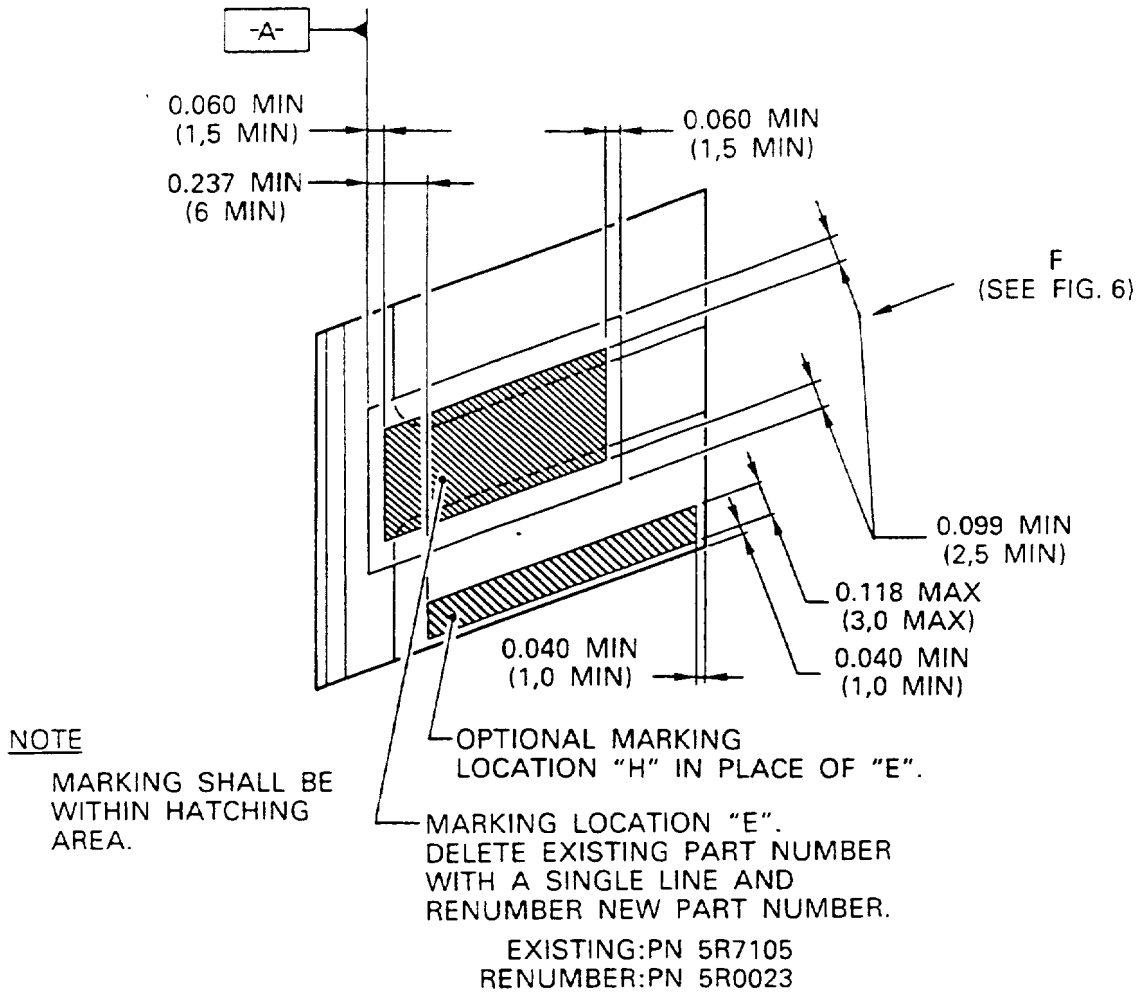
Marking location  
Fig.5

VIEW ON ARROW D (SEE FIG. 1)

(c) Delete existing Part Number with a single line and renumber New Part Number	Refer to Figure 5 and 6. Mark by vibro-peen, Ident No.AD005 or equivalent
	Old Part Number      New Part Number
	5R7105                      5R0023

- NOTE: 1. Marking locations 'G' and 'H' are permissible to mark if location 'E' does not have a sufficient area for marking.
2. Refer to Standard Practices/Processes Manual TASK 70-09-00-400-501.
3. All raised metal which exceeds 0.0009in. (0,025 mm) must be removed.

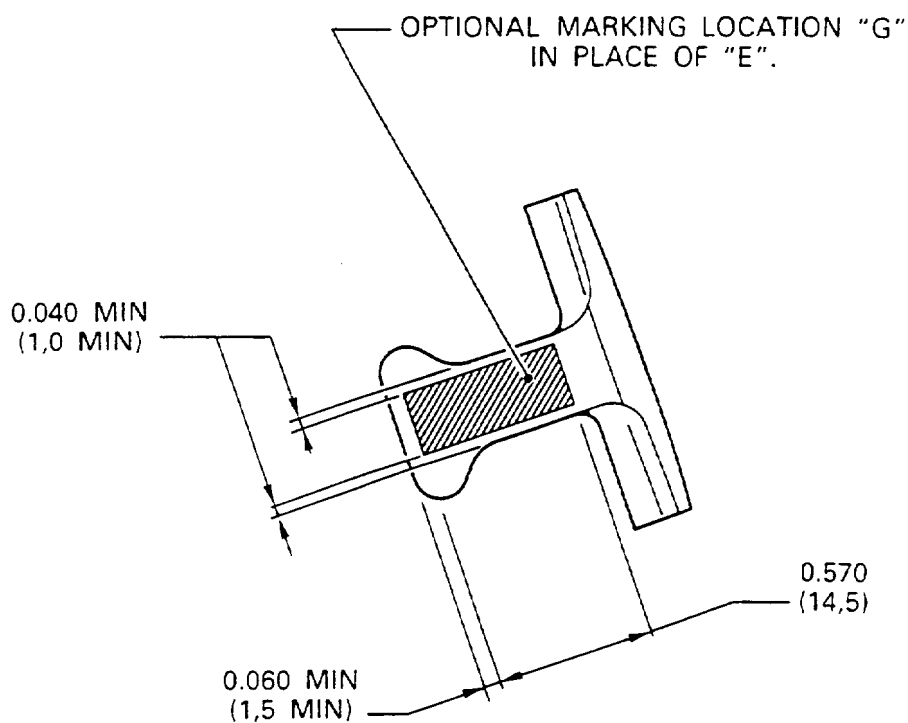
Marking Location  
Fig.6

VIEW ON ARROW F (SEE FIG. 5)
