SERVICE BULLETIN

<u>ENGINE - LP TURBINE - INTRODUCE A REVISED STAGE 7 LPT AIR SEAL - CATEGORY CODE 7 - MOD.ENG-72-0003</u>

V2500-ENG-72-0003

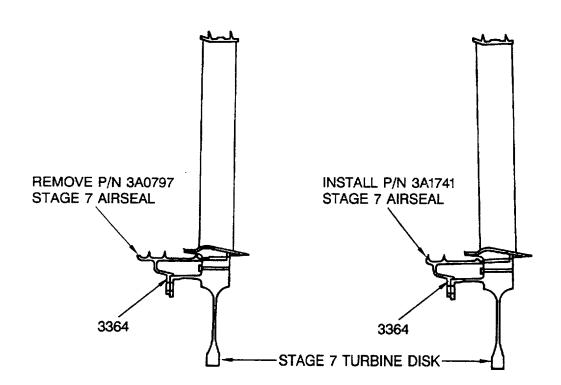
- (1) The changes introduced by this Service Bulletin are as follows:
 - (a) The weight of the part is reduced by removal of the front lip and reduction of the aft shoulder diameter.
 - (b) The snap diameter of the airseal is reduced.

View showing stage 7 airseal - Before and after alteration Fig.1 $\,$

- A. Rework Instructions
 - (1) There are no rework instructions necessary to accomplish this Service Bulletin.
- **B.** Assembly Instructions
 - (1) Install new 3A1741 stage 7 air seal on to the stage 7 Turbine disk by the approved procedure in Reference (2), Chapter/Section 72-50-30, Assembly-05 and figure 1 except:
 - (a) New air seal snap diameter: 19.1181 19.1221 inch (485,6 485,7 mm).
 - (b) Required new interference fit at location 3364: 0.0157 0.0236 inch (0.4 0.6 mm).
- C. Recording Instructions
 - (1) A record of accomplishment is necessary.
