ENGINE - LP TURBINE - INCORPORATE REVISED (EGT) BRACKETS OF FLANGE P - CATEGORY CODE 4
- MOD.ENG-72-0007

V2500-ENG-72-0007

SERVICE BULLETIN

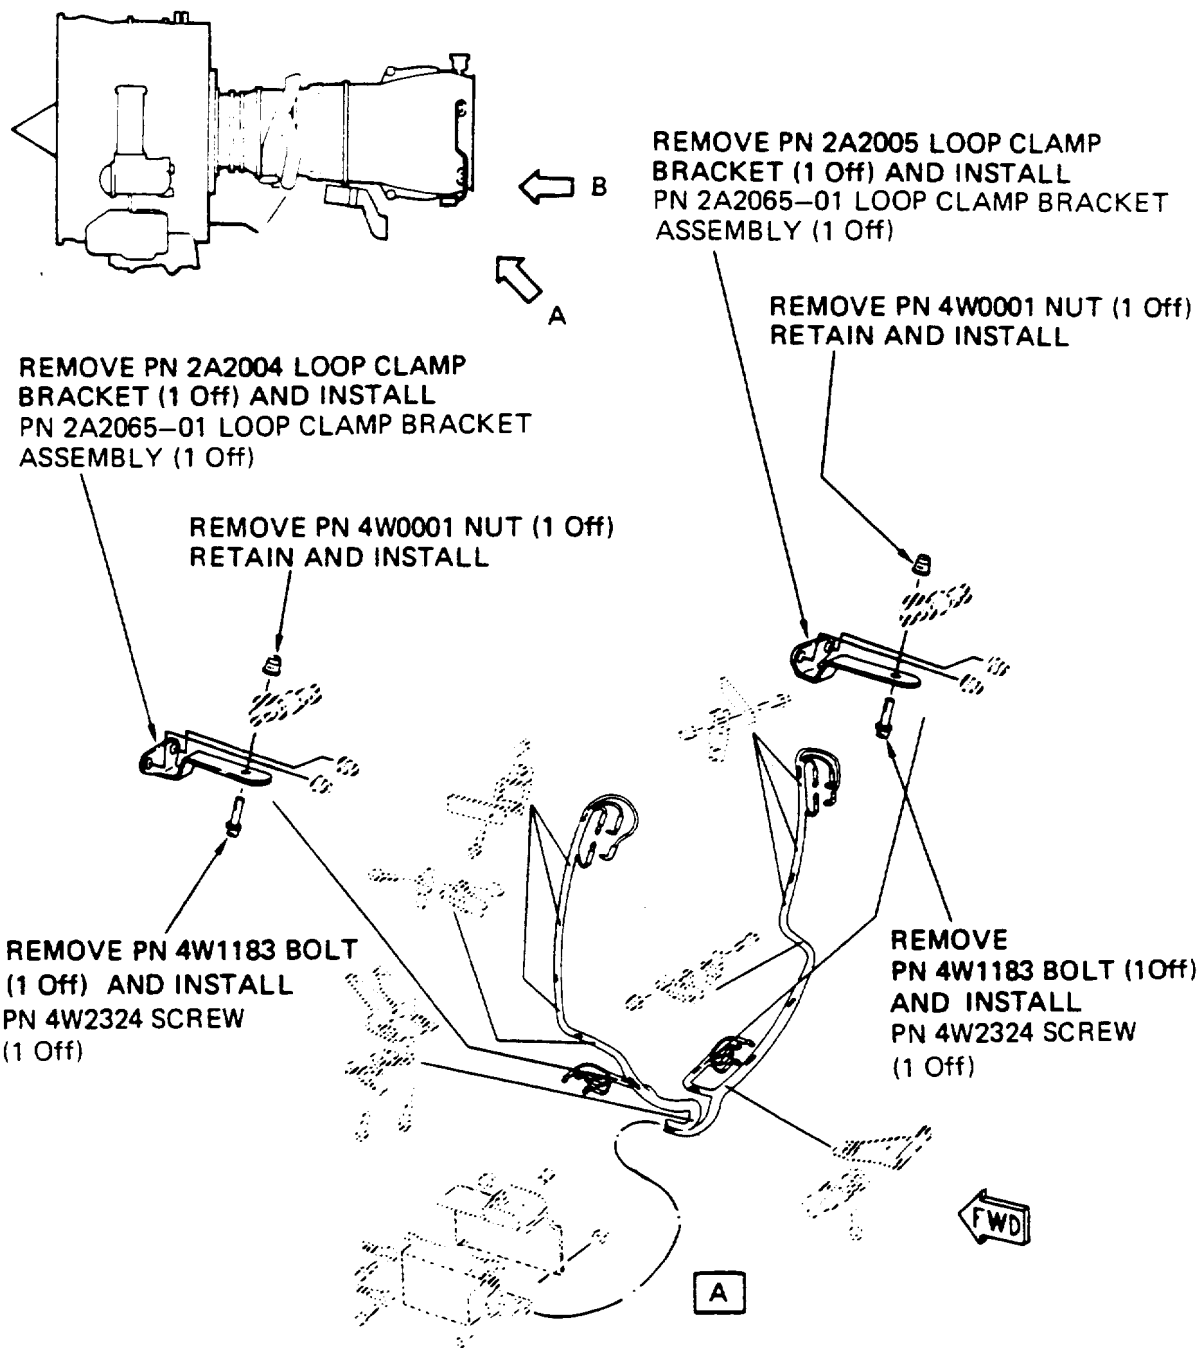
Fig.1

Replacement of Loop Clamp Brackets and Attaching Bolts (For Engines not Incorporating V2500-ENG-72-00-0050))

- (1) Remove the Nuts and Bolts which hold the two Loop Clamp Brackets 2A2004 and 2A2005 to the Loop Clamps
- (2) Remove the Nuts and Bolts which hold the 2A2004 and 2A2005 Loop Clamp Brackets to the Turbine Exhaust Case (Hole Locations 52, 53, 62 and 63). Refer to Figure 1.
- (3) Remove the Loop Clamp Brackets.

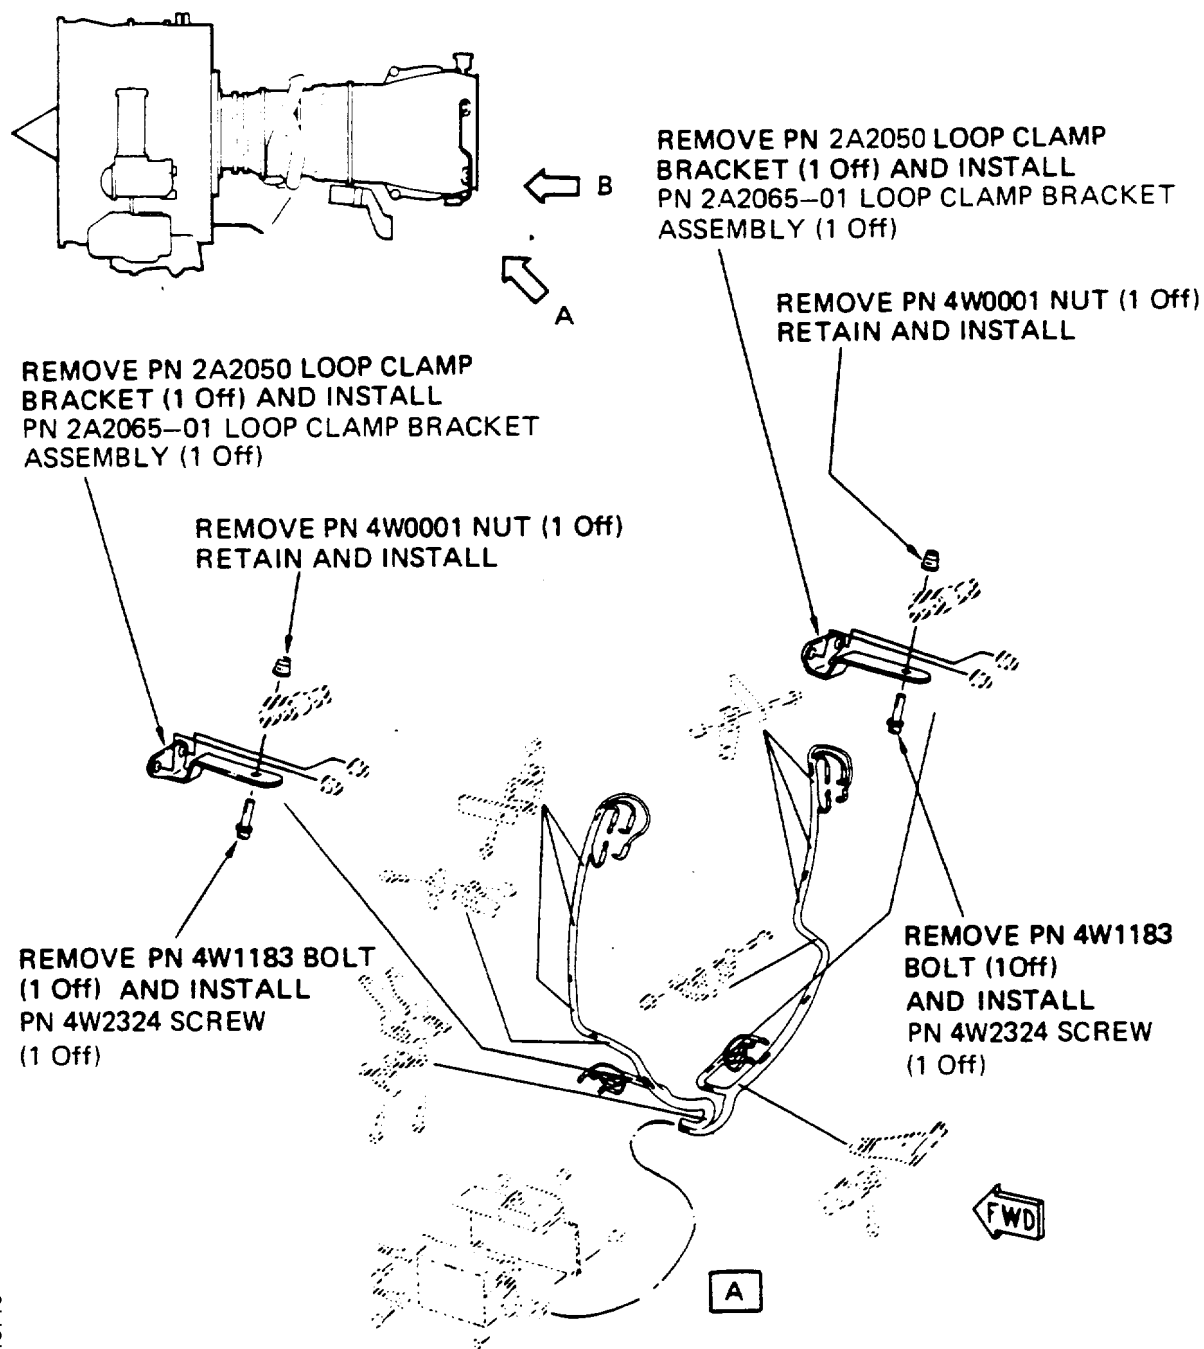
FIG. 1

Replacement of Loop Clamp Brackets and Attaching Nuts (For Engines incorporating V2500-ENG-72-00-0050)

- (1) Remove the Nuts and Bolts which hold the two Loop Clamp Brackets 2A2050 to the Loop Clamps.
- (2) Remove the Nuts and Bolts which hold the 2A2050 Loop Clamp Brackets to the Turbine Exhaust Case (Hole Locations 52, 53, 62 and 63). Refer to Figure 1.
- (3) Remove the Clamp Brackets.

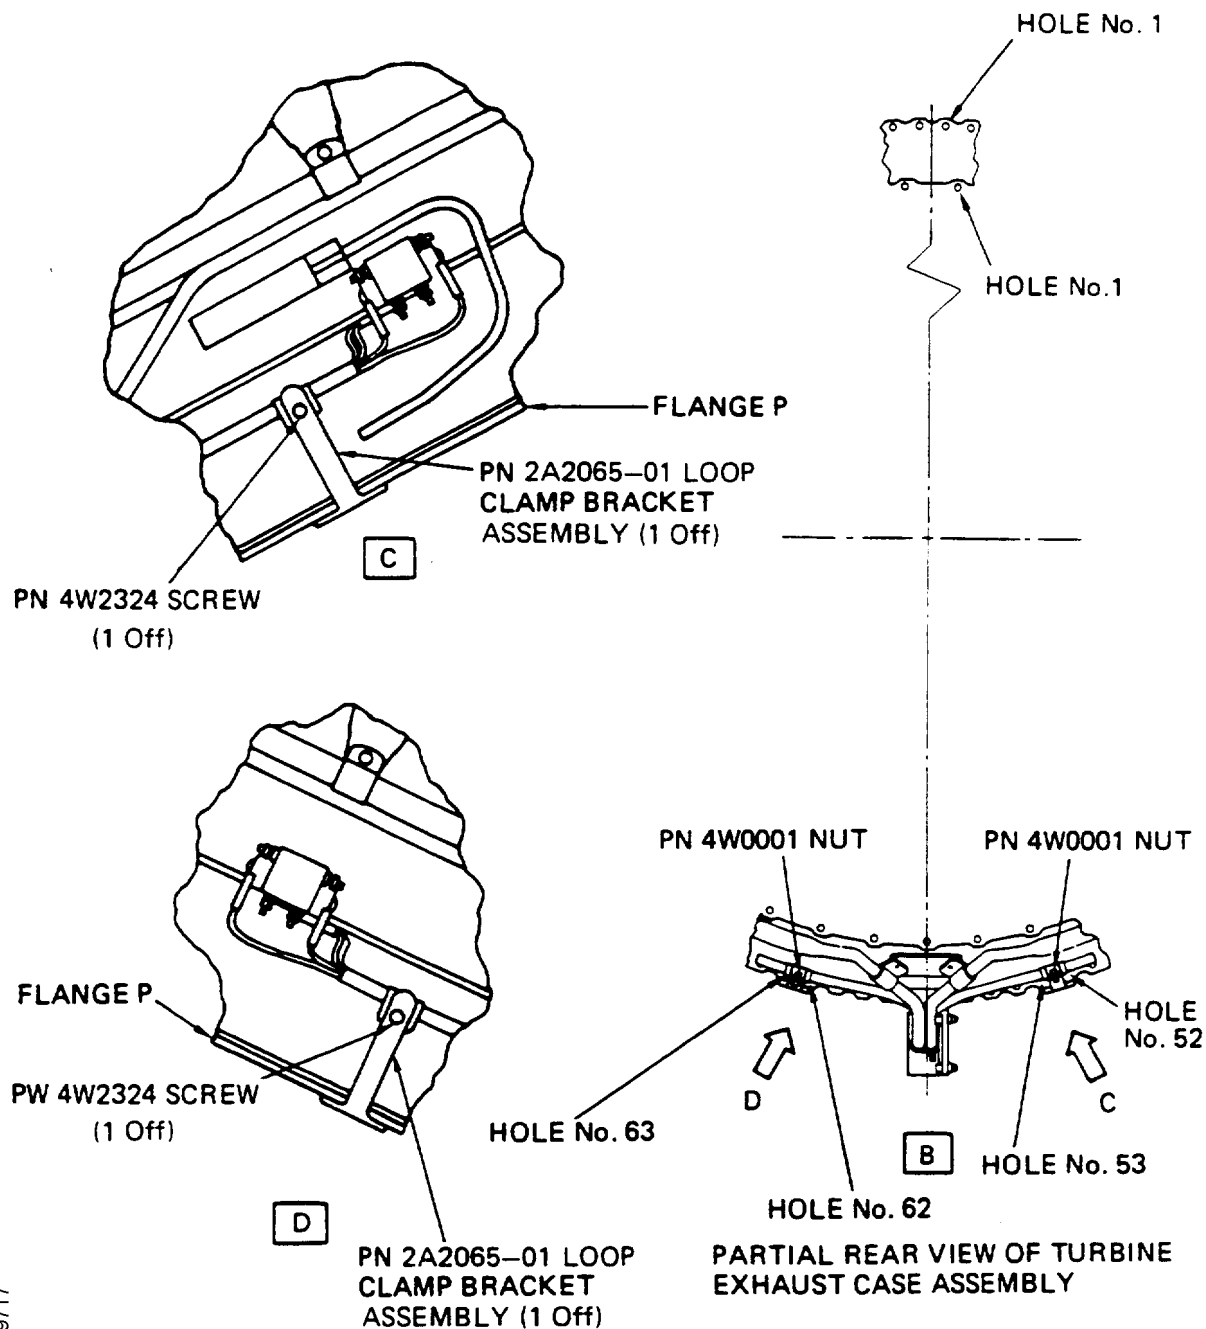
Fig.1

Replacement of Loop Clamp Brackets and Attaching Nuts (Assembly for all Engines to incorporate this Modification)

- (1) Lubricate the threads of 4W0001 Nuts (4 off) and the Bolts (which will hold the Brackets to the flange) with CoMat 10-039 Engine Oil.
- (2) Put the 2A2065-01 Loop Clamp Bracket Assembly (1 off) at the location of holes 62 and 63. Refer to Figure 1.
 - (a) Make sure that the bracket mount flange is forward of Flange P.
- (3) Install the Nuts and Bolts and tighten them with your hand.

- (4) Put the 2A2065-01 Loop Clamp Bracket Assembly (1 off) at the location of holes 52 and 53. Refer to Figure 1.

(a) Make sure that the bracket mount flange is forward of Flange P.

- (5) Install the Nuts and Bolts and tighten them with your hand.
- (6) Torque the Bolts to between 85 to 105 lbfin (9,60 to 11,86 Nm). See in Reference (3), Chapter/Section 70-41-00, Torque Tightening Technique.
- (7) Move the Loop Clamps so that the bolt holes in the Clamps align with the bolt holes in the Loop Clamp Brackets.
- (8) Lubricate the threads of the two 4W2324 Screws (2 off) and the Nuts, removed in step (2) of Paragraph c. or D. with CoMat 10-039 Engine Oil.
- (9) Install the Screws and Nuts and tighten them with your hand.
- (10) Torque the Screws to between 36 to 45 lbfin (4,07 to 5,08 Nm). See Reference (3), Chapter/Section 70-41-00, Torque Tightening Technique.
