ENGINE - INTERMEDIATE STRUCTURE - REWORK THE FAN FRAME ASSEMBLY TO INCLUDE FILLER COMPOUND IN THE REAR INNER FLANGE AREA - CATEGORY CODE 3 - MOD.ENG-72-0009

V2500-ENG-72-0009

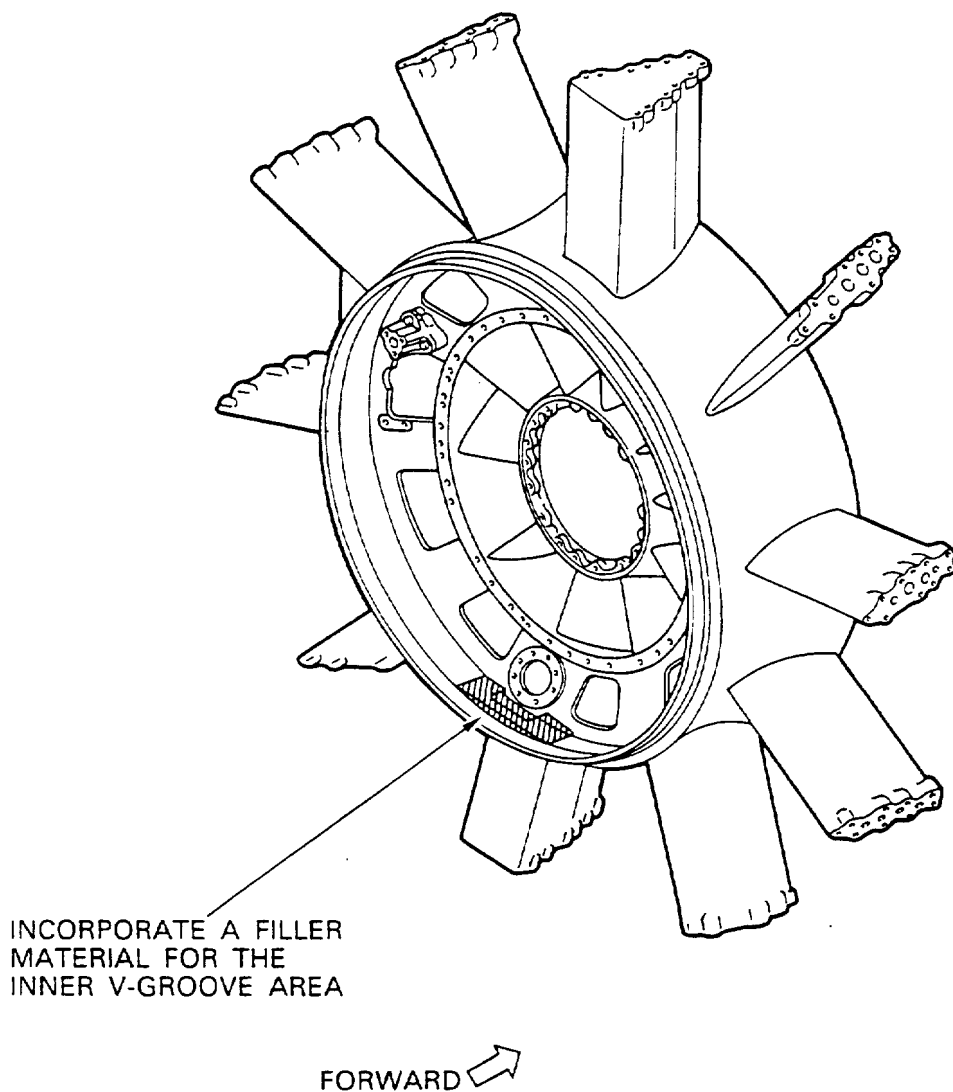
Modification of the fan frame assembly
Fig.3(Sheet 1 of 5)

The inside of the Fan Frame inner V-groove at B.D.C. may accumulate large amounts of fluid which will not conform to the requirements for the "Pylon, Nacelle, Engine Drainage" Test.

The cause of the problem is due to insufficient structure of the Fan Frame to drain fluid trapped in the V-groove.

(a) The filler material (CoMat 08-006 Two-pack filler - Spec No. J-MSRR 9152 Two part epoxy low density void filling compound) is applied to the Fan Frame rear V-groove in the specified area.

Procedure	Supplementary Information
(1) Find the filling area	Refer to Figure 3, Sheet 1.
(2) Clean the specified area	Use a clean white lint free cloth made moist with CoMat 01-031 acetone or CoMat 01-060 acetone or CoMat 01-076 methylethylketone or CoMat 01-124 isopropyl alcohol.
