#### International Aero Engines

# **SERVICE BULLETIN**

# <u>ENGINE - LP COMPRESSOR - REPLACEMENT OF NO.3 BEARING SEAL RING HOLDER - CATEGORY CODE</u> 7 - MOD.ENG-72-0010

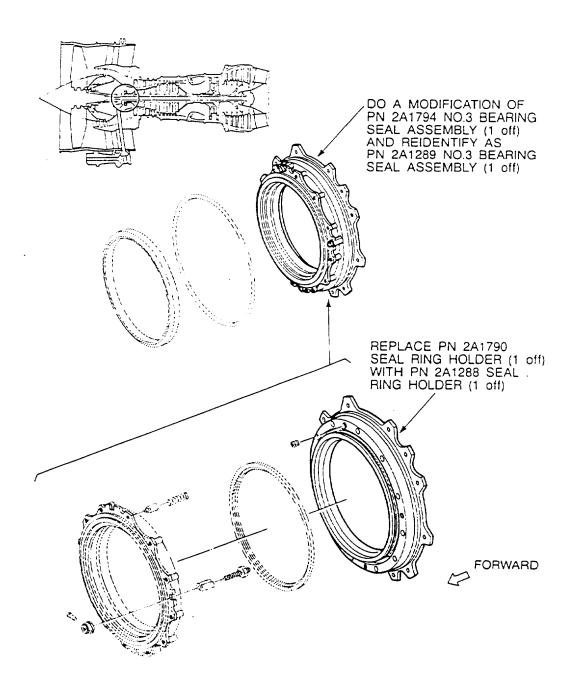
Location of No.3 Bearing Seal Assembly Fig.1

A titanium Seal Ring Holder of No.3 Bearing Seal Assembly has been provided in place of existing steel Seal Ring Holder.

- (a) 2A1288 Seal Ring Holder made of titanium supersedes 2A1790 Seal Ring Holder made of steel
- (b) Existing 2A1794 No.3 Bearing Seal Assembly can be reidentified as 2A1289 by replacing the Seal Ring Holder from 2A1790 to 2A1288.

- A. Rework Instructions
  - (1) There are no rework instructions necessary for this Service Bulletin.
- B. Assembly Instructions
  - (1) Install 2A1288 Ring Holder by Figure 1 and approved procedure in Reference (2), Chapter/Section 72-32-25, Assembly.
  - (2) Reidentify 2A1794 No.3 Bearing Seal Assembly as 2A1289. Refer to Reference (3), Chapter/Section 70-09-00, Marking of Parts. Use the vibration peen method.
- C. Recording Instructions
  - (1) A record of accomplishment is necessary.
