Subject: Transmittal of Revision 5 to Service Bulletin Number  
V2500-ENG-72-0011

ENGINE - HP TURBINE ROTOR AND STATOR ASSEMBLY - REWORK THE STAGE 2  
TURBINE HUB ASSEMBLY TO INCORPORATE A TURBINE HUB HEATSHIELD

V2500-A1

72-45-00

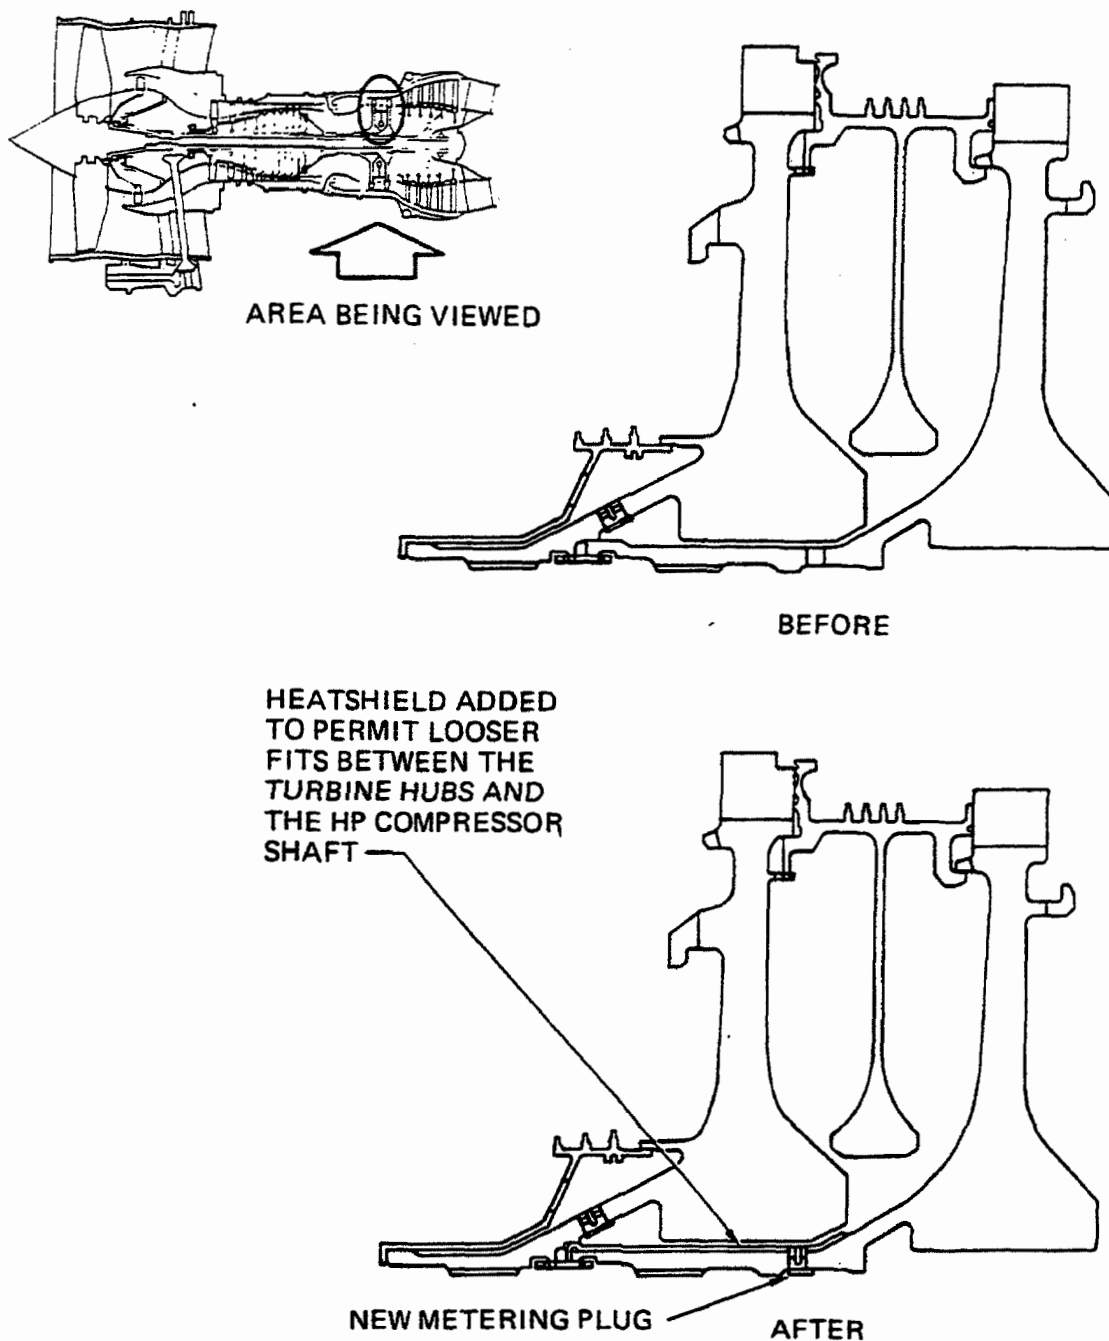
Figure 1

Potential for galled snaps was found on Stage 2 Turbine Hubs and the mating snaps of Compressor Rear Hubs.

Galled snaps on some Stage 2 Turbine Hubs and mating snaps on the Compressor Rear Hubs can be caused by the tight fits between the HP Compressor Shaft and the HP Turbine Hubs.

Before and after views of configuration changes that affect HP compressor to HP turbine hub mating diameters

- (a) A heatshield was installed to loosen fits between the Turbine Hubs and the HP Compressor Shaft. Refer to Figure 1.
- (b) A change was made to the Hub dimensions to permit installation of the Heat Shield.
- (c) New metering plugs are installed to maintain Disk and Heatshield alignment.

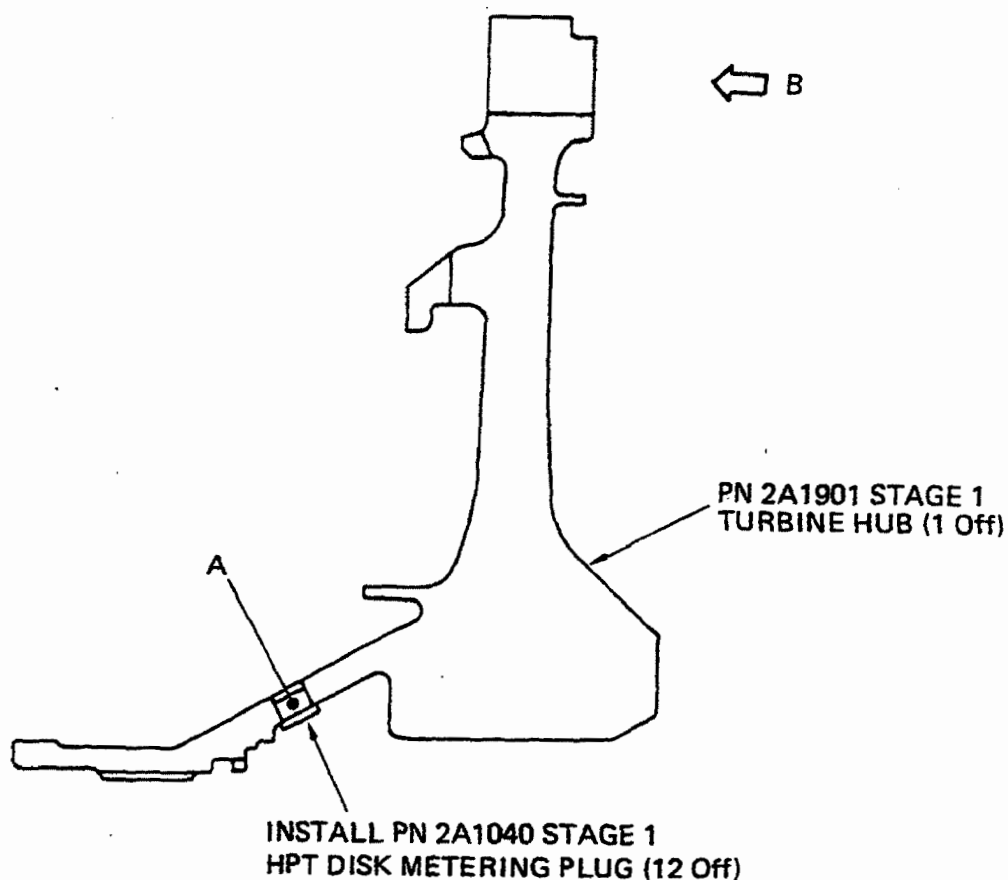
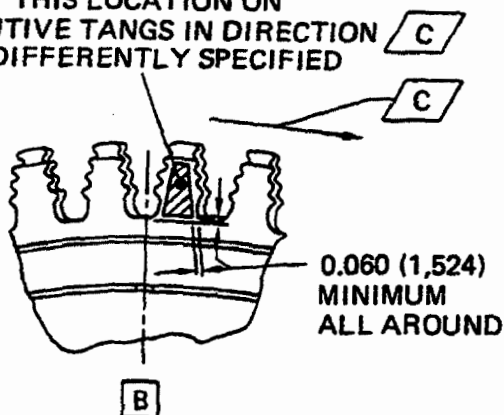
Modification of the stage 1 turbine hub (Installation of disk metering plugs)  
Figure 3

0.002 (0,051)  
MAXIMUM  
GAP PERMITTED

- (d) Install 2A1040 Metering Plugs (12 off) in the 2A1901 Stage 1 Turbine Hub.

Refer to Figure 3, requirements.

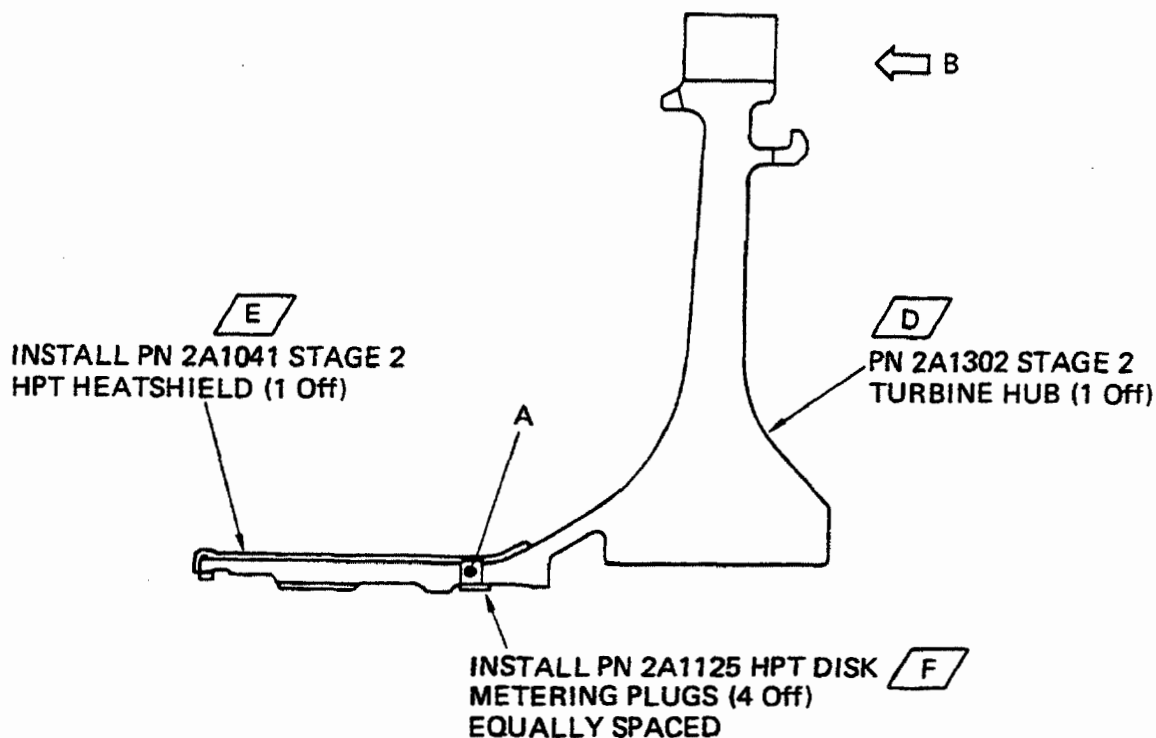
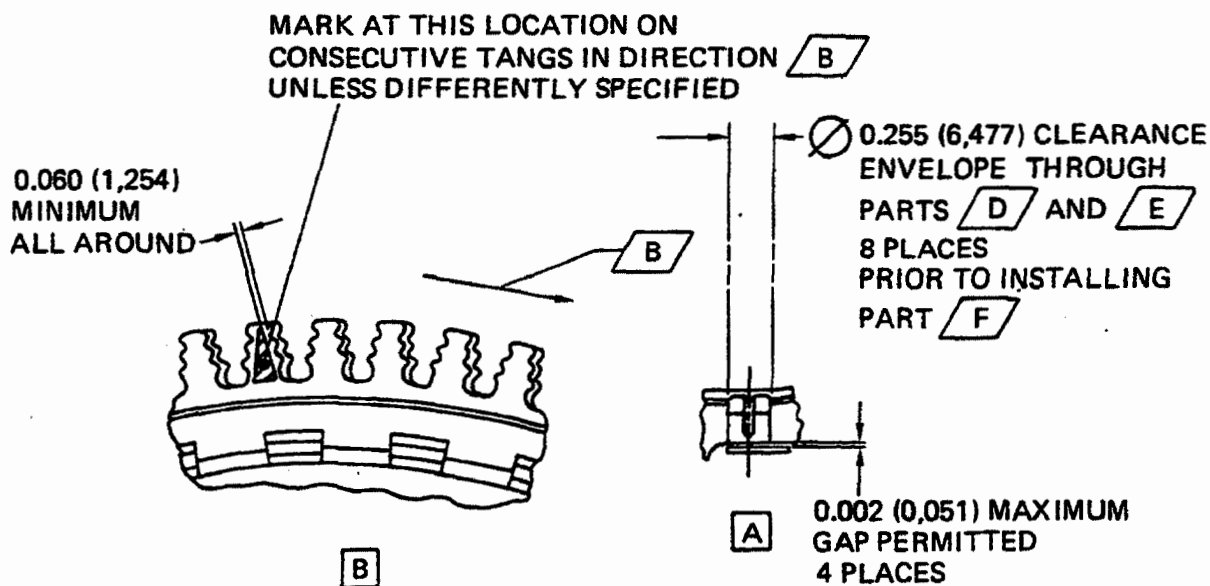
Figure 5

Modification of the stage 2 turbine hub (Installation of the disk heatshield and metering plugs)

- (d) Install 2A1041 Stage 2 HPT Heat shield (1 off) on the 2A1302 Stage 2 Turbine Hub (1 off).
- (e) Install 2A1125 HPT Metering Plugs (4 off) in the four holes from the inside (flanged end to contact the inner diameter of the hub).
- (f) Mark the new assembly part by the approved procedure. Use the vibration peen method.

Refer to Figure 5, requirements.

Refer to Figure 5, requirements. Refer to the approved procedure in Reference (2), Control No./ TASK No.70-09-00-400-501.
