ENGINE – MAIN GEARBOX ASSEMBLY – REWORK THE IDG HOUSING ASSEMBLY AND THE RADIAL GEAR SUPPORT ASSEMBLY TO IMPROVE CLEARANCE REQUIREMENT – CATEGORY CODE 6 – MOD.ENG-72-0012

V2500-ENG-72-0012

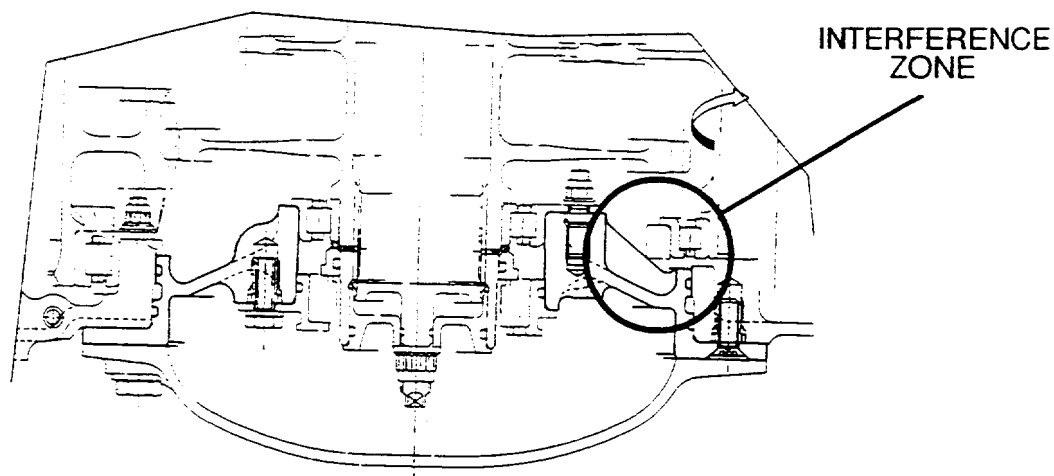
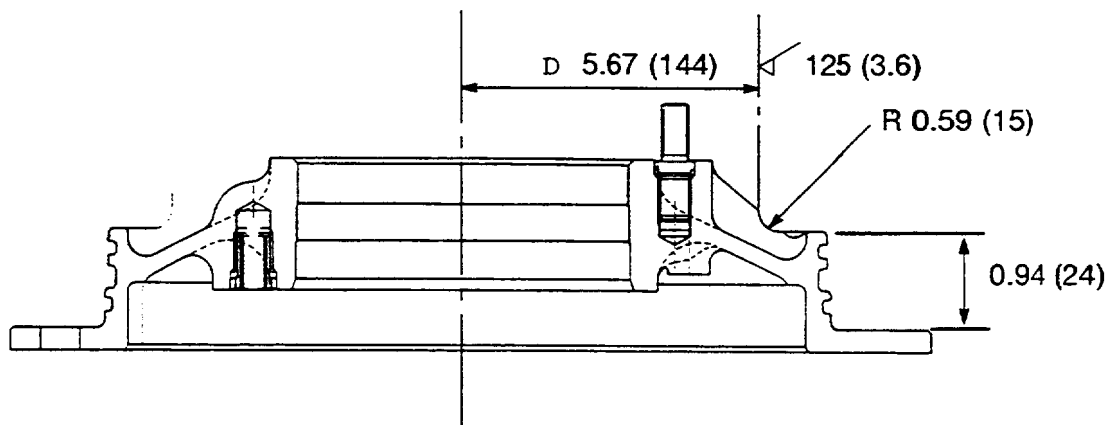
Rework the ribs of the IDG drive housing
Fig.1

- (a) Interference may occur between the ribs of the IDG drive housing and the support of the main gearbox.
- (b) Interference may occur between the oil shroud of the bevel gear and the support of the radial gear.

- (1) Remove the IDG housing. Refer to the approved procedure in Reference (1).
 - (a) Rework the IDG drive housing ribs (3 off) as shown in Figure 1.
- (2) Remove the radial gear support. Refer to the approved procedure in Reference (2).
 - (a) Rework the radial gear support as shown in Figure 2.

- NOTE: - MARK 4B0271 AND CROSS OUT 4B0161
- PROTECT MARKING WITH RESIN VERNISH
USE CoMat 07-050
- TOUCH UP THE REWORKED AREAS.
USE CoMat 07-028
