Subject: Transmittal of Revision 3 to Service Bulletin Number
V2500-ENG-72-0014

V2500 – ENG – 72 – 0014

ENGINE - INCORPORATE RE-ROUTED E.G.T. HARNESS ASSEMBLY

V2500-A1

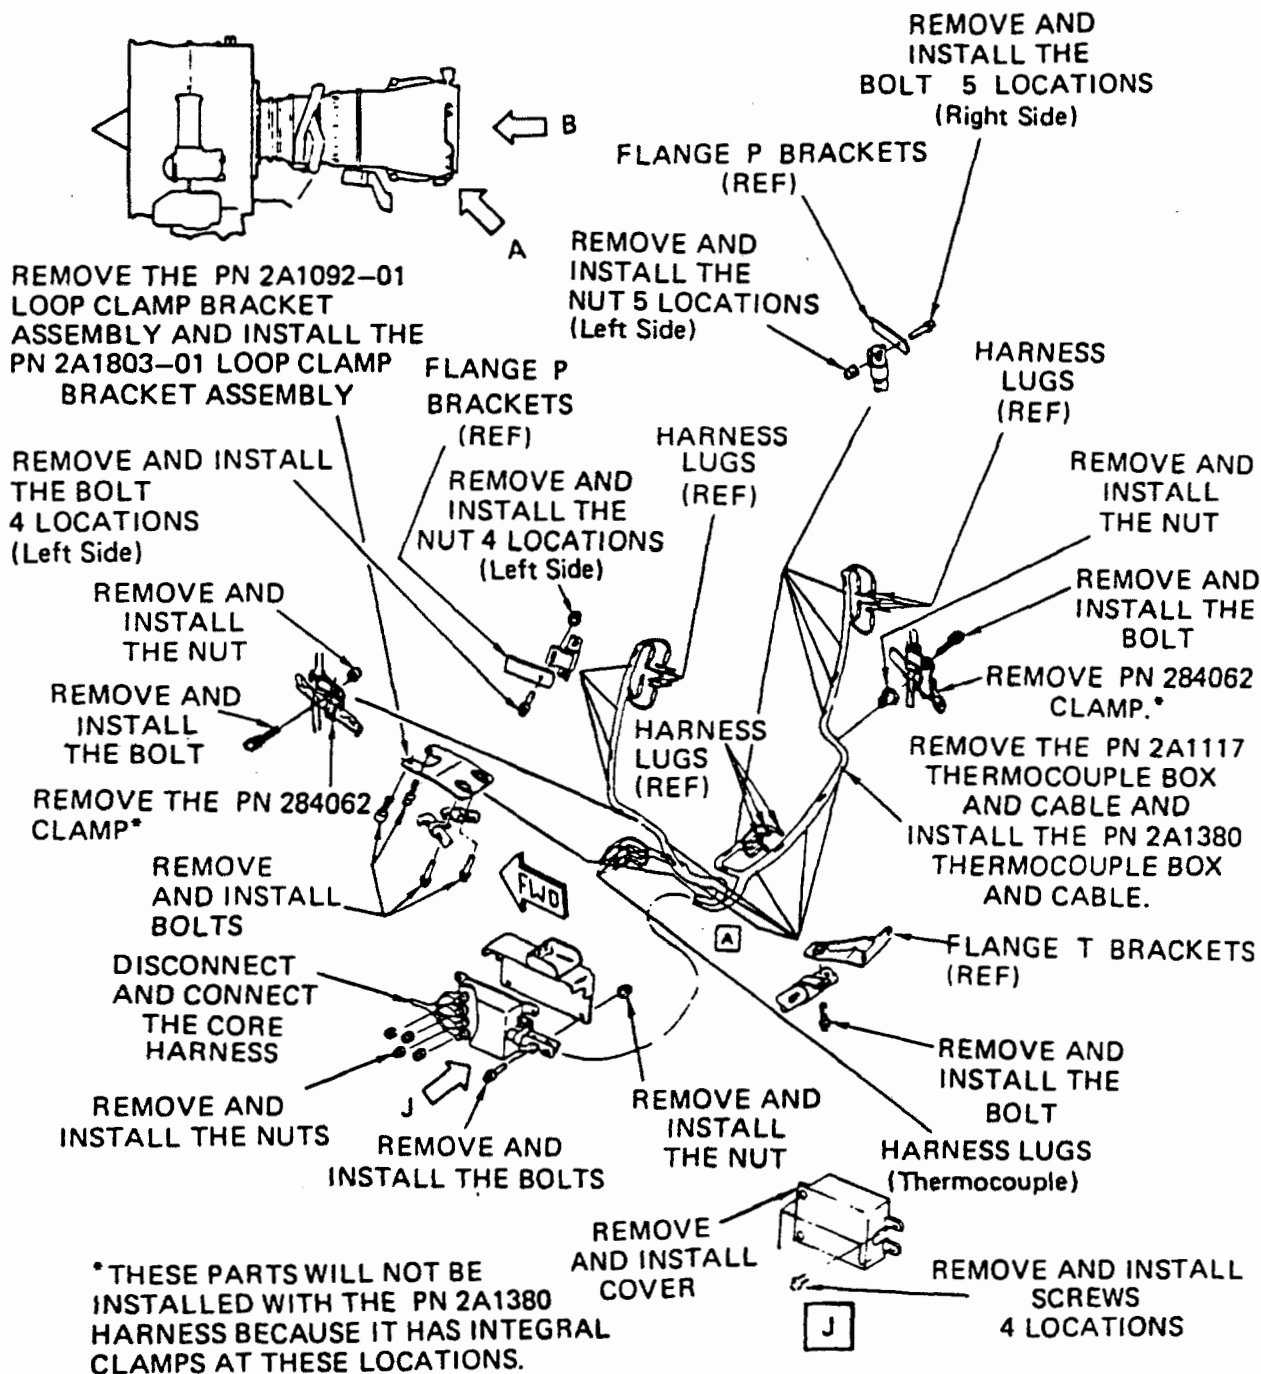
Replacement of thermocouple box and cable
Figure 1
Sheet 1 of 3

The harness may become chafed.

The harness does not have sufficient length so that its routing can be changed to clear the parts which may cause chafing. As a result, a new harness, brackets, and a revised clipping configuration are necessary.

A. Remove the PN 2A1117 Thermocouple Box and Cable by the instructions which follow and Figure 1.

(2) Disconnect the harness at the flange T and flange P bracket locations. Refer to Figure 1.

B. Remove the PN 2A1092 Loop Clamp Assembly by Figure 1 and as follows:

C. Install the PN 2A1803 Loop Clamp Bracket (1 off) on the P4.9 Pipe Adapter at the 6 o'clock position on the Turbine Exhaust Case, as follows:

D. Install the PN 2A1804 Loop Clamp Bracket (1 off) to P flange on the Turbine Exhaust Case Assembly by Figure 1 and as follows:

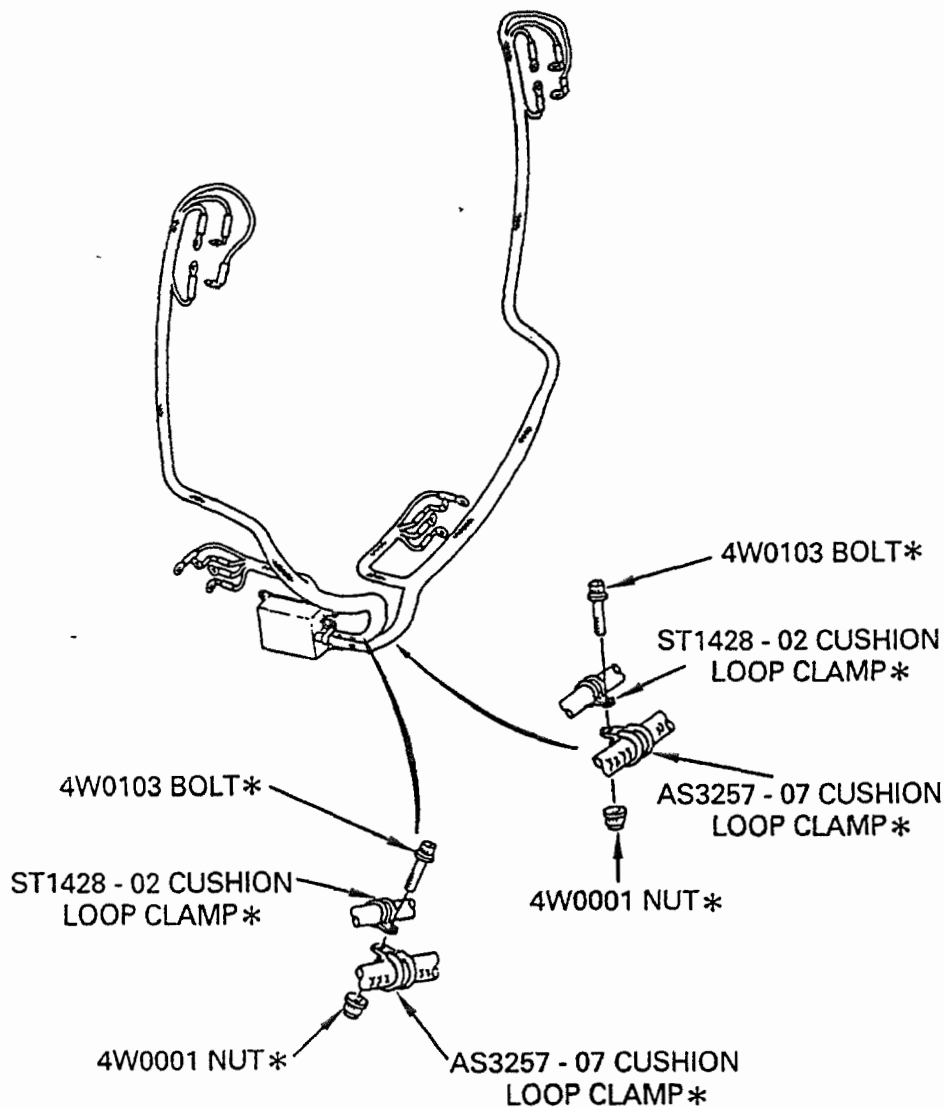
Replacement of Thermocouple Box and Cable
(Removed Parts)

* THESE PARTS ARE REMOVED AND
WILL NOT BE INSTALLED AGAIN IN
THE NEW CONFIGURATION

R (4) Remove the Cushion Loop Clamps that hold the EGT Harness to the P4.9 Manifold. See Figure 2.

R (a) Remove the nuts and bolts that connect the cushion loop clamps.

R (b) Remove the cushion loop clamps from the P4.9 manifold.

R (c) Remove the cushion loop clamps from the EGT harness.

R NOTE: The parts removed in step (4) will not be installed again in
R the new configuration.
