ENGINE - LP TURBINE ASSEMBLY - REPLACEMENT OF LP TURBINE ROTOR BOLTS - CATEGORY CODE 6  
- MOD.ENG-72-0015

V2500-ENG-72-0015

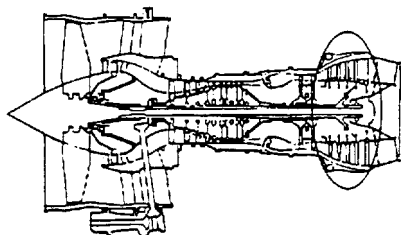
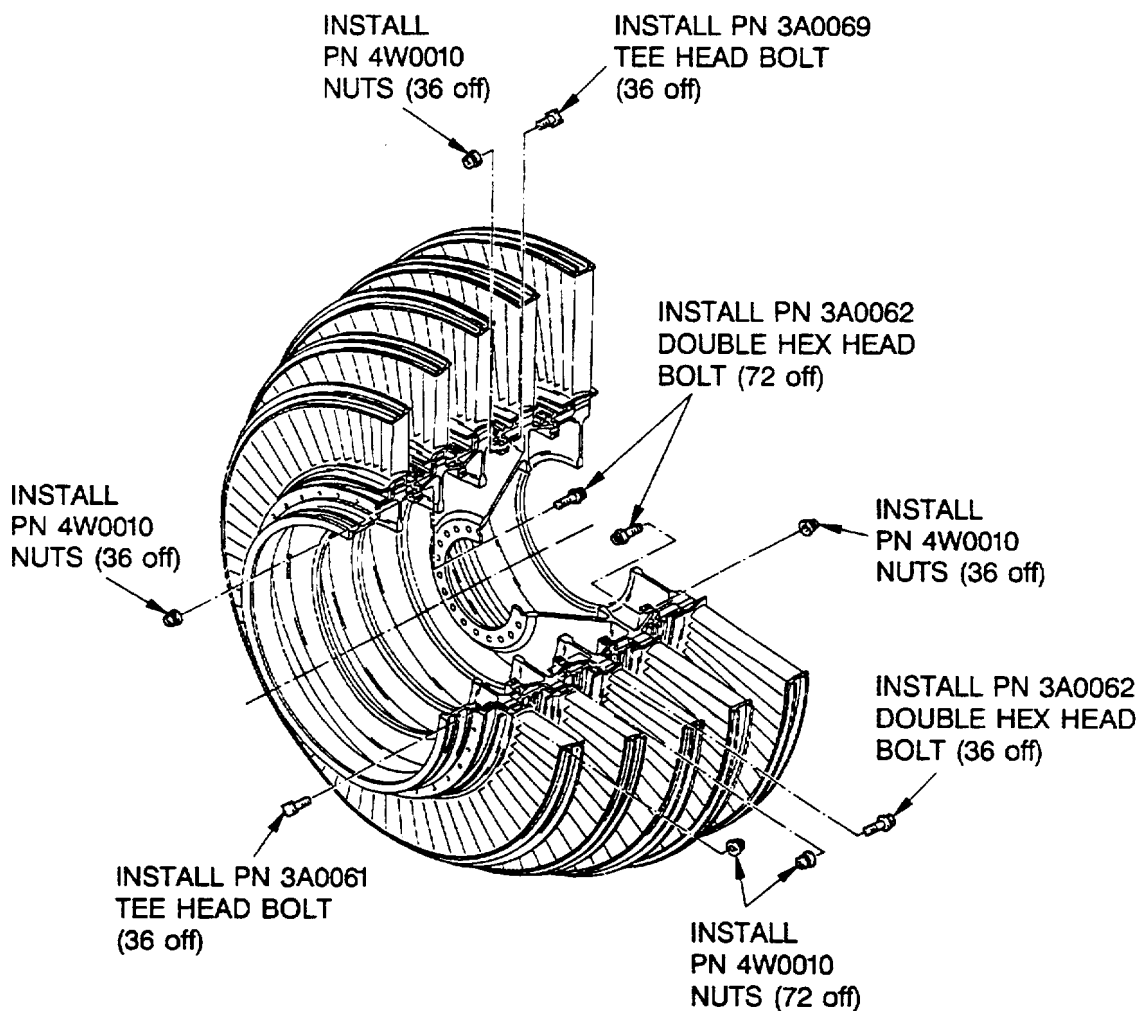
Location of LP Turbine Rotor Bolts  
Fig.1

The Engine Serial Numbers listed above may have LP Turbine Rotor Bolts installed which do not fully comply with IAE specifications.

Tests and detailed inspection of LP Turbine Rotor Bolts have shown that some bolts were not delivered as specified.

- (1) Install new P/N 3A0062 Double Hex Head Bolts (108 off) by the instructions given in Reference (3), 72-50-10, Assembly 04, Assembly 06 and Assembly 10. Refer to Figure 1.
- (2) Install new P/N 3A0069 Tee Head Bolts (36 off) by the instructions given in Reference (3), 72-50-10, Assembly 08. Refer to Figure 1.
- (3) Install new P/N 3A0061 Tee Head Bolts (36 off) by the instructions given in Reference (3), 72-50-30, Assembly 01. Refer to Figure 1.
