ENGINE - DIFFUSER AND COMBUSTION GROUP - NEW INNER NO.4 BEARING AND AIRFRAME MANIFOLD
ASSEMBLY - CATEGORY CODE 8 - MOD.ENG-72-0016

V2500-ENG-72-0016

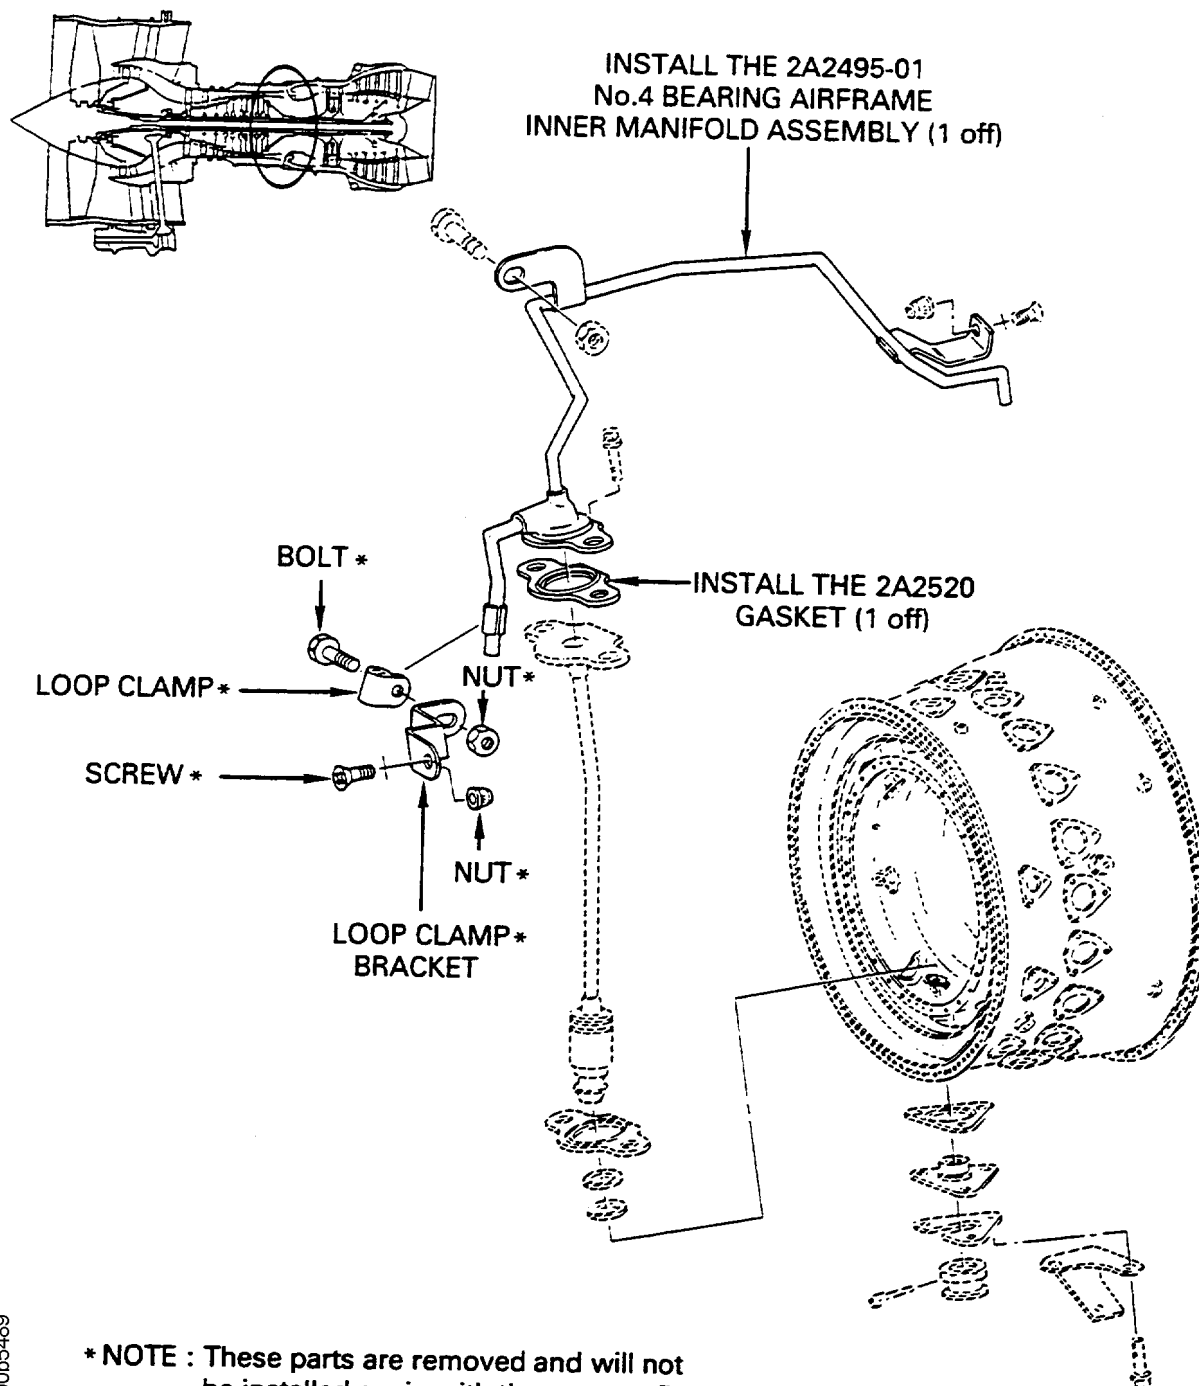
Location of the Inner No. 4 Bearing And Airframe Manifold Assembly
Fig.1

An interface clearance may not be adequate. The interface occurs during a blind assembly of the parts, but is not seen until disassembly of the parts.

After test, an inspection was done on two Inner No. 4 Bearing and Airframe Manifold Assemblies (No. 4 bearing oil weep tube assemblies). These parts, which came from two test engines, showed signs of interference with the HPC Static Air Seal Assembly (thrust balance seal). This occurs because the tube end point coordinates are changed during engine run, so that, after disassembly, it is possible they cannot be assembled again.

- (1) Install the 2A2496-01 No. 4 Bearing Airframe Inner Manifold Assembly (1 off) by the approved procedure given in Reference (1), Chapter/Section 72-42-00, Assembly, and Figure 1.
 - (a) The parts which follow are not installed with the new configuration: the 2A0489 Loop Clamp bracket (1 off), the MS122902 Loop Clamp (1 off), the MS9489-05 Bolt (1 off), the 4W2326 Screw (1 off), the 493773 Nut (1 off), and the 4W001 Nut (1 off). See Figure 1.
