ENGINE – INCORPORATE ROOT SEALING STRIPS ON STAGE 1.5, 2.0 AND 2.5 LPC BLADES –
CATEGORY CODE 6 – MOD.ENG-72-0017

V2500-ENG-72-0017

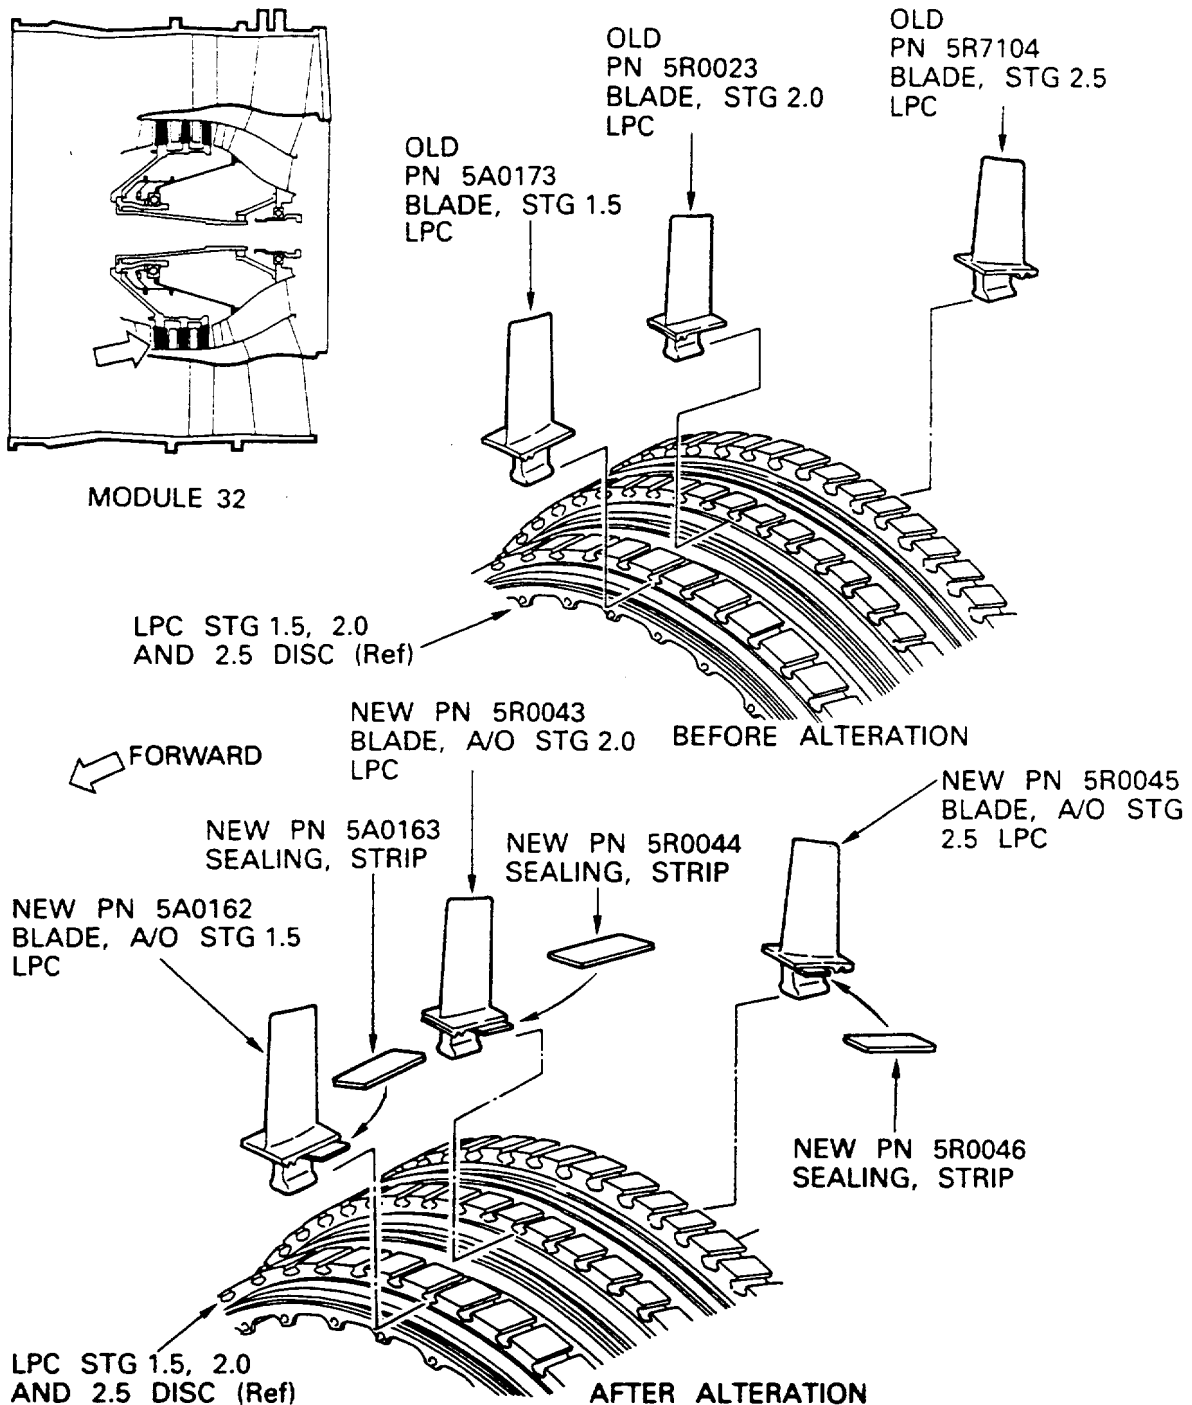
LP Compressor Stage 1.5, 2.0 and 2.5 blades - Before and after alteration
Fig.1

Existing Stages 1.5, 2.0 and 2.5 Blades have inadequate sealing features.

Existing configuraton may cause undesirable air flow circulation.

- (1) The changes introduced by this Service Bulletin are as follows:
 - (a) An Additional Sealing Strip is bonded to the Stage 1.5, 2.0 and 2.5 Blades LPC to prevent circulation of air flow. Refer to Figure 1.
- (2) Existing Blades on Stage 1.5, 2.0 and 2.5 must be replaced or reworked.
- (3) The new Blades on Stage 1.5, 2.0 and 2.5 will be available for future replacement purposes.
- (4) These changes must be accomplished as a complete set per engine.

To incorporate the improved blades with sealing strips to prevent air flow circulation.
