ENGINE - PROVIDE A NEW LP COMPRESSOR FRONT CASE ASSEMBLY AND A NEW LPC INLET GUIDE VANE ASSEMBLY - CATEGORY CODE 7 - MOD.ENG-72-0018

(1) Aircraft: Airbus A320

V2500-ENG-72-0018

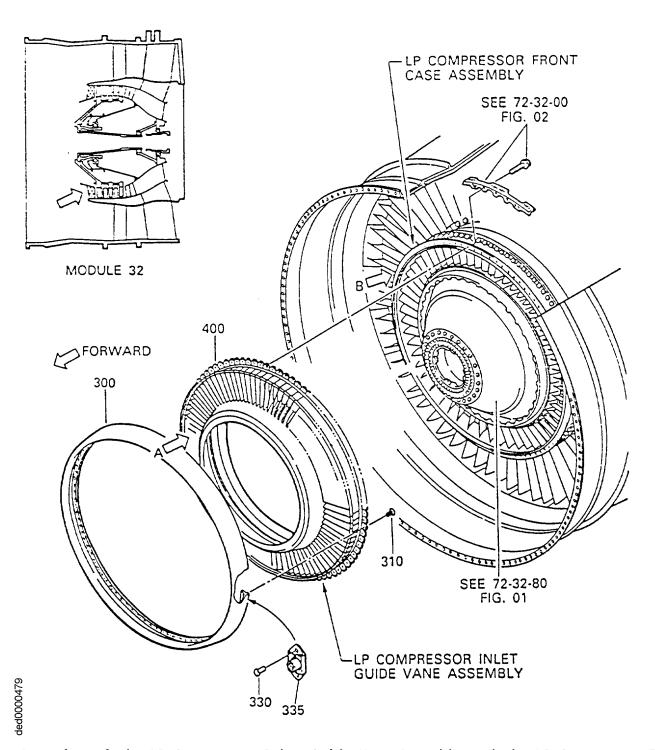
- (1) New LP Compressor Front Case Assemble and new LP Compressor Inlet Guide Vane Assembly which have the following changes have been introduced:
 - (a) The rear flange thickness of the LP Compressor Front Case Assembly has been reduced. (See Figures 1 and 3).

Location of the LP Compressor Inlet Guide Vane Assembly and the LP Compressor Front
Case assembly
Fig.1

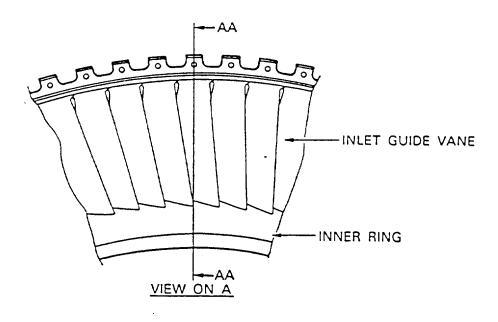
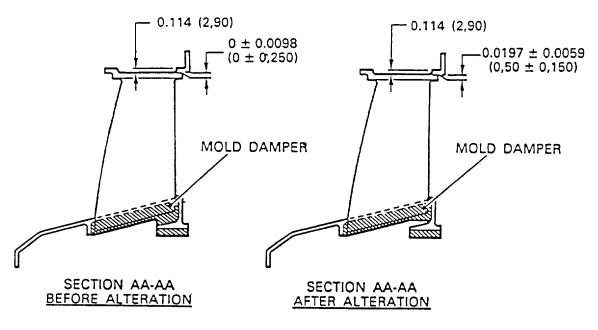
- (b) The thickness of the LPC Inlet Guide Vane platform has been reduced. (See Figures 1 and 2).
 - (c) The molding shape of the damper rubber in the LPC Inlet Guide Vane inner ring has been changed to reduce a quantity of the damper rubber. (See Figures 1 and 2).

LP Compressor Inlet Guide Vane Assembly - Before and After alteration Fig.2

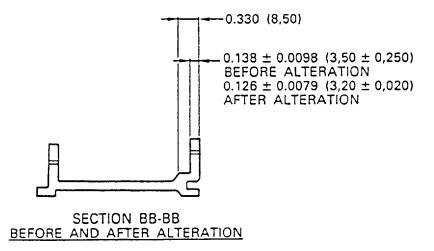
LP Compressor Front Case Assembly – Before and After alteration Fig.3 $\,$
