ENGINE - INCORPORATE REPLACEMENT VARIABLE INLET GUIDE VANE BRACKET - CATEGORY CODE 4 -  
MOD.ENG-72-0019

(1) Aircraft: Airbus A320

(2) Engine: V2500-A1 Engine, Serial No's.V0014 through V0061, V0063, V0065  
and V0066

V2500-ENG-72-0019

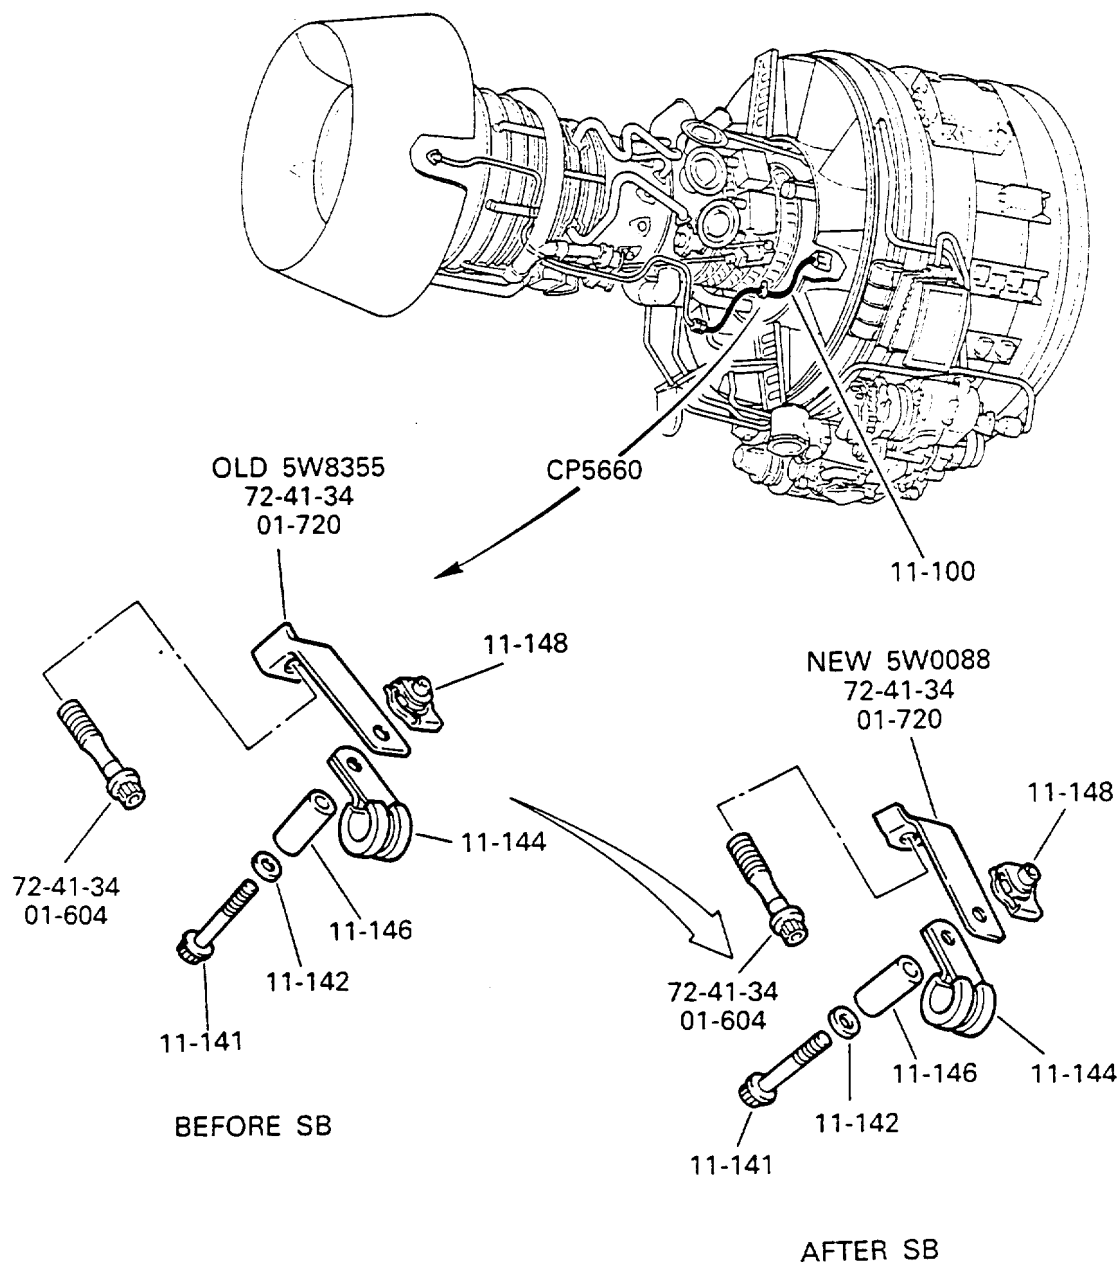
Change of the bracket  
Fig.1

There is some possibility that the current Bracket cannot be installed on  
the Shaft, Assy.

- (1) Remove PN 5W8355, Bracket (72-41-34-01-720), Figure 1 and 2
- (a) Remove bolt (11-141), washer (11-142) and spacer (11-146) at the clipping point 5660.
  - (b) Let clip (11-144) stay on tube (11-100).
  - (c) Remove bolt (72-41-34-01-604) from Shaft, Assy.
  - (d) Remove PN 5W8355, Bracket (72-41-34-01-720) from the engine.
  - (e) Remove nut (11-148) from the Bracket (72-41-34-01-720), Figure 2.

- (1) Install PN 5W0088, Bracket (72-41-34-01-720), Figure 1 and 3
- (a) Put nut(11-148) on PN 5W0088, Bracket (72-41-34-01-720), Figure 3.
  - (b) Install PN 5W0088, Bracket (72-41-34-01-720) in position on the engine.
  - (c) Tighten bolt (72-41-34-01-604) to 150 to 170 lbfin (16.94 to 19.21 Nm).
  - (d) Install bolt (11-141), washer (11-142) and spacer (11-146) at the clipping point 5660.
  - (e) Tighten bolt (11-141) to 32 to 36 lbfin (3.61 to 4.07 Nm).
