ENGINE - LP COMPRESSOR - FAN EXIT GUIDE VANE A/O - INCORPORATION OF A REVISED BONDING
PROCESS - CATEGORY CODE 6 - MOD.ENG-72-0020

V2500-ENG-72-0020

SERVICE BULLETIN

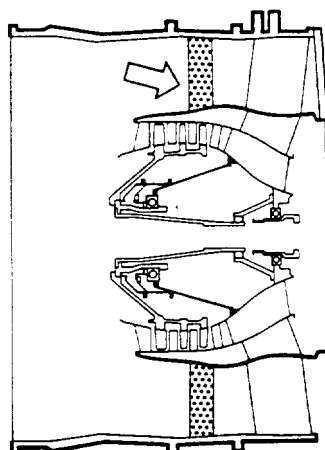
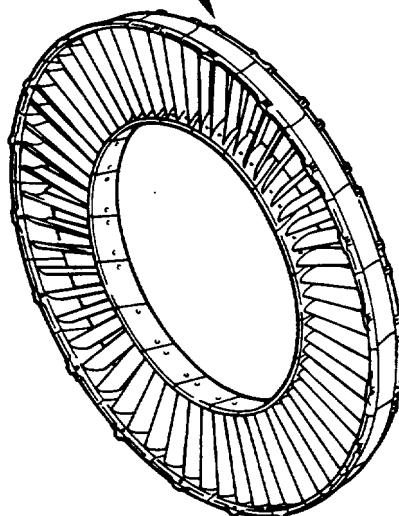
Reidentification of the Fan Exit Guide Vane A/O (FEGV) - Part 1 of SB
Fig.1

MARK NEW PN 5A0283 BY VIBRO-PEEN ADJACENT TO OLD PN 5A0037 IDENTIFIED HERE. MARK TWO LINES (==) ON OLD PN BY VIBRO-PEEN TO ERASE IT.

5A0037 FEGV A/O
RENUMBER TO PN 5A0283
FEGV A/O (20 Segments)

(2) The existing 5A0037, FEGV's which are used the Type II bonding process must be reidentified to the new 5A0283, FEGV's which are the equal part number to that of used the Type III bonding process, to discriminate them from the FEGV's used the Type I bonding process (See Figure 1).

- (a) Reidentify the existing part number of FEGV's which is made a mark on each segment with the Vibro-peen (Refer to Figure 1 and 1.K.(1)(c)).

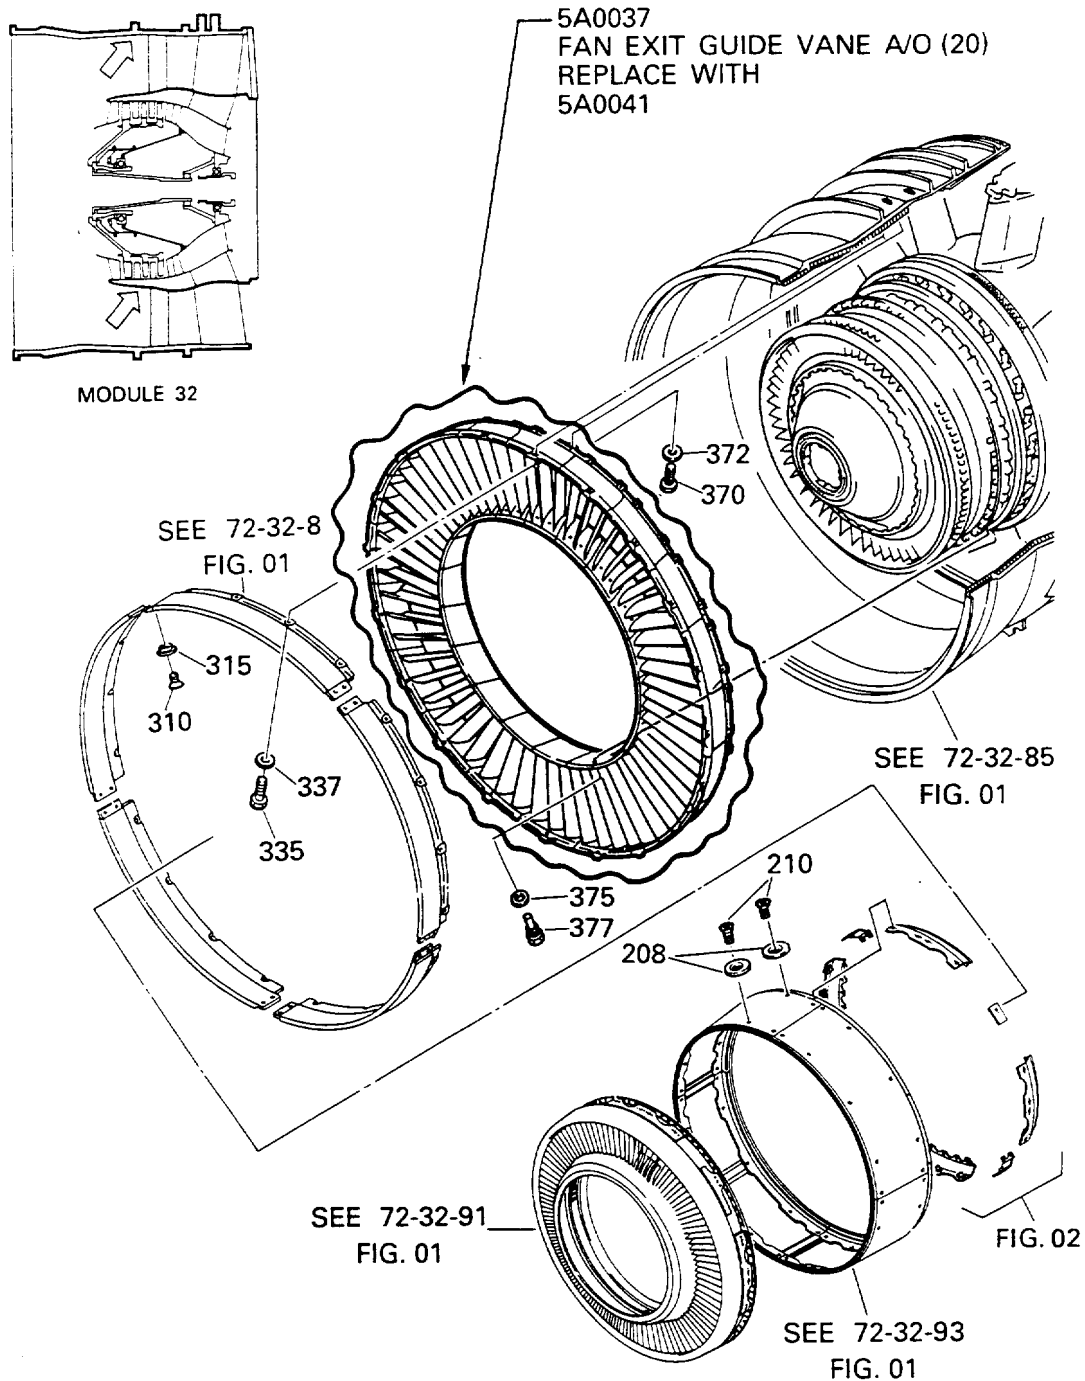
Location of the Fan Exit Guide Vane A/O (FEGV) - Part 2 of SB Fig.2

Lifting of the Fan Exit Guide Vane A/O (FEGV) inner platforms may occur because of unbonding of polyurethane resin used to bond each FEGV to its inner platform.

The cause for the problem is premature deterioration of bonding strength due to unsatisfactory bonding quality.

(3) The existing 5A0037, FEGV's which are used the Type I bonding process must be replaced with the improved FEGV's which use Type III bonding process (See Figure 2). The existing FEGV's removed from service can be reworked by engine manufacturer.

- (a) Remove the 20 segments of 5A0037, FEGV's by the approved procedures in the Aircraft Maintenance Manual 72-32-88, TASK 72-32-88-000-010. (Refer to 1.K.(2)(a)).
- (b) Install the 20 segments of 5A0041, FEGV's by the approved procedures in the Aircraft Maintenance Manual, 72-32-88, TASK 72-32-88-400-010. (Refer to 1.K.(2)(a)).
