ENGINE - NO.4 BEARING COMPARTMENT TUBES, REPLACEMENT OF OUTER SCAVENGE TUBE ASSEMBLY
SEAL RINGS, SEALING SLEEVE AND TUBE TO BOSS ELBOW - CATEGORY CODE 3 - MOD.ENG-72-0021

V2500-ENG-72-0021

SERVICE BULLETIN

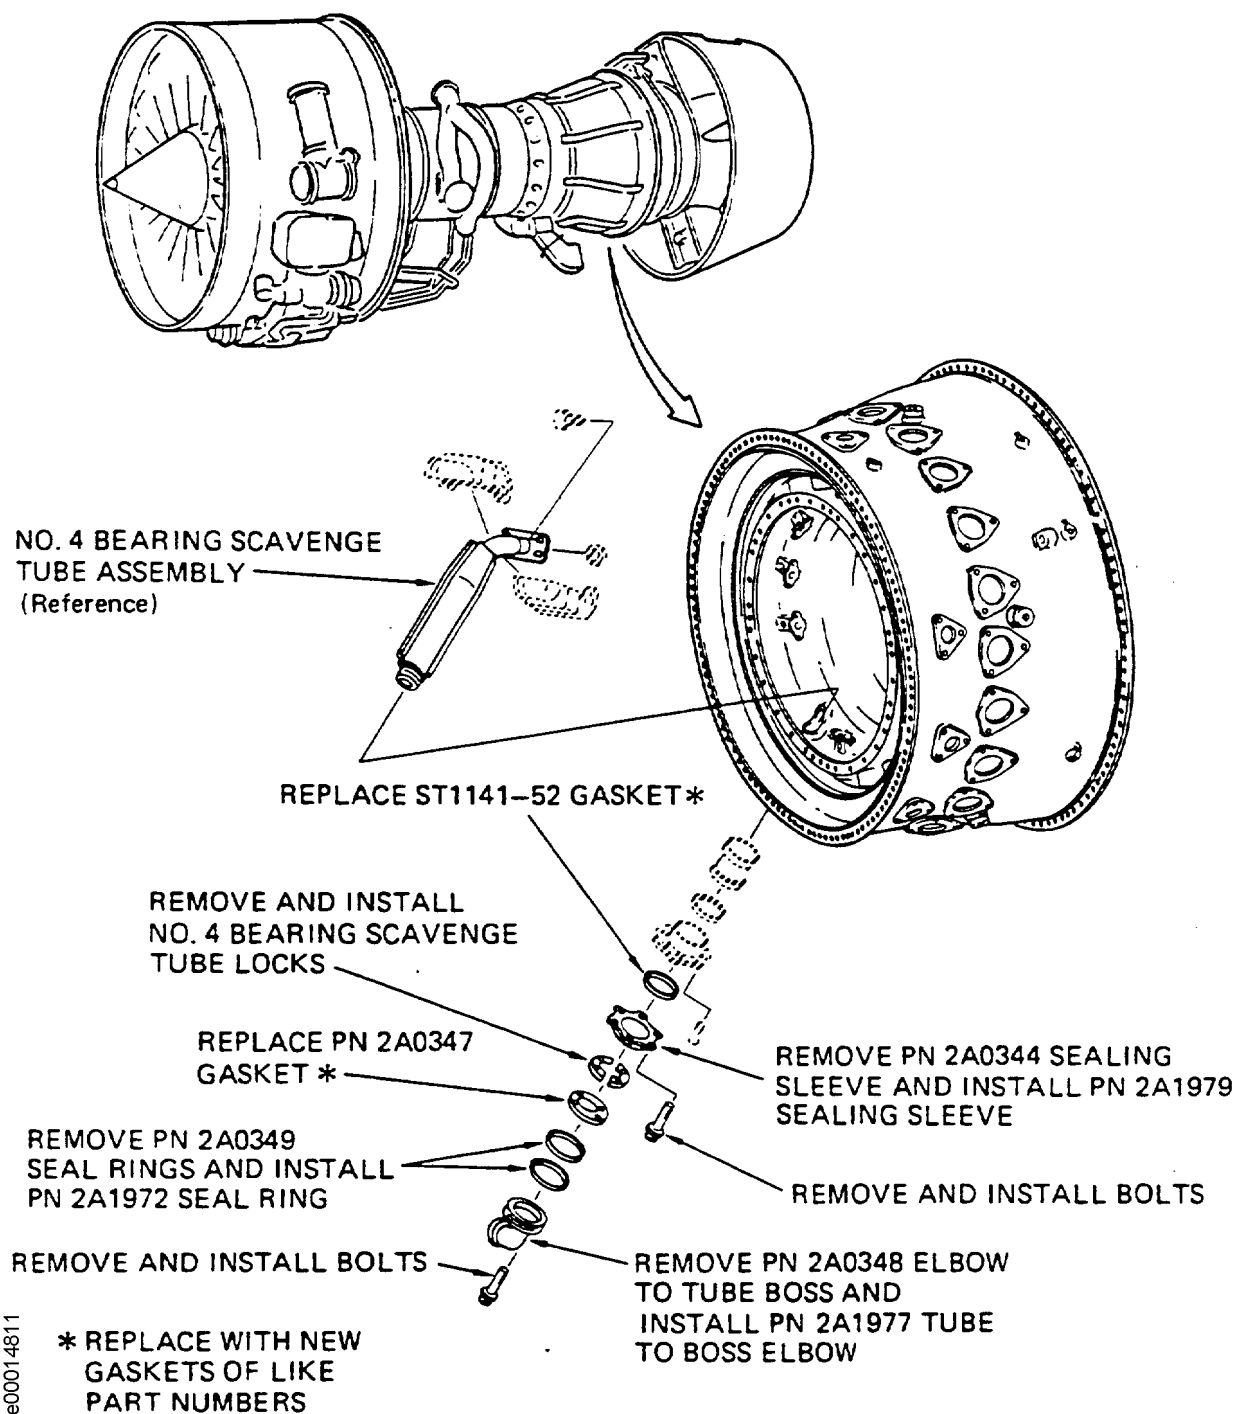
Replacement of the seal rings, sealing sleeve and tube to boss elbow
Fig.2

Binding at the outer slip-joint attachment can result in a broken tube.

During the development tests a No.4 Bearing Scavenge Tube broke at the inner weld joint. After the tube was examined it was found that there were no weld problems but there was binding at the outer slip-joint.

The slip-joint binds when normal thermal growth occurs. Binding is relieved by a change in the design of the slip-joint to a spherical shape and the elimination of one Seal Ring.

- (a) Install the PN 2A1972 Seal Ring (1 off) into the PN 2A1977 Tube to Boss Elbow (1 off). See Figure 2.
- (b) Lubricate the Bolts (4 off), which will secure the Elbow, with CoMat 10-039 Engine Oil.
- (c) Install the upper and lower Locks (flat face in) to the groove at the end of the No.4 Bearing Scavenge Tube Assembly.
- (d) While you hold the Locks in place install the new PN 2A0347 (1 off) Gasket (raised area in) and the PN 2A1977 Elbow (1 off).
- (e) Install the Bolts (4 off) which hold the Elbow to the Locks.
- (f) Tighten the Bolts with your hand.
- (g) Install a new PN ST 1141-52 Gasket (1 off) in the inner diameter (at the flanged end) of the PN 2A1979 Sealing Sleeve (1 off).
- (h) Hold the Gasket in place with CoMat 01-223 Wax.

- (i) Lubricate the Bolts (6 off), which will secure the Sealing Sleeve, with CoMat 10-039 Engine Oil.
- (j) Install the Sealing Sleeve (large O.D. toward the diffuser) and Gasket, over the Elbow and against the Sealing Sleeve (inner).

- (k) Install the Bolts (6 off) and tighten them with your hand.
- (l) Torque the Bolts (6 off) which attach the Sealing Sleeve to the Diffuser Case Assembly 75 to 85 lbfin (8,474 to 9,604 Nm). (see Reference (1) 70-41-00 Torque Tightening Technique).

- (m) Lock the Bolts with CoMat 02-141 Lockwire.
- (n) Torque the Bolts (4 off) that attach the Elbow to the Scavenge Tube 75 to 85 lbfin (8,474 to 9,604 Nm). (See Reference (1) 70-41-00 Torque Tightening Technique).
