SERVICE BULLETIN

ENGINE - HP TURBINE ROTOR AND STATOR ASSEMBLY - REPLACE THE STAGE 1 AND 2 HP TURBINE WIRE SEAL - CATEGORY CODE 6 - MOD.ENG-72-0022

V2500-ENG-72-0022

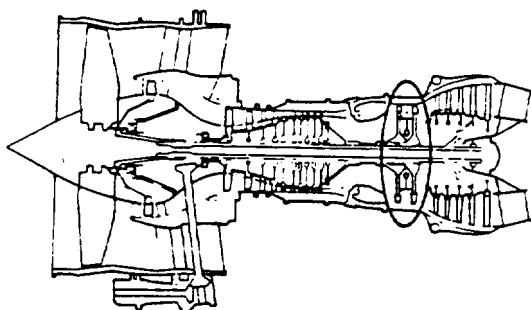
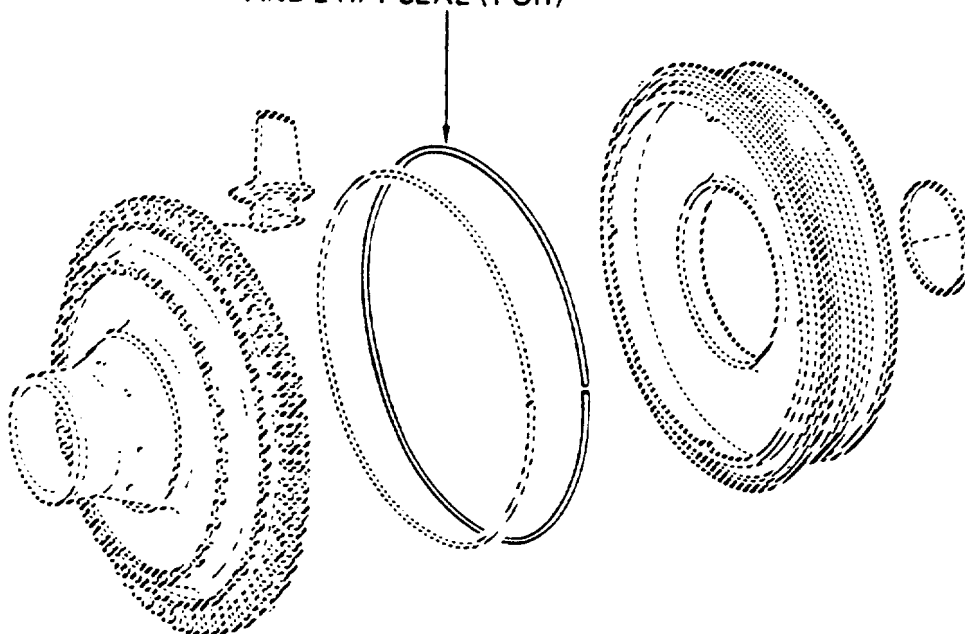
Location of Stage 1 and 2 HPT Seal
Fig.1

REMOVE THE PN 2A0044 STAGE 1
AND 2 HPT SEAL (1 Off) AND
INSTALL THE PN 2A0140 STAGE 1
AND 2 HPT SEAL (1 Off)

- (1) Install the PN 2A0140 Stage 1 and 2 HPT Air Seal (1 off) by the approved procedure in Reference (1), Chapter/Section 72-45-00, Assembly, Figures 1 and 2 as follows:
 - (a) Make sure that the PN 2A0140 stage 1 and 2 HPT Air Seal (Part B) is trimmed to the gap shown in Figure 2.

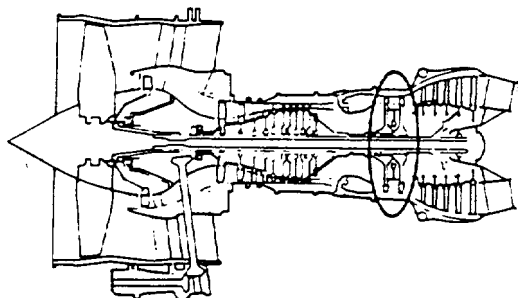
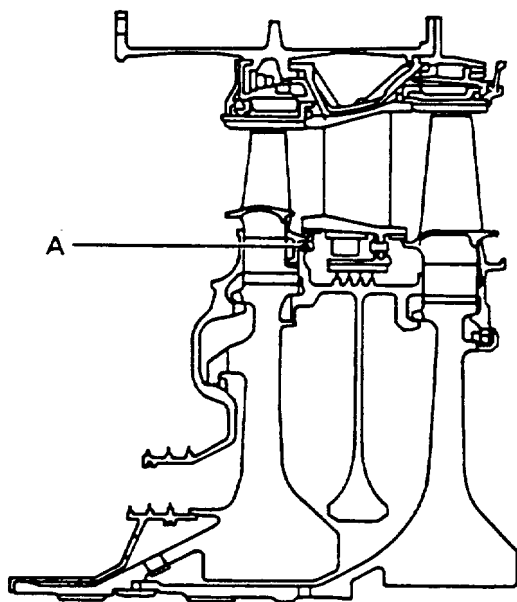
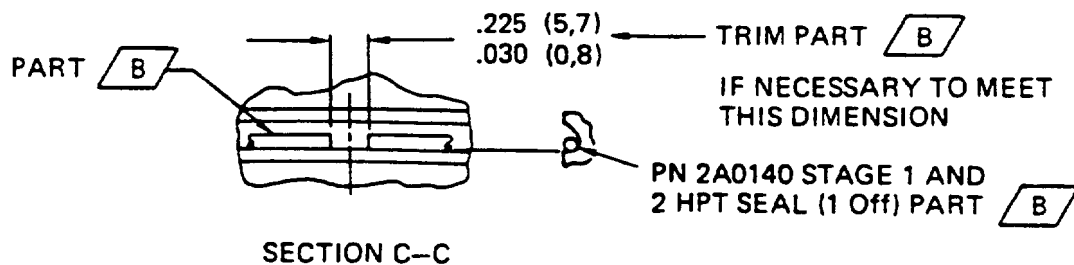
Location of Stage 1 and 2 HPT Seal
Fig.2

SECTION THROUGH HPT
