ENGINE - ADDITION OF WASHERS FOR CONNECTION OF THE NF TERMINAL BLOCK AND THE EEC  
HARNESS-CORE - CATEGORY CODE 3 - MOD.ENG-72-0023

V2500-ENG-72-0023

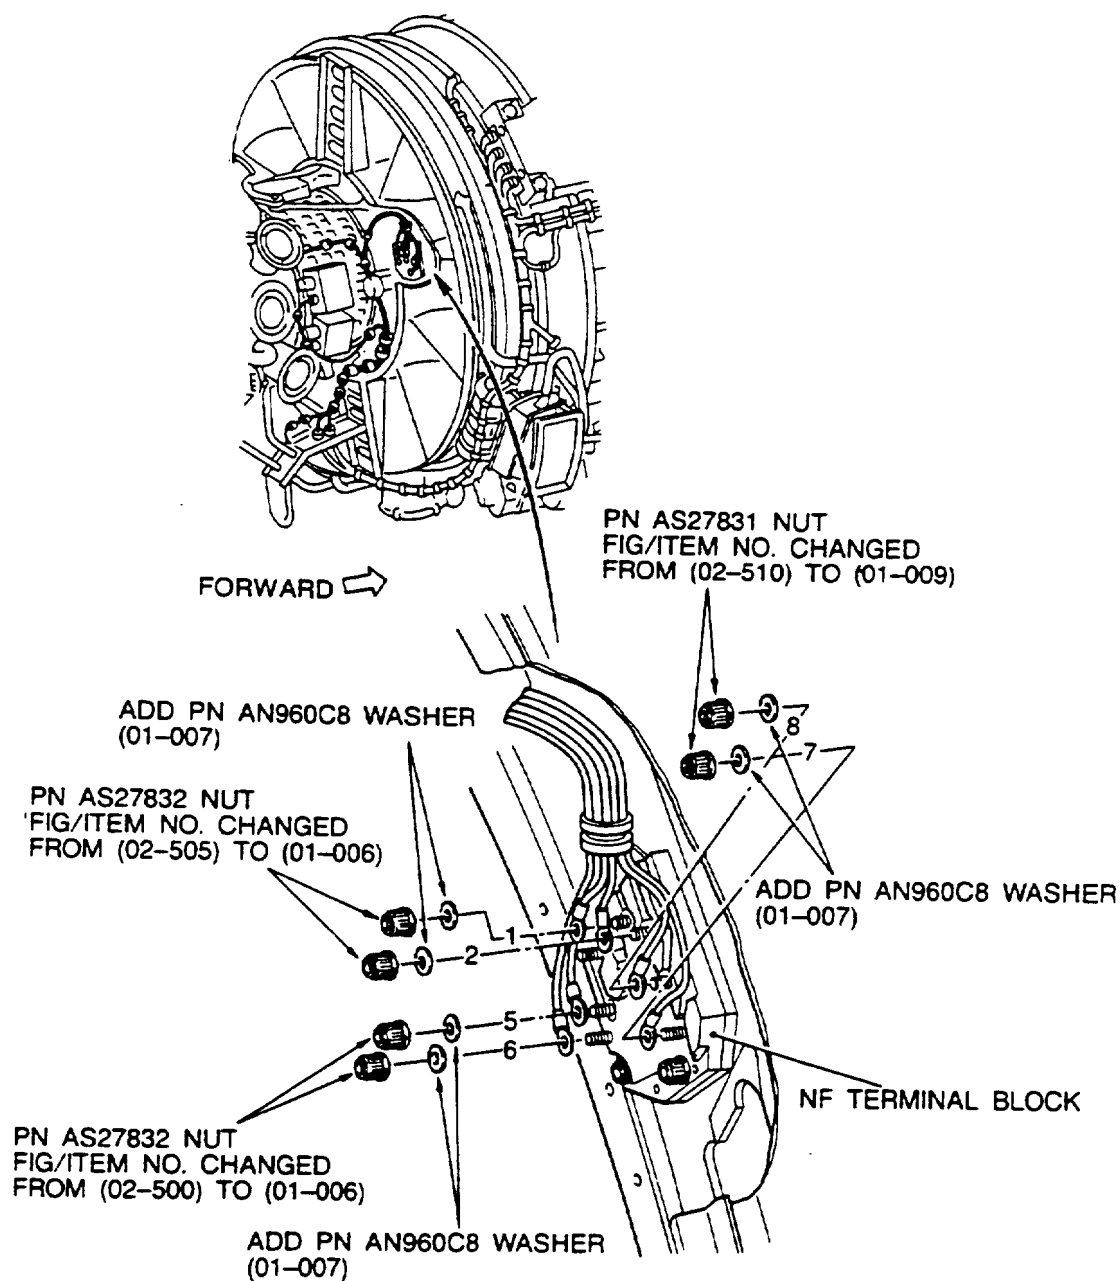
Addition of the washers  
Fig.1

Existing terminal studs on the NF terminal block have excessive shank length. Therefore the terminal of the EEC harness-core has play on the stud, even after the nut is fully screwed. Additional washer was introduced in order to fill the clearance between the nut and the terminal.

- (1) Remove two AS27831 Nuts from studs, position seven and eight.
- (2) Install an AN960C8 Washer to each of two studs nut removed.
- (3) Install an AS27831 Nut to each stud.
- (4) Torque the nuts to 10 to 11.5 lbfin (1,13 to 1,30 Nm).
- (5) Remove four AS27382 Nuts from studs, position one, two, five and six.
- (6) Install an AN960C8 Washer to each of four studs nut removed.
- (7) Install an AS27832 Nut to each stud.
- (8) Torque the nuts to 20 to 22 lbfin (2,26 to 2,48 Nm).

Refer to Figure 1.
