ENGINE - INCORPORATION OF FIRE SHIELDS ON THE NO.1 STRUT FAIRING PANEL A/O - CATEGORY
CODE 3 - MOD.ENG-72-0024

V2500-ENG-72-0024

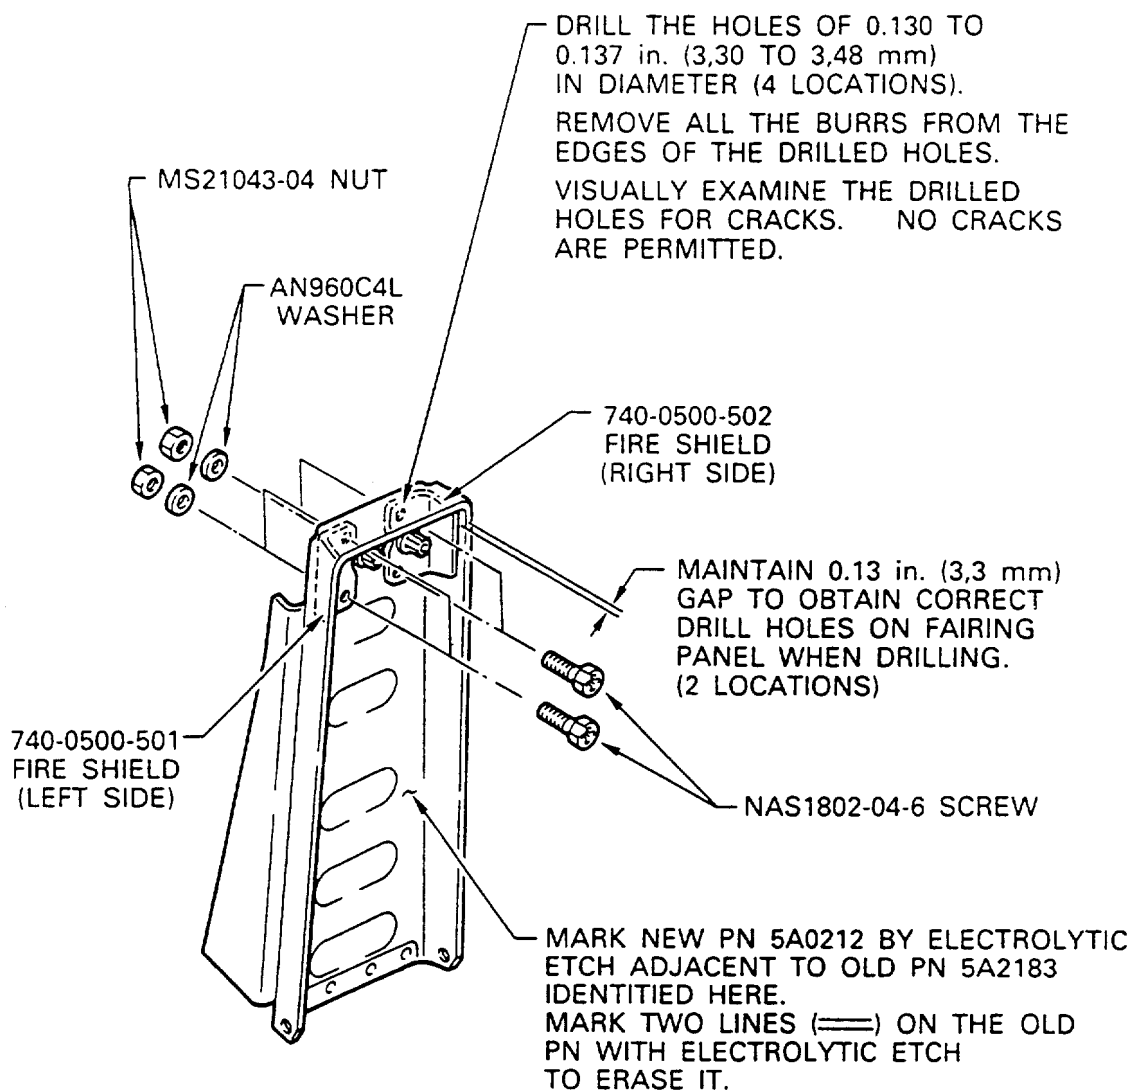
Rework of the No.1 Strut Fairing Panel A/0
Fig.2, Sheet 1 of 2

- (a) The Fire Shields and their attaching parts are being added to the No.1 Strut Fairing Panel (A/0), to provide the thermal protection for the Thrust Reverser Firewall Seal. (See Figure 2).
- (b) In agreement with the above, the No.1 Strut Fairing Panel (A/0) is reworked to include drilled holes which permit the installation of the Fire Shields on the Fairing Panel with the Screws, Nuts, and Washers. (See Figure 2).
- (2) The existing No.1 Strut Fairing Panel (A/0) can be reworked to a new configuration. (See Figure 2).
- (3) New No.1 Strut Fairing Panel (A/0) and Fire Shields including their attaching Screws, Nuts, and Washers will be available for future replacement purposes.

- (3) Drill two 0.130 to 0.137in. (3,30 to 3.48 mm.) diameter holes from two pilot holes in the Fire Shield through the Fire Shield and the Fairing Panel. Remove the clamp, and keep the Fire Shield. (Refer to Figure 2, Sheet 1).

- (4) Remove all burrs from the holes in the Fire Shield and the Fairing Panel. (Refer to Figure 2, Sheet 1).
- (5) Remove only enough Bolts, Nuts, Washers and Strut Corner Fillers to peel back the Fairing Panel allowing access as follows: (Refer to Figure 2, Sheet 2).

- (6) Attach 740-0500-501, Fire Shield to the Fairing Panel with two NAS1802-04-6, Screws, AN960C4L, Washers, and MS21043-04, Nuts. Torque the Nuts to 6 – 7 lbfin (0,68 – 0,80 Nm). (Refer to Figure 2, Sheet 1 and 1.K.(2), Aircraft Maintenance Manual, 70-23-11, Torque Tightening Technique).

- (9) Renumber by the Electrolytic etch adjacent to the existing Part Number on the Fairing Panel as follows. (Refer to Figure 2, Sheet 1, and 1.K. (3)).
