ENGINE - HP COMPRESSOR - FRONT SHAFT AND SEAL ASSY WITH STIFFENED SEAL CARRIER -
CATEGORY CODE 7 - MOD.ENG-72-0026

V2500-ENG-72-0026

SERVICE BULLETIN

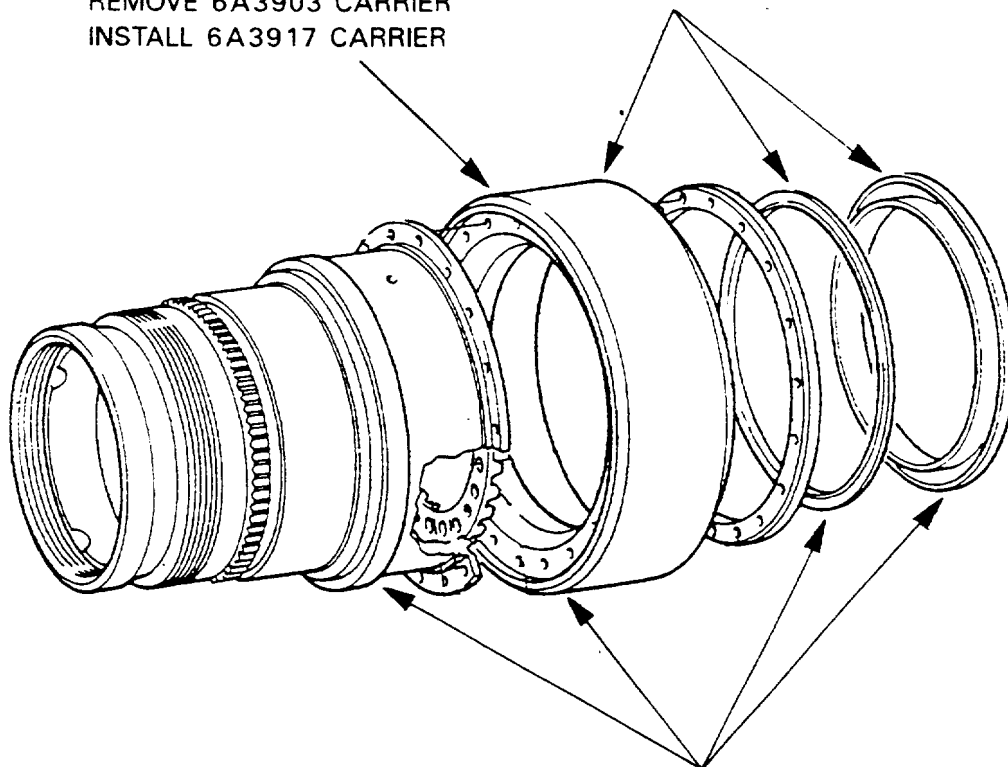
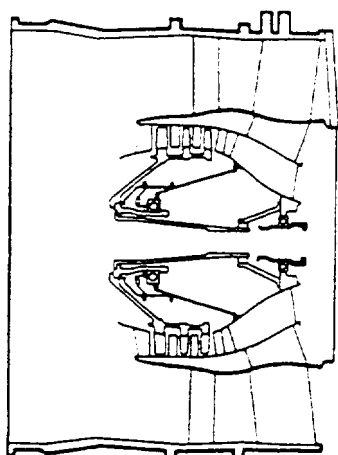
Location of H.P. compressor front shaft and seal assembly
Fig.1

Cracking of the seal carrier can occur in the bolt holes.

Cracks were found in the shaft seal carrier during inspection after the strip of development test of three engines. These were probably caused by fretting and high cycle fatigue.

- (a) A new HPC front shaft and seal assembly is introduced which features a shorter seal diameter, thicker outer front diameter and increased flange thickness.

REMOVE 6A3903 CARRIER
INSTALL 6A3917 CARRIER

REMOVE 6A3902 CARRIER ASSEMBLY
INSTALL 6A3916 CARRIER ASSEMBLY

REMOVE 6A3898 SHAFT AND SEAL ASSEMBLY
INSTALL 6A3915 SHAFT AND SEAL ASSEMBLY
