SERVICE BULLETIN

ENGINE - H.P. COMPRESSOR STAGE 7 AND 8 ROTOR PATHS WITH REDUCED SPRAYED THICKNESS ABRADABLE LININGS - CATEGORY CODE 6 - MOD.ENG-72-0030

(1) Aircraft: Airbus A320

(2) Engine: V2500 A1 Engines prior to Serial No.V0071, excluding V0061,

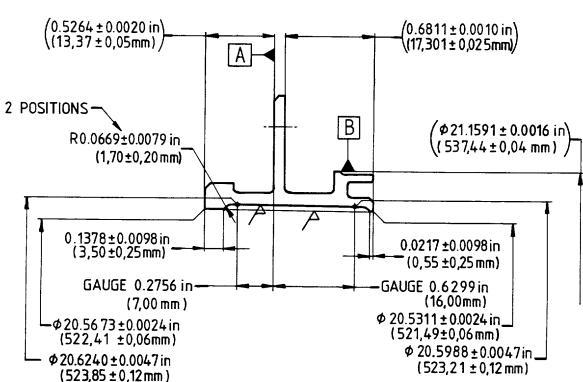
Modification of HP Compressor Stage 7 Rotor Path Fig.2

THE REMOVAL OF THE SEAL MATERIAL FROM THE STAGE 7 COMPRESSOR ROTOR PATH

MACHINE WHERE SHOWN

REMOVE THE SHARP EDGES 0.012 ± 0.008 in $(0.30 \pm 0.20$ mm)

MACHINED SURFACE FINISH TO BE 250 MICROINCHES (6,30 MICROMETRES)

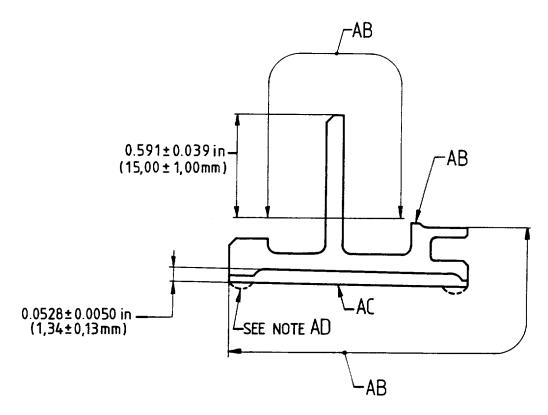
Modification of HP Compressor Stage 7 Rotor Path Abradable Lining Fig.3

THE REPLACEMENT OF THE SEAL MATERIAL IN THE STAGE 7 COMPRESSOR ROTOR PATH

MAKE GOOD ALL DAMAGE TO ENAMEL AS GIVEN IN TEXT. DO NOT LET THE ENAMEL TOUCH THE AREAS SPECIFIED AB OR GO INTO THE HOLES.

APPLY THE SEAL MATERIAL AS GIVEN IN THE TEXT ON THE AREA SPECIFIED AC. NOTE AD:-

IT IS PERMITTED TO MAKE SURFACE NOT SMOOTH.

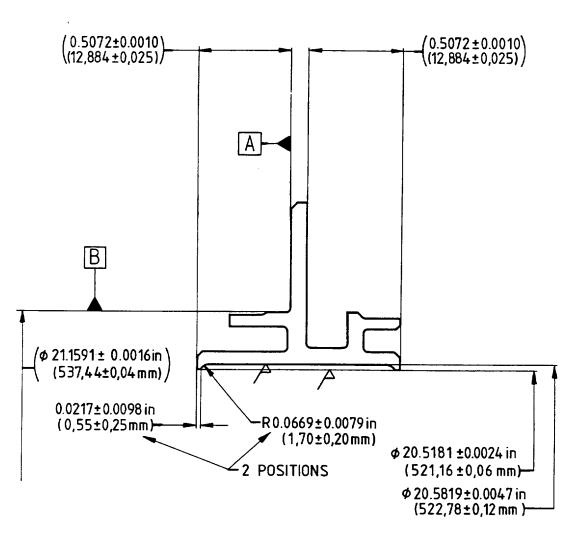
THE REMOVAL OF THE SEAL MATERIAL FROM THE STAGE8 COMPRESSOR ROTOR PATH.

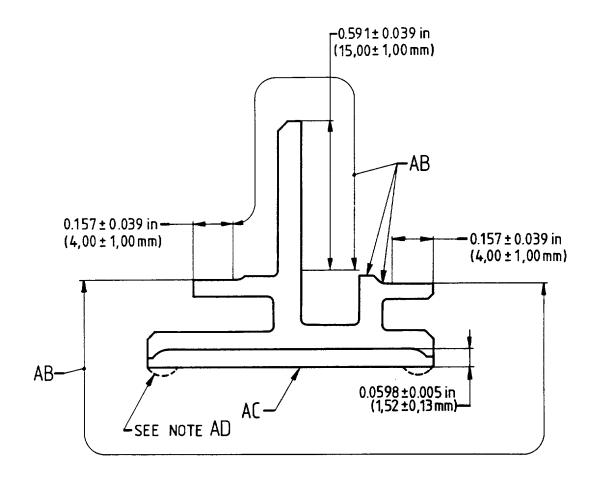
Modification of HP Compressor Stage 8 Rotor Path Abradable Lining Fig.5

THE REPLACEMENT OF THE SEAL MATERIAL IN THE STAGE 8 COMPRESSOR ROTOR PATH.

MAKE GOOD ALL DAMAGE TO ENAMEL AS GIVEN IN TEXT.

DO NOT LET THE ENAMEL TOUCH THE AREAS SPECIFIED AB OR GO INTO THE HOLES.

APPLY THE SEAL MATERIAL AS GIVEN IN THE TEXT ON THE AREA SPECIFIED AC. NOTE AD:-

IT IS PERMITTED TO MAKE THE SURFACE NOT SMOOTH.
