ENGINE – PROVIDE A SEAL FOR THE BOOSTER STAGE BLEED VALVE A/O AND A REPLACEMENT LPC
INLET GUIDE VANE ASSEMBLY – CATEGORY CODE 7 – MOD.ENG-72-0031

- (1) Aircraft: Airbus A320
- (2) Engine: V2500-A1 Engines, prior to Serial Numbers V0051

V2500-ENG-72-0031

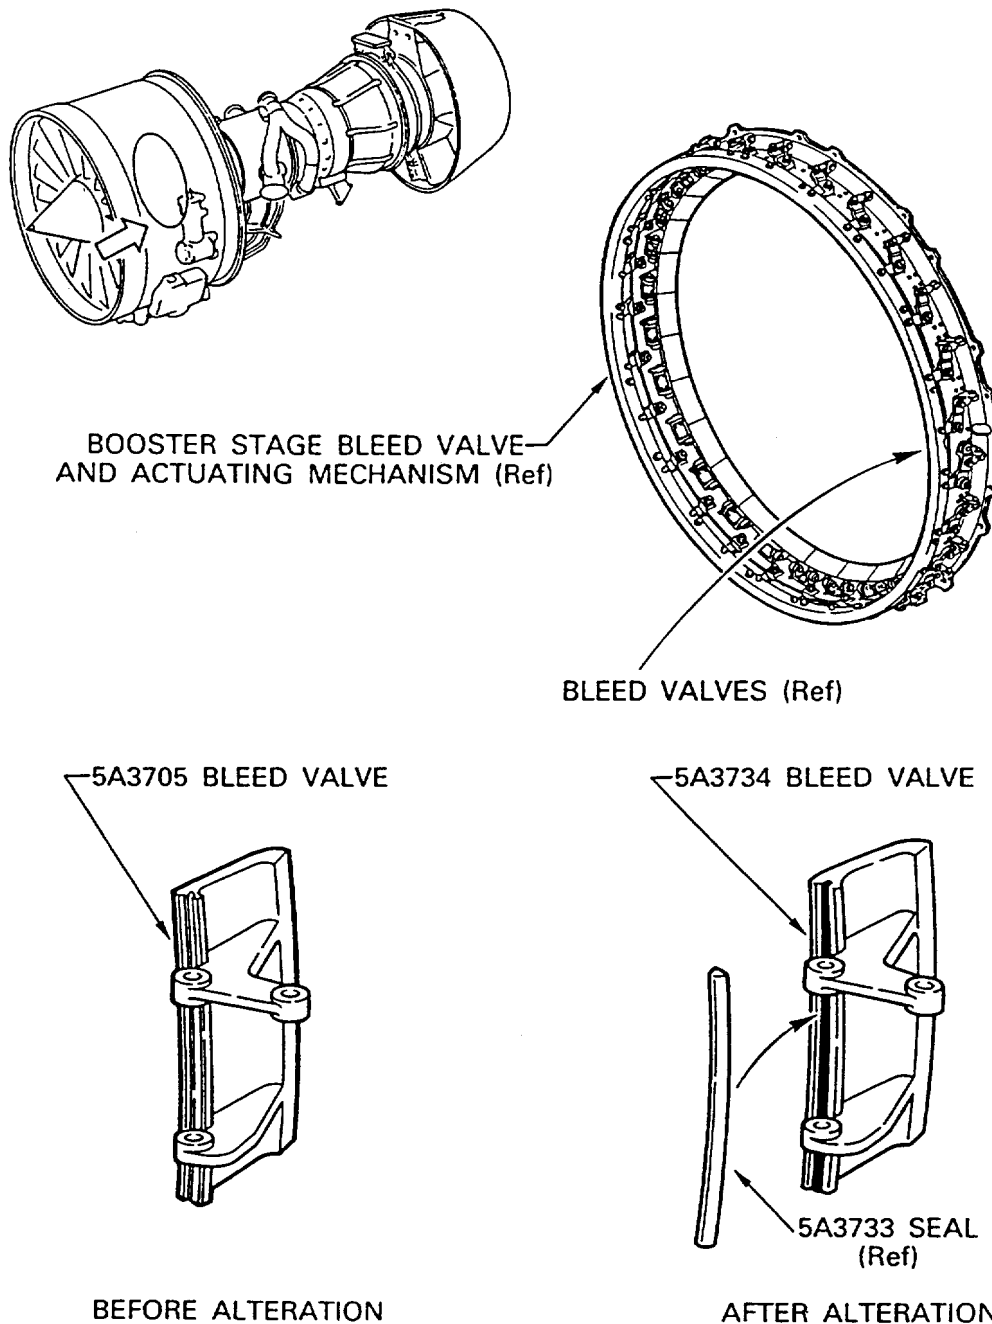
- (a) The LPC booster stage bleed valve A/O which has the front rubber seal, has been reintroduced as a performance benefit. (See Figure 1.)

Booster stage bleed valve A/O before and after alteration
Fig.1

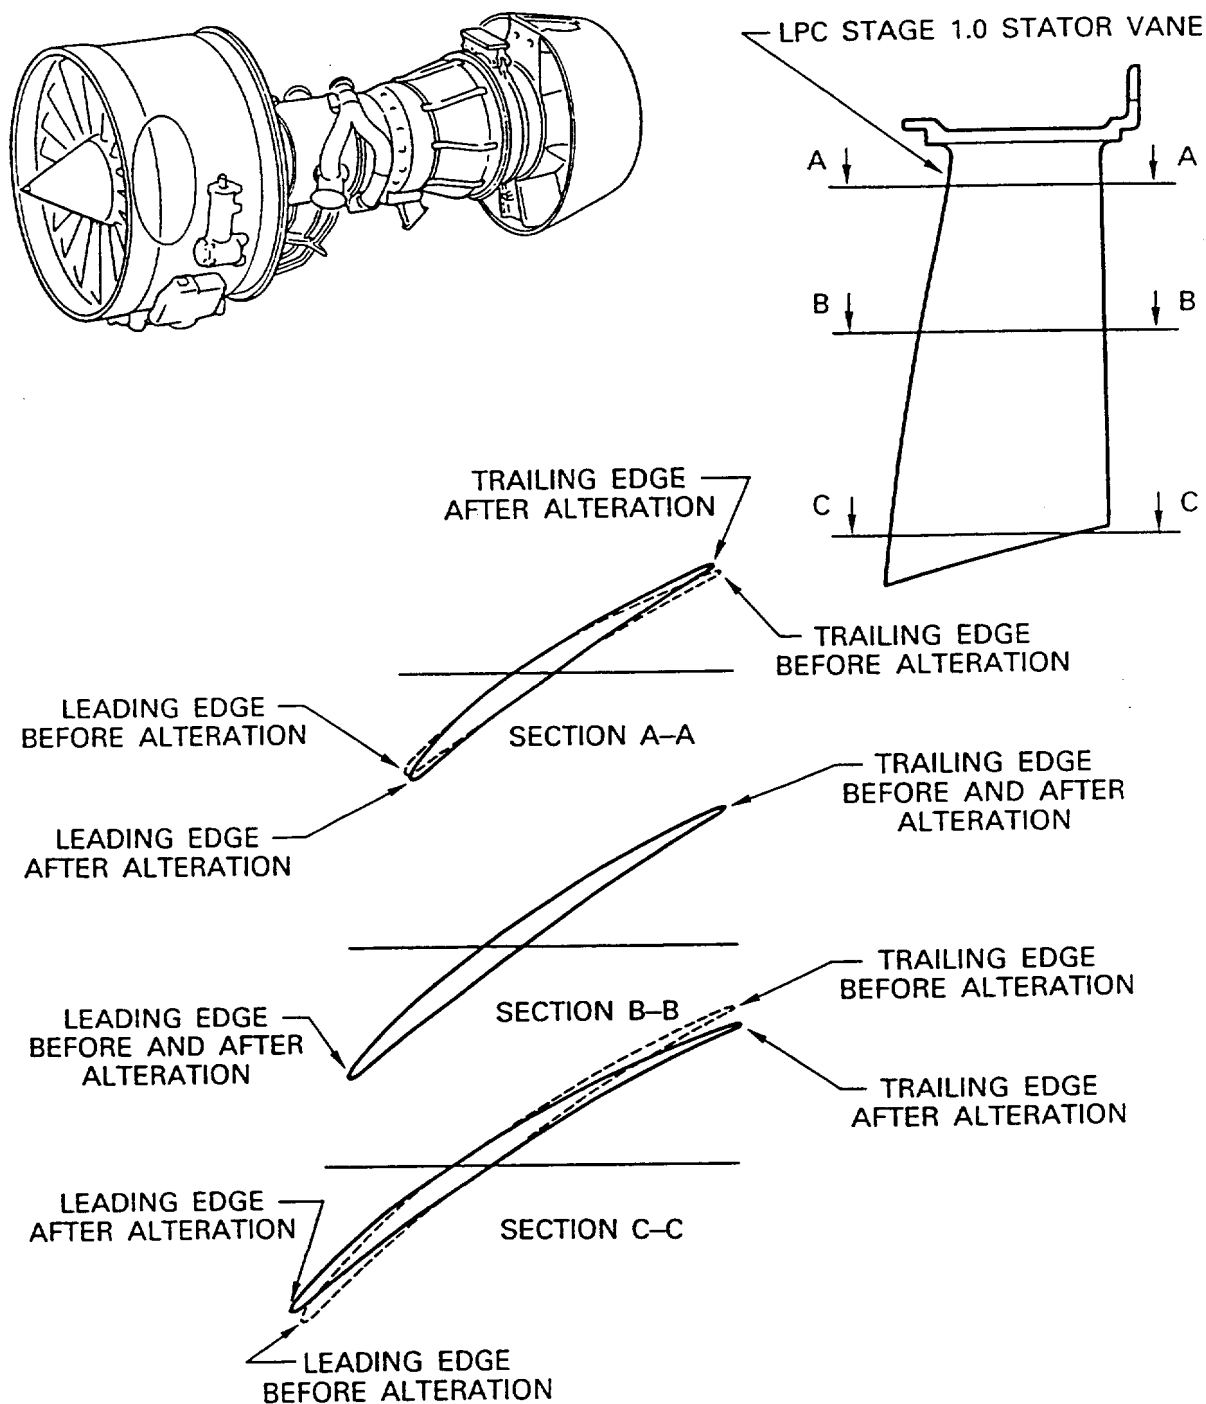
- (b) A new LPC inlet guide vane assembly which has the redesigned airfoil profile of the vane leading and trailing edge angles, has been introduced to improve the surge margin. (See Figure 2.)

LPC inlet guide vane assembly before and after alteration
Fig.2
