SERVICE BULLETIN

ENGINE - DIFFUSER AND COMBUSTION GROUP AND NO.4 BEARING FRONT AND REAR COMPARTMENT -
INCORPORATE NEW NO. 4 BEARING CARBON SEAL ASSEMBLIES MADE OF REVISED MATERIAL -
CATEGORY CODE 6 - MOD.ENG-72-0032

V2500-ENG-72-0032

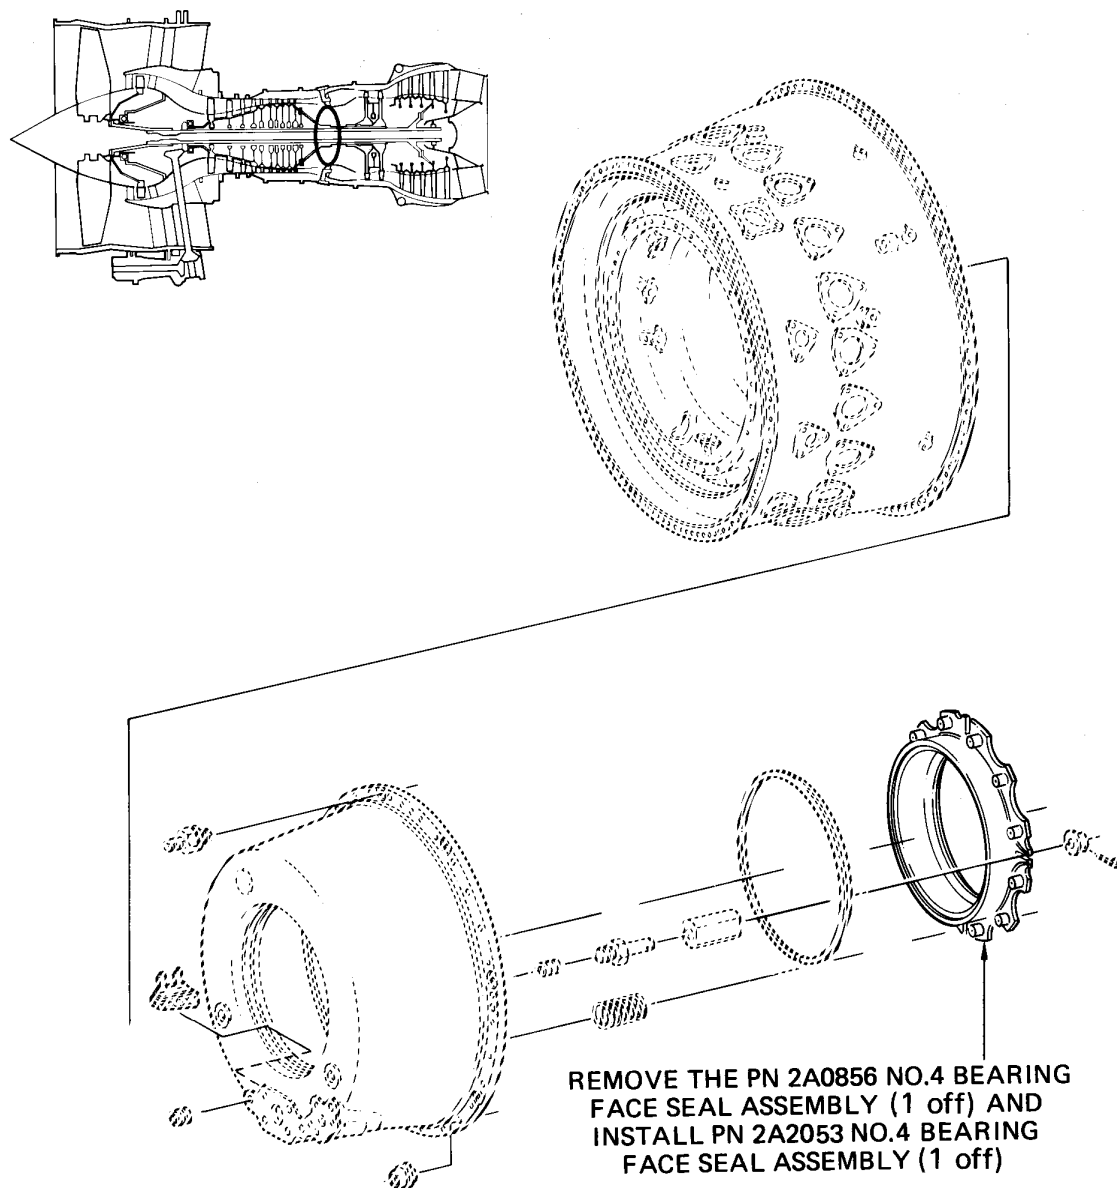
Location and Modification of the No.4 Bearing Front Seal Assembly (2A2055)
Fig.1

Carbon seals wore at a rate which was not satisfactory. The first material used in the carbon seal was too soft.

- (1) Install the 2A2053 No.4 Bearing Face Seal Assembly (1 off) in the Front Seal Assembly by the approved procedure in Reference (2), Chapter/Section 72-42-33, Assembly. See Figure 1.
- (2) Identify the new No.4 Bearing Front Seal Assembly as 2A2055 by the approved procedure in reference (3), Chapter/Section 70-09-00, Marking of Parts. Use the vibration peen method.
- (3) Install the 2A2053 No.4 Bearing Face seal Assembly (1 off) in the Rear Seal Assembly by the approved procedure in Reference (2), Chapter/Section 72-43-20, Assembly. See Figure 2.
- (4) Identify the new No.4 Bearing Rear Seal Assembly as 2A2056 by the approved procedure in Reference (3), Chapter/Section 70-09-00, Marking of Parts. Use the vibration peen method.
