ENGINE - H.P. COMPRESSOR - INTRODUCTION OF SCALLOPED HEAT SHIELD RETAINER - STAGE 7
BOROSCOPE POSITION - CATEGORY CODE 6 - MOD.ENG-72-0033

V2500-ENG-72-0033

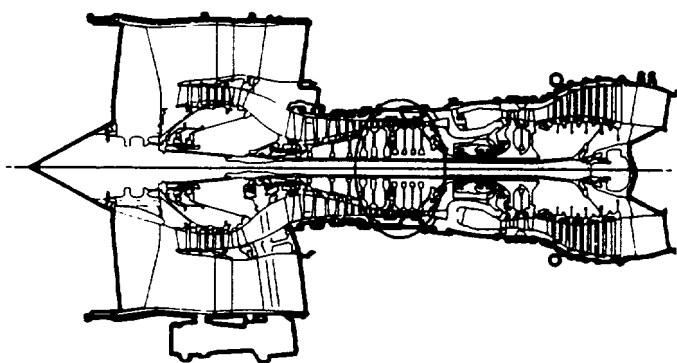
Rework of H.P. compressor stage 7 rear heatshield retainer
Fig.1

Examination during audit strip, revealed a foul on the stage 7 rear heat shield retaining half ring after difficulties were experienced in carrying out a boroscope inspection. An appraisal of the tolerances on the relevant components revealed that it is possible to have a clearance to interference situation.

- (1) A new H.P. compressor stage 7 rear heatshield is introduced
- (2) The changes introduced by this Service Bulletin are as follows:
 - (a) An additional scallop is machined, adjacent to the boroscope access, at the same compound angle as the boroscope, the size is such that it breaks through the half ring and produces a small leakage hole. Any sharp corners produced by break through to be removed by hand dressing. For commonality and to prevent interchangeability problems both half rings to be the same.
 - (b) Existing H.P. compressor stage 7 rear heatshield retainers can be reworked, see Fig.1 to 3.

Procedure	Supplementary Information	
(a) Align and clamp the component	Use fixture 3R18732	
(b) Remove material to form the scallop	Use a hand held air operated rotary cutter to remove the bulk of the material. Finish using a round file. Remove the part from the fixture after filing to size	
(c) Deburr the machined edges	Remove all sharp edges and cusps. Refer to Fig.1, 2 and 3. Use hand tools	
(d) Visually/dimensionally inspect	Refer to Fig.1, 2 and 3	
(e) Crack test	Standard Practices Manual TASK 70-23-01 or 70-23-03. Reject if cracked	
(f) Degrease	S.P.M. TASK 70-11-01	
(g) Enamel the areas exposed by machining and make good all damage to the enamel	S.P.M. TASK 70-38-21-380-501, SUBTASK 70-38-21-380-010. Use CoMat 07/037 or 07/038	
(h) Re-identify the part	Existing	Renumber
	6A3028	6A3993
