SERVICE BULLETIN

ENGINE - NO.4 BEARING COMPARTMENT - REWORK NO.4 BEARING FRONT AND REAR SEAL SEATS TO
INCORPORATE REVISED SURFACE FINISH AND HARDFACE THICKNESS - CATEGORY CODE 5 -
MOD.ENG-72-0036

V2500-ENG-72-0036

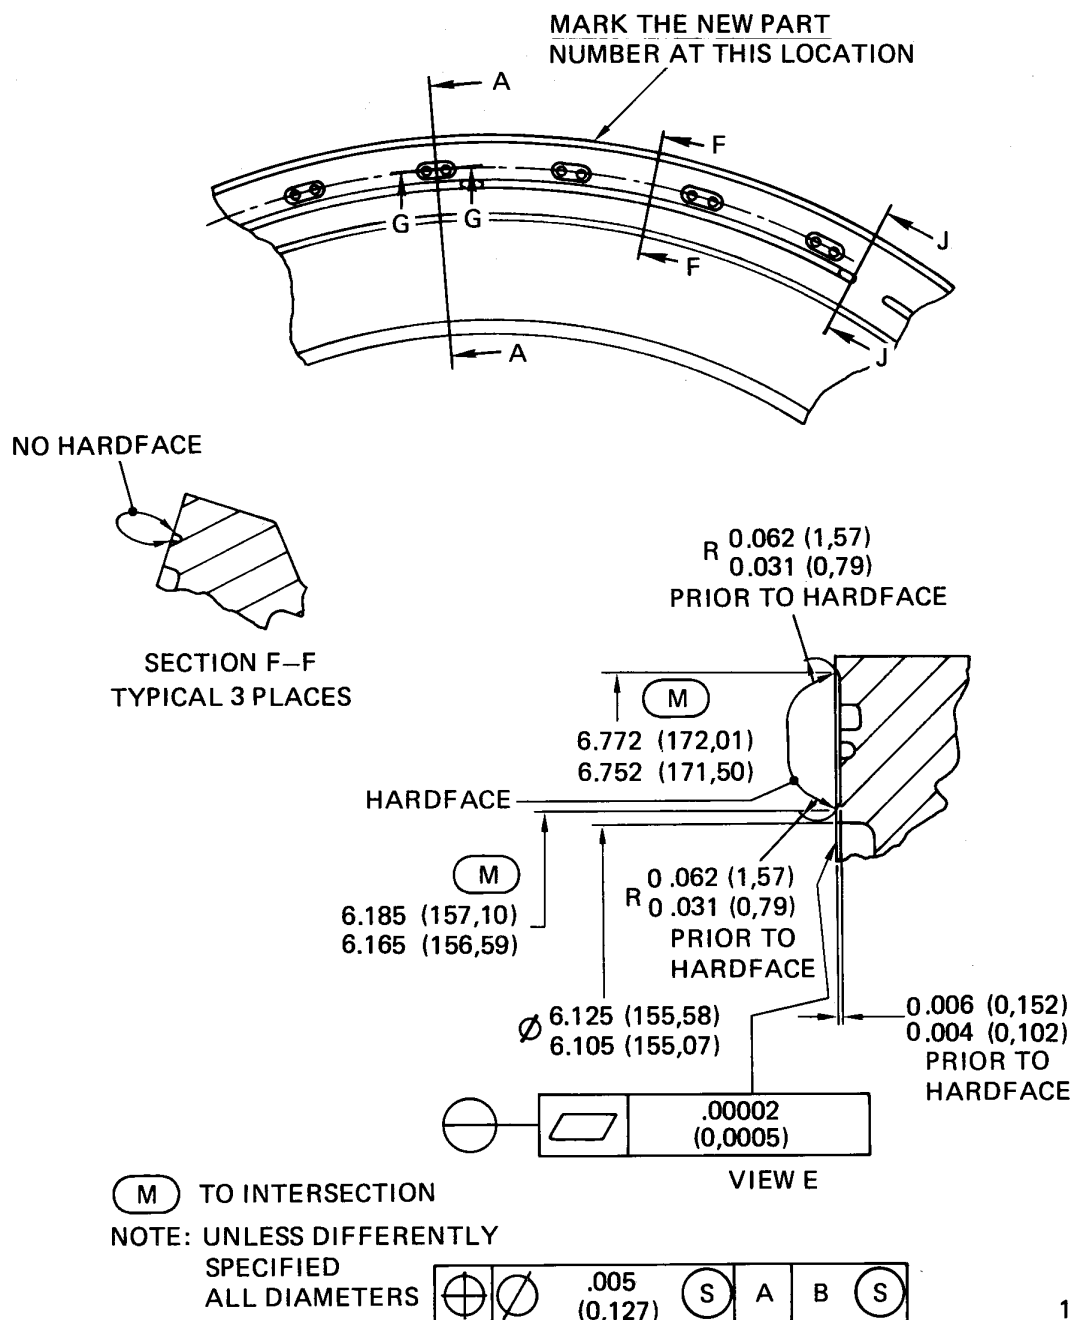
Fig.2 (Sheet 1 of 2)

The plasma coat thickness now used on the No.4 Bearing Seal Seat is not sufficient to permit repair. When seals with this coat thickness are lapped the surface that results is not satisfactory.

During the experimental program it was found that when the seal seats were lapped after use, there was not enough plasma thickness necessary to meet the specification. It was also found during experimental testing that one of the two approved lapping methods led to accelerated wear of the carbon seal. The need for additional material thickness, for repair purposes, was not considered in the design. The deficiencies in the lapping procedure were not understood.

| (a) Set-up and machine the No.4 Bearing Front Seal Seat | Refer to Figure 2, Sheets 1 and 2 requirements |
| (b) Hardface the enclosed area (View E) with chromium carbide coating, Make sure that no overspray goes into the areas marked "no hardface" | Refer to Figure 2, Sheets 1 and 2 for coating location which is to be applied by Reference (3), Control No./TASK 70-34-02-340-501 |

| (c) Set-up and machine to the dimensions and surface finish specified | Refer to Figure 2, Sheets 1 and 2 requirements and References (3), Control No./TASK 70-35-09-350-501 |

| (d) Make a mark adjacent to the old part number to show the new part number. Use the vibration peen method | Old Part No. New Part No.

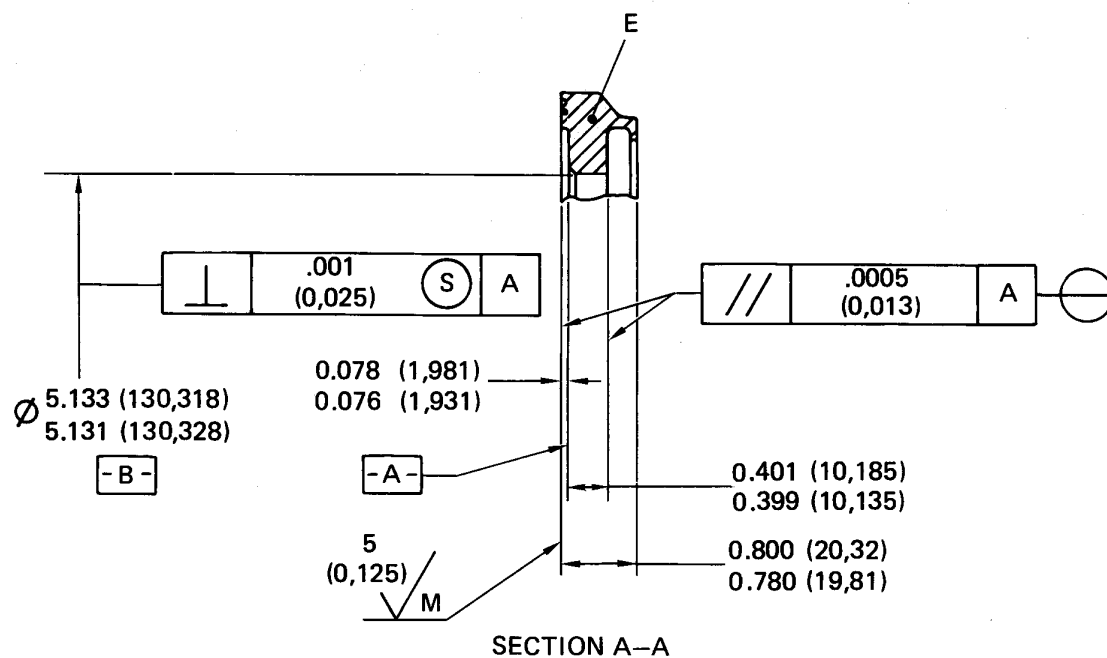
Fig.2 (Sheet 2 of 2)

NO HARDFACE 6 PLACES

NO HARDFACE 36 PLACES
