Subject: Transmittal of Revision 2 to Service Bulletin
No.V2500-ENG-72-0037

**ENGINE - LP TURBINE - REPLACE THE LP TURBINE SHAFT REAR END
SEALING RING**

V2500-A1

V2500-ENG-72-0037

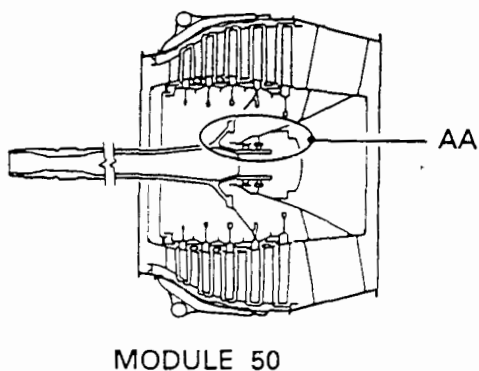
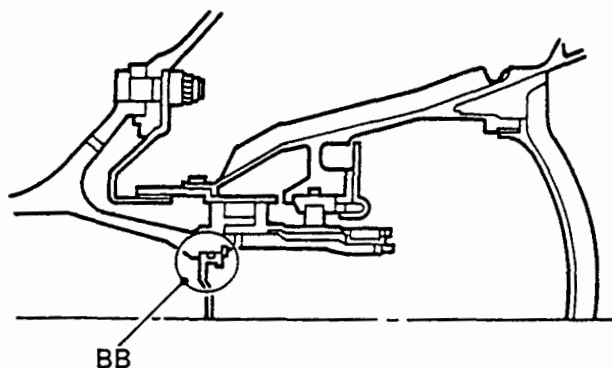
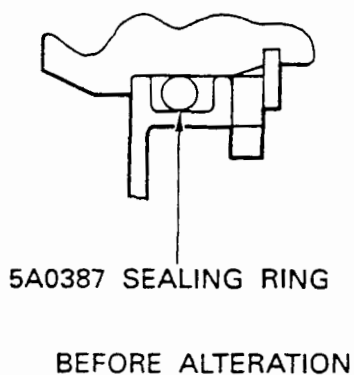
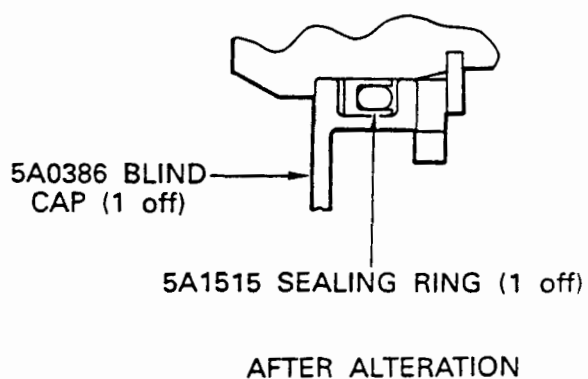
Modification of the Sealing Ring
Figure 1

Oil leak problems may occur due to the distortion of the Sealing Ring installed on the Blind Cap at the end of LP Turbine Shaft.

The distortion of the Sealing Ring caused by shortage of that durability at high temperature.

- (a) The configuration of the Sealing Ring was changed.
- (b) Existing Part Number of the Sealing Ring has been changed to a new Part Number.

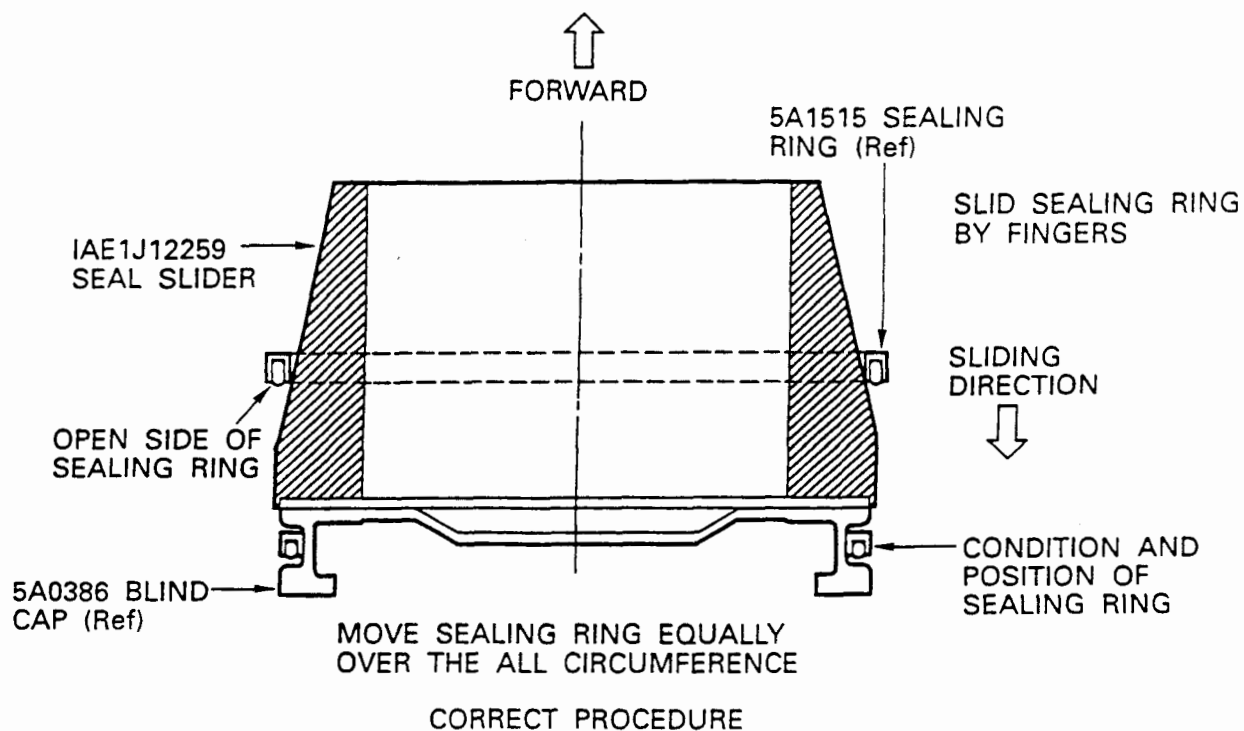
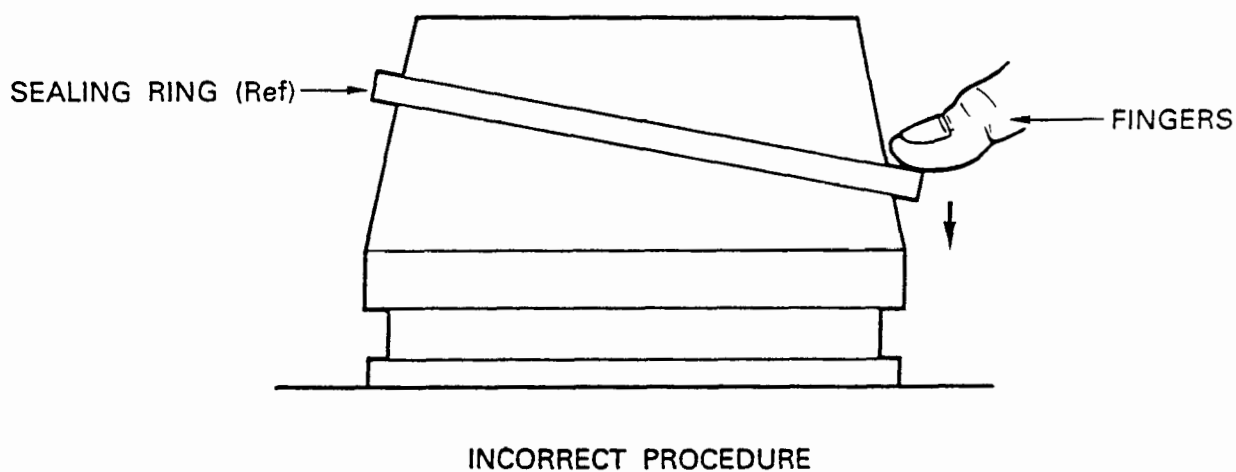
Installation of the Sealing Ring onto the Blind Cap
Figure 2

CAUTION: MOVE THE SEALING RING SMOOTHLY AND EQUALLY OVER THE ALL CIRCUMFERENCE. IF NOT SO, THE SEALING RING IS EXTENDED LOCALLY. LOCAL EXTENSION CAN CAUSE DAMAGE TO THE SEALING RING.

- R (1) Part 1: Installation procedure of Sealing Ring with tools.
- R (a) Install the new 5A1515, Sealing Ring into the groove on the Blind Cap
R (Refer to Figure 2).
- R 1) Put the Blind Cap on to the work bench with rear end down.
- R 2) Install the IAE1J12259, Slider onto the Blind Cap.

- 3) Lubricate the Sealing Ring with CoMat 10-077 approved engine oil.
- 4) Lubricate outer diameter surface of the slider with CoMat 10-077 approved engine oil.
- 5) Put the Sealing Ring on to the outer diameter of the slider.
The open side of the Sealing Ring must be in down direction.

- 6) Slowly push down the Sealing Ring by hand until it is installed into the groove of the Blind Cap.
- 7) Remove the slider from the Blind Cap.

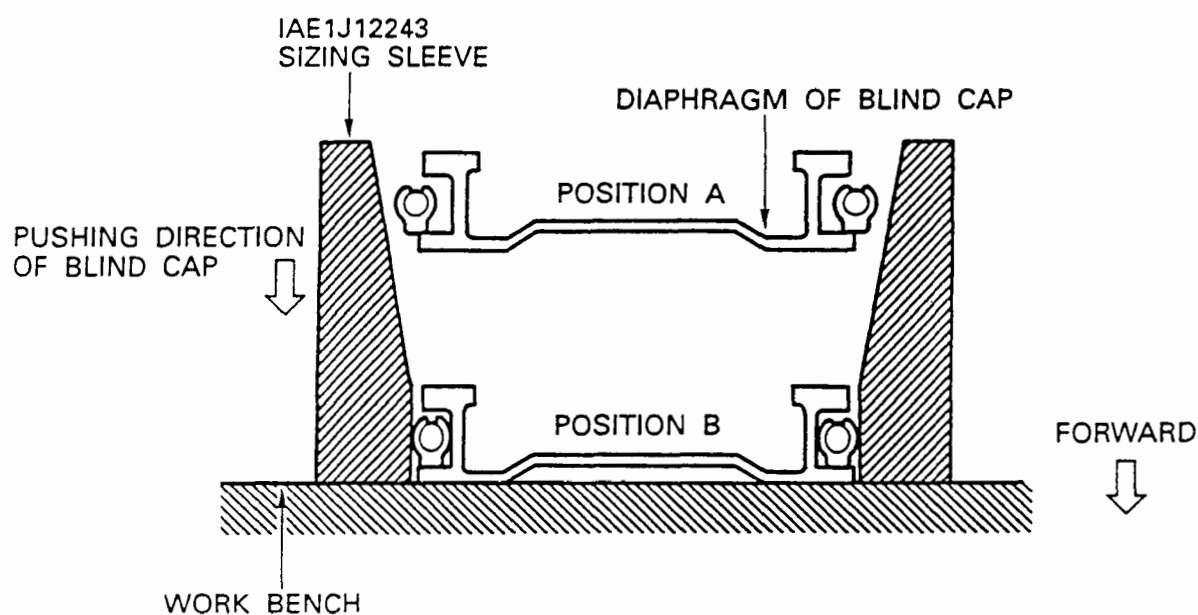
Installation of the Blind Cap in to the Sizing Sleeve
Figure 3

CAUTION: DO NOT INSTALL THE BLIND CAP AND THE SEALING RING INTO THE LPT SHAFT WITHOUT FOLLOWING STEPS, THE SEALING RING DIAMETER WILL BE EXTENDED AND THE LPT SHAFT BORE CAN CAUSE DAMAGE TO THE OUTER DIAMETER ON THE SEALING RING.

- (b) Make the shrinkage satisfactory of the Sealing Ring on the Blind Cap (Refer to Figure 3).

- 2) Lubricate the inner diameter face of the Sizing Sleeve and the outer diameter of Sealing Ring with CoMat 10-077 approved engine oil.
- 3) Put the Blind Cap in to the Sizing Sleeve. Diaphragm of the Blind Cap must be in down direction (At position A shown in Figure 3).
- 4) Slowly push the Blind Cap down until it touches the work bench (At position B shown in Figure 3).
- 5) Keep the Blind Cap in the Sizing Sleeve for 10 or more minutes.
- 6) Remove the Sizing Sleeve from the Blind Cap.

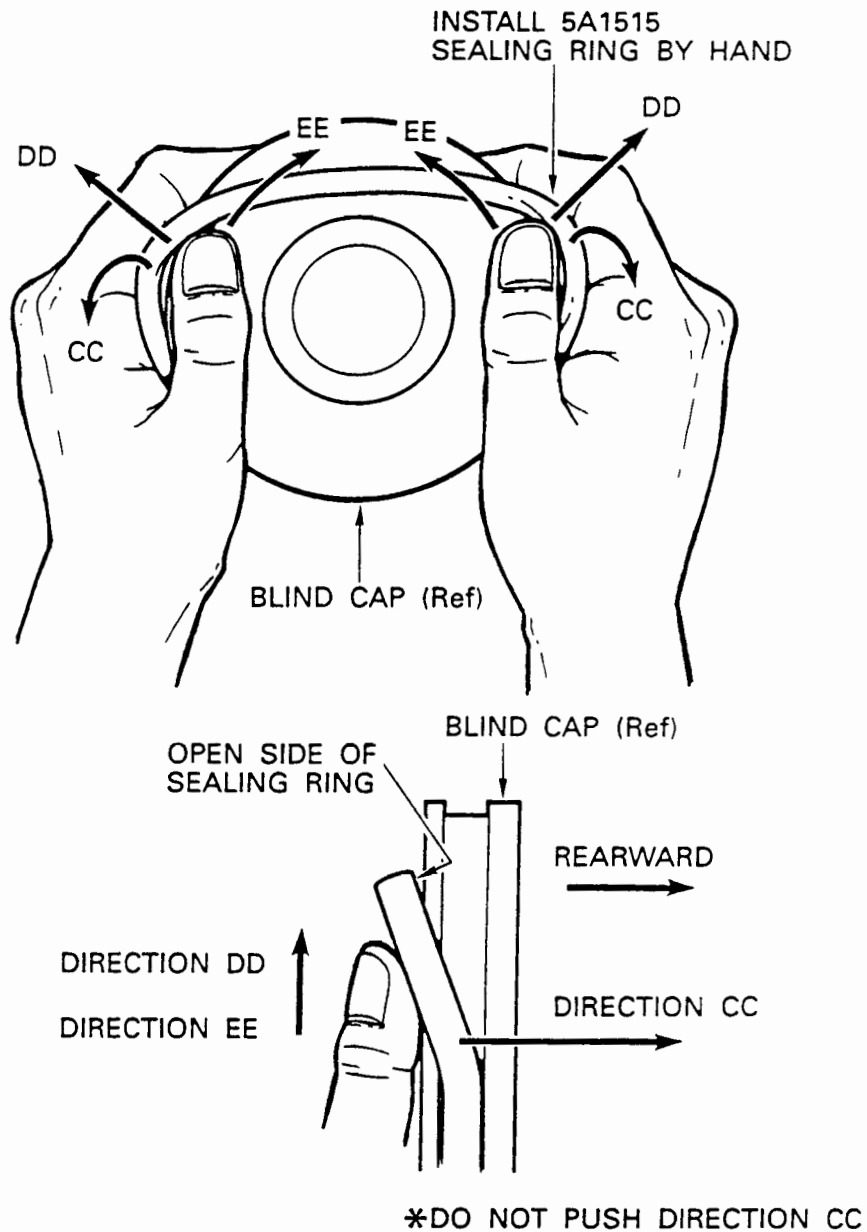
Installation of the Sealing Ring on to the Blind Cap
Figure 4

CAUTION: DO NOT PUSH THE SEALING RING IN DIRECTION CC SHOWN IN FIGURE 4, BECAUSE EDGE OF THE BLIND CAP CAN CAUSE DAMAGE OR TWIST TO THE SEALING RING. THE DEFECTIVE SEALING RING CAUSES OIL LEAK.

CAUTION: DO NOT EXTEND THE SEALING RING TOO MUCH. MUCH EXTENSION CAN CAUSE PERMANENT EXTENSION OF THE PLASTIC COVER OF SEALING RING AND CAUSE OIL LEAK.

- 2) Make sure that the Sealing Ring is not twisted (Refer to Figure 5).
- (2) Part 2: Installation procedure of Sealing Ring without tools.
 - (a) Install the new 5A1515, Sealing Ring in to the bottom half of groove on the Blind Cap (Refer to Figure 4).
 - 1) Lubricate the Sealing Ring and the Blind Cap with CoMat 10-077 approved engine oil.

- 2) Install the Sealing Ring in to the bottom half of the groove of the Blind Cap and open side of the Sealing Ring must be rearward.
- (b) Install the Sealing Ring around all the groove of the Blind Cap (Refer to Figure 4).
 - 1) Push the Sealing Ring inner face in direction DD with finger sides to let the Sealing Ring go in to the groove of the Blind Cap.
 - 2) Move the fingers in direction EE.
 - 3) Repeat steps 1) and 2) until the Sealing Ring is installed around all of the groove.
- (c) Visually examine the Sealing Ring.
 - 1) Make sure that there is no damage on the surface.

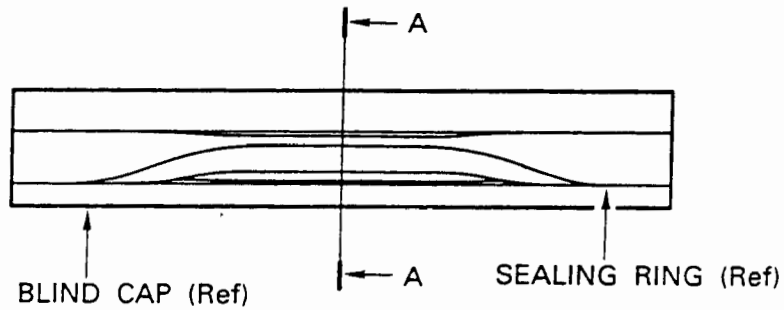
Installed condition of the Sealing Ring
Figure 5

CAUTION: DO NOT USE SEALING RING, IF IT IS TWISTED. THIS TWISTED SEALING RING MUST BE DISCARDED.

REJECTED

ACCEPTABLE

- 2) Make sure that the Sealing Ring is not twisted (Refer to Figure 5).
- (3) Install the 5A0386, Blind Cap into the engine in Reference (2), TASK 72-00-50-420-003-A00.
- (4) Install the No.5 Bearing Compartment Cover onto the engine in Reference (2), TASK 72-00-50-420-003-A00.
