ENGINE - HP COMPRESSOR - INTRODUCTION OF 12 SPACERS ON THE REAR PISTON RING SEAL -
CATEGORY CODE 6 - MOD.ENG-72-0038

V2500-ENG-72-0038

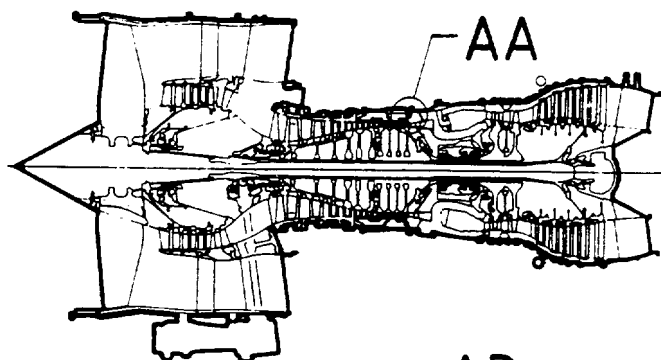
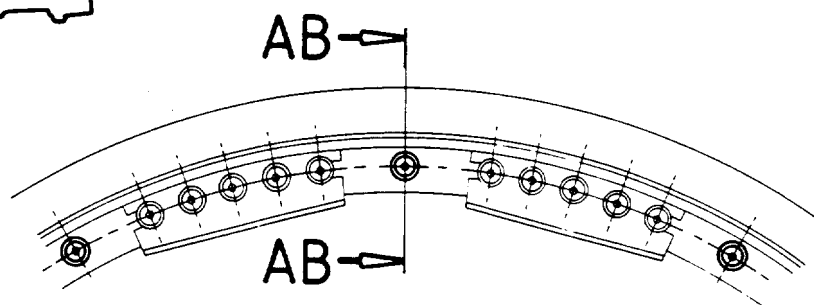
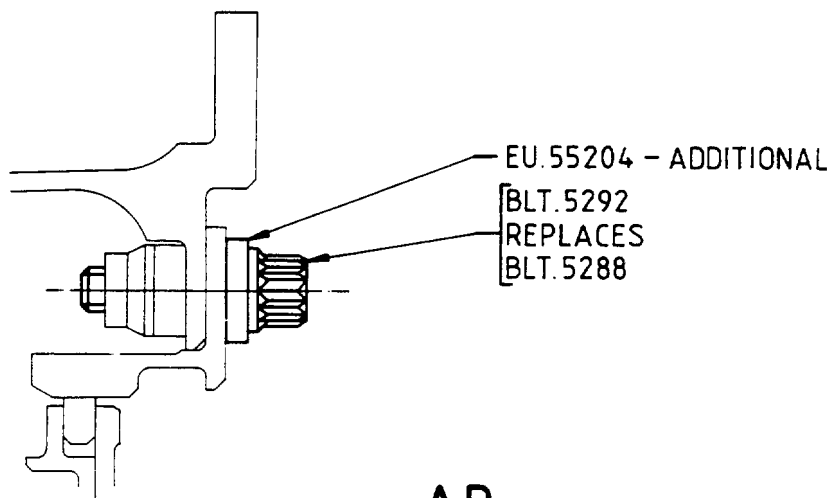
View showing bolt and spacer on rear piston ring seal - After alteration
Fig.1

Pitting and metal pickup on the flange of the piston seal outer member underneath the 12 bolt heads.

An audit strip revealed that metal pickup had occurred under the 12 bolt heads clamping directly to the rear piston ring seal flange on the outer member. At the other 60 positions on the same flange, the bolts also clamp the cross key plate and a spacer is fitted under the bolt heads. Metal pick-up was not observed at these positions.

- (a) Twelve spacers are introduced at the twelve bolt positions on the rear piston ring seal where previously no spacers were utilized.
- (b) The twelve existing bolts have been deleted and are now common with the existing sixty longer bolts to accommodate the extra clamped thickness.
