ENGINE - REVISED CLIPPING AT CP5737 AND THE CLIPPING BRACKET MODIFICATION - CATEGORY
CODE 4 - MOD.ENG-72-0039

V2500-ENG-72-0039

SERVICE BULLETIN

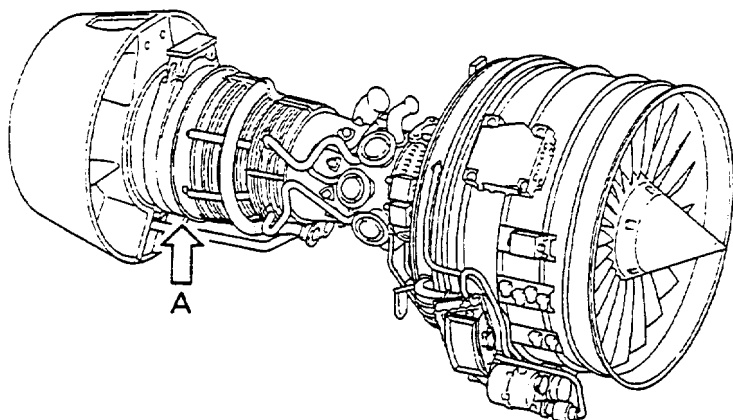
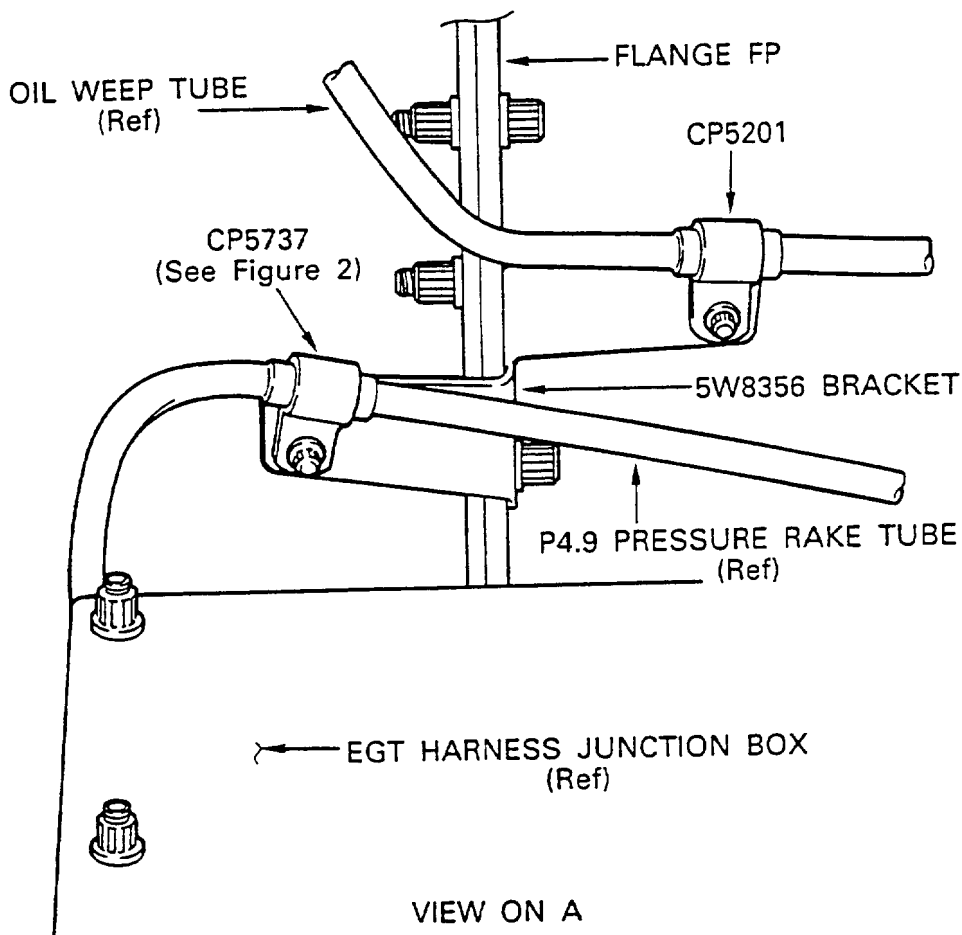
Location of the clipping position CP5737 and the clipping bracket
Fig.1

A foul occurs between the P4.9 Pressure Rake Tube (Fuel System Air Tube) and the RH side C-Duct Hold Open Rod when the RH side Hold Open Rod is in a stowed position.

The contact area is where tube run changes from axial to circumferential above the EGT Harness Junction Box, with the top rear edge of the stowed Hold Open Rod.

An examination has shown that unsatisfactory clipping and bracket arrangement at CP5737 can cause the P4.9 Pressure Rake Tube to contact the RH C-Duct Hold Open Rod.

(a) The existing CP5737 which safties the P4.9 Pressure Rake Tube and the clipping Bracket has been rearranged to reroute the tube. (See Figures 1 and 2).

- (1) Find PN 5W8356, Clipping Bracket, which is used for the clipping position CP5201 and CP5737. (Refer to Figure 1).
- (2) At CP5737, remove PN 4W0102, Bolt, PN 5W1086, Washer, PN 5W1109, Clip, and PN 4W0043, Clip Nut, from the P4.9 Pressure Rake Tube and PN 5W8356, Clipping Bracket. (Refer to Figures 1 and 2).

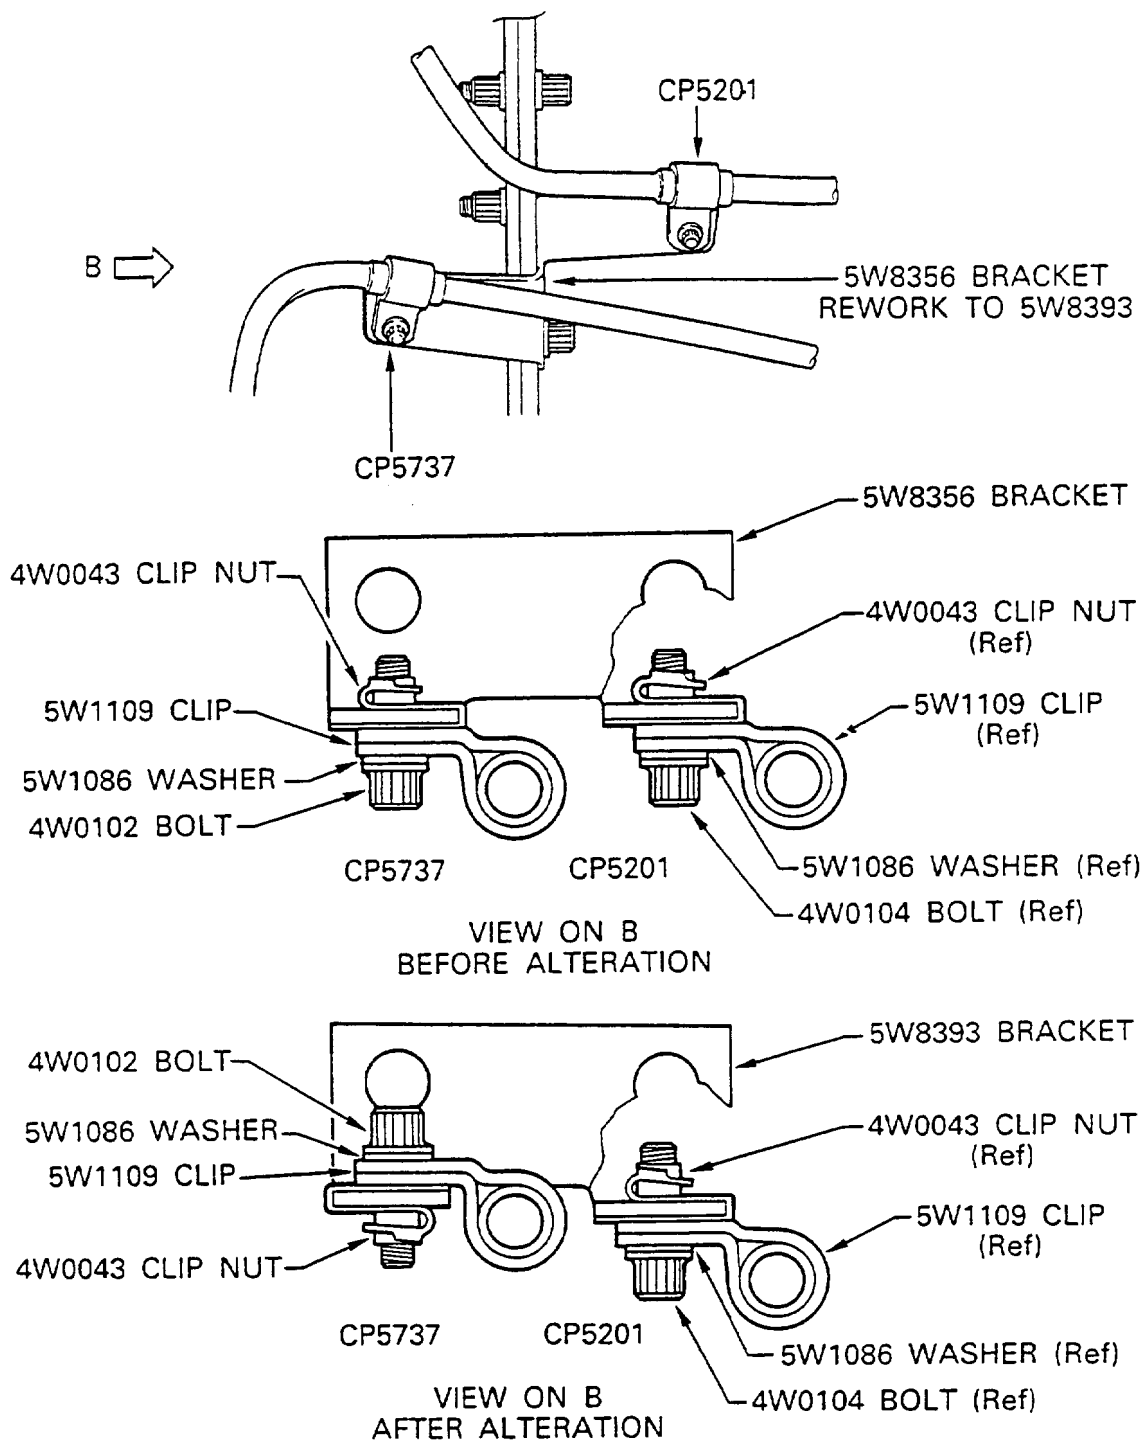
Clipping detail at clipping position CP5737 - Before and after alteration
Fig.2

The cause of condition is due to unsatisfactory tube run of the P4.9 Pressure Rake Tube.

- (3) At CP5201, remove PN 4W0104, Bolt, PN5W1086, Washer, PN5W1109, Clip, and PN 4W0043, Clip Nut, from the Oil Weep Tube and PN 5W8356, Clipping Bracket. (Refer to Figures 1 and 2).

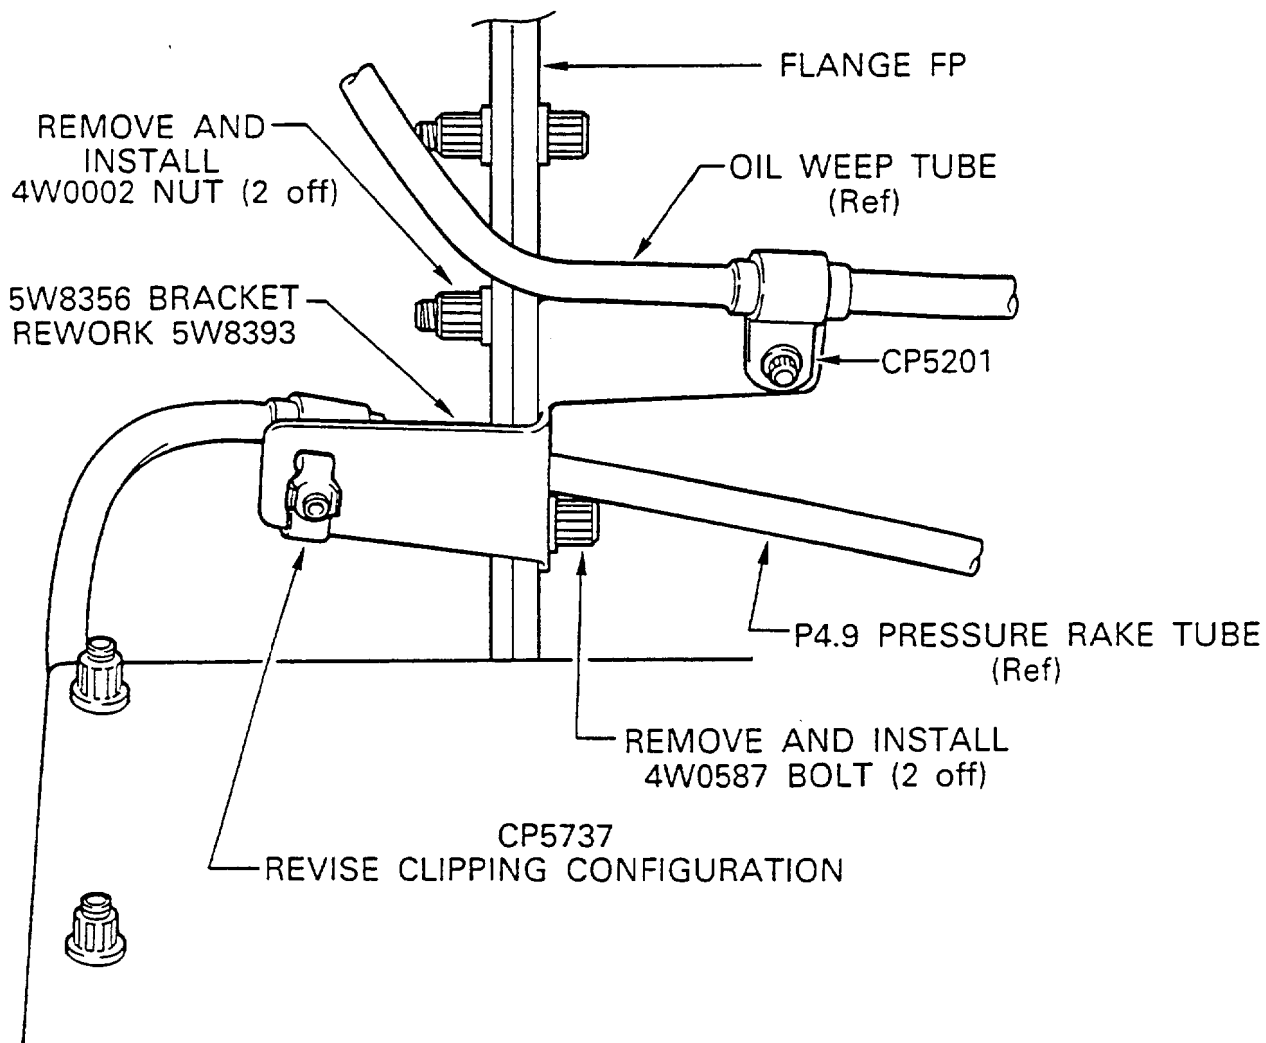
Rework of the clipping bracket
Fig.3

(b) The existing clipping Bracket PN 5W8356 is modified to prevent a foul to the rerouted P4.9 Pressure Rake Tube. (See Figure 3).

- (4) Remove the two PN 4W0002, Nuts, and two PN 4W0587, Bolts, which attach PN 5W8356, Clipping Bracket, to the Flange FP. (Refer to Figure 3, Sheet 1).

- (9) Attach the reworked PN 5W8393, Clipping Bracket; with two PN 4W0587, Bolts, and two PN 4W0002, Nuts, to the FP Flange. (Refer to Figure 3, Sheet 1).

- (10) Tighten two PN4W0002 Nuts, on two PN 4W0587, Bolts, with a torque of 85-95 lbfin (9,6-10,7 Nm). (Refer to Figure 3, Sheet 1 and the Aircraft Maintenance Manual, 70-23-11, Torque Tightening Technique).
- (11) At CP5201, attach PN 4W0043, Clip Nut, PN 5W1109, Clip, PN 4W0104, Bolt, and PN 5W1086, Washer, to PN 5W8393, Clipping Bracket, and the Oil Weep Tube. Tighten PN 4W0104, Bolt with a torque of 36-40 lbfin (4,07-4,52 Nm). (Refer to Figure 2 and the Aircraft Maintenance Manual, 70-23-11, Torque Tightening Technique).
- (12) At CP5737 with a new clipping configuration, attach PN 4W0043, Clip Nut, PN 5W1109, Clip, PN 4W0102, Bolt, and PN 5W1086, Washer, to PN 5W8393, Clipping Bracket, and the P4.9 Pressure Rake Tube. Tighten PN 4W0102, Bolt with a torque of 36-40 lbfin (4,07-4,52 Nm). (Refer to Figure 2 and the Aircraft Maintenance Manual, 70-23-11, Torque Tightening Technique).
