ENGINE - DIFFUSER AND COMBUSTOR GROUP - SHOTPEEN THE NO.4 BEARING SUPPORT - CATEGORY  
CODE 5 - MOD.ENG-72-0040

V2500-ENG-72-0040

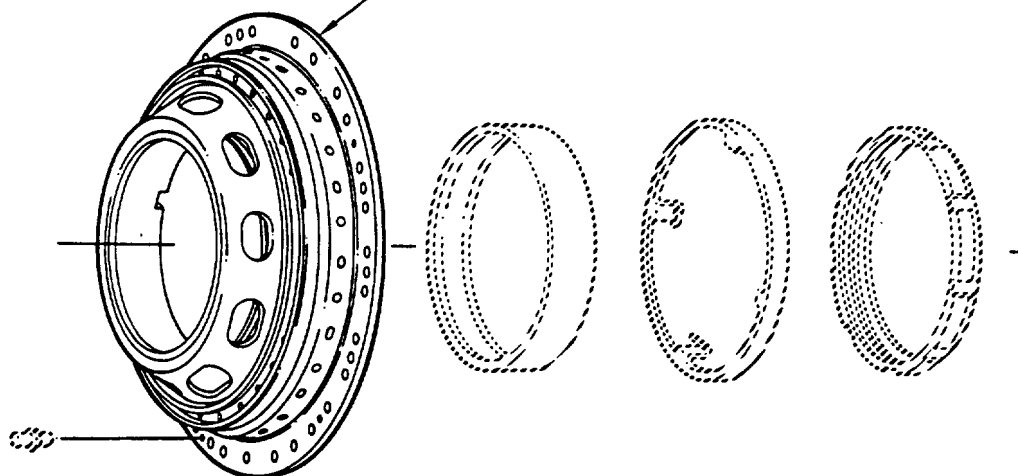
Location of No.4 Bearing Support Assembly  
Fig.1

REMOVE THE PN 2A0846 No.4 BEARING  
SUPPORT ASSEMBLY (1 Off) DO A  
MODIFICATION, IDENTIFY, AND INSTALL  
AS PN 2A2038 No.4 BEARING SUPPORT  
ASSEMBLY (1 Off)
