DATE ~~R~~ Nov.16/01**V2500-A1 SERIES PROPULSION SYSTEM SERVICE BULLETIN**

This document transmits Revision 1 to Service Bulletin EV2500-72-0042

ENGINE - LP COMPRESSOR - REWORK THE LPC FRONT CASING ASSEMBLY TO INCORPORATE AN
ENLARGED PIN HOLE DIAMETER

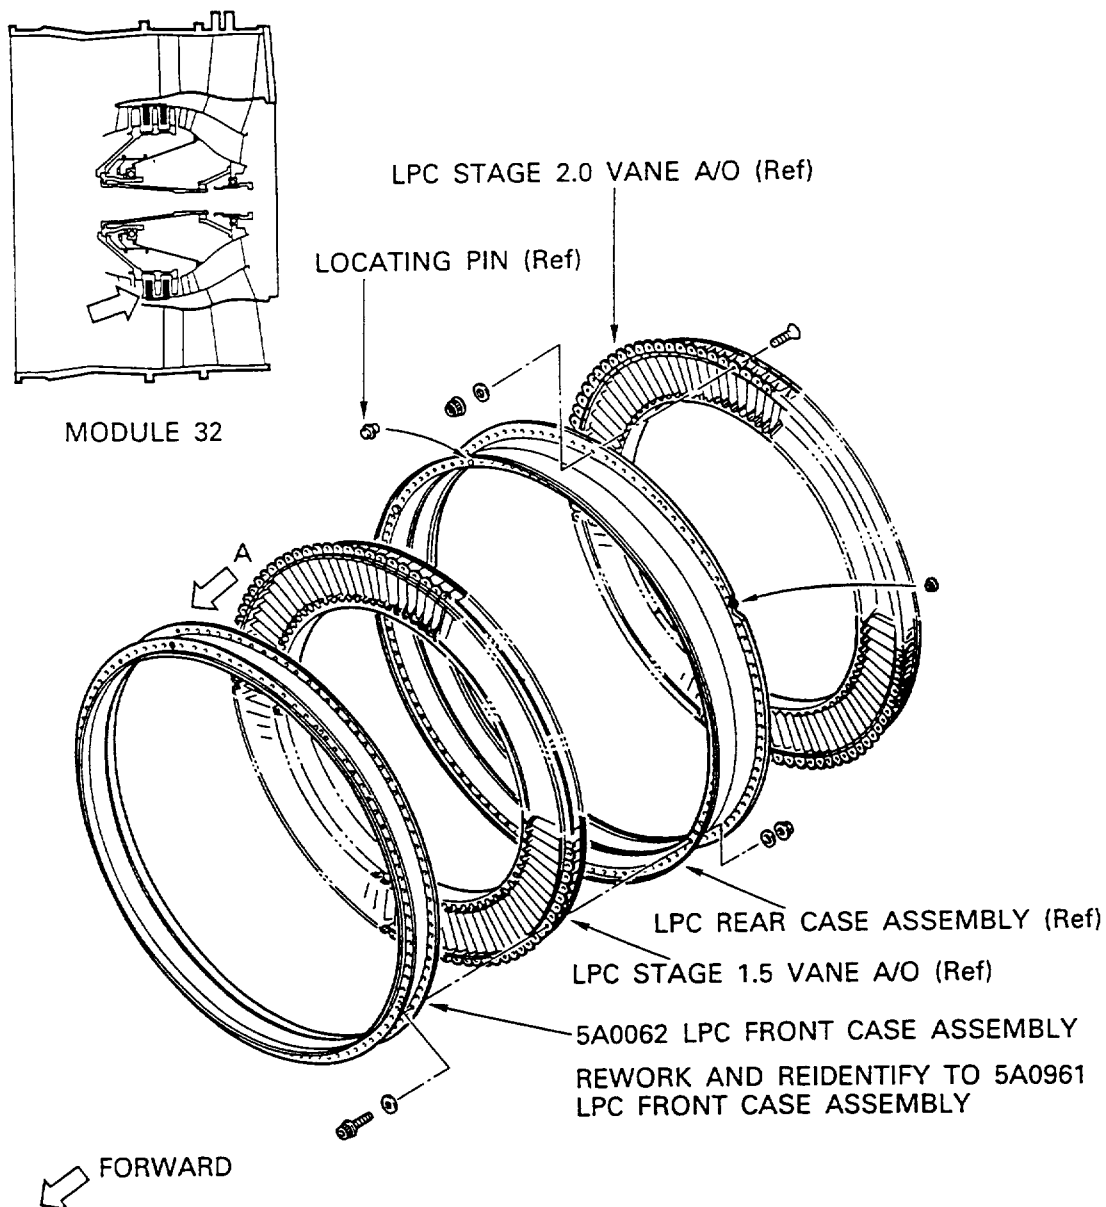
Location of the LP compressor front case assembly
Figure 1

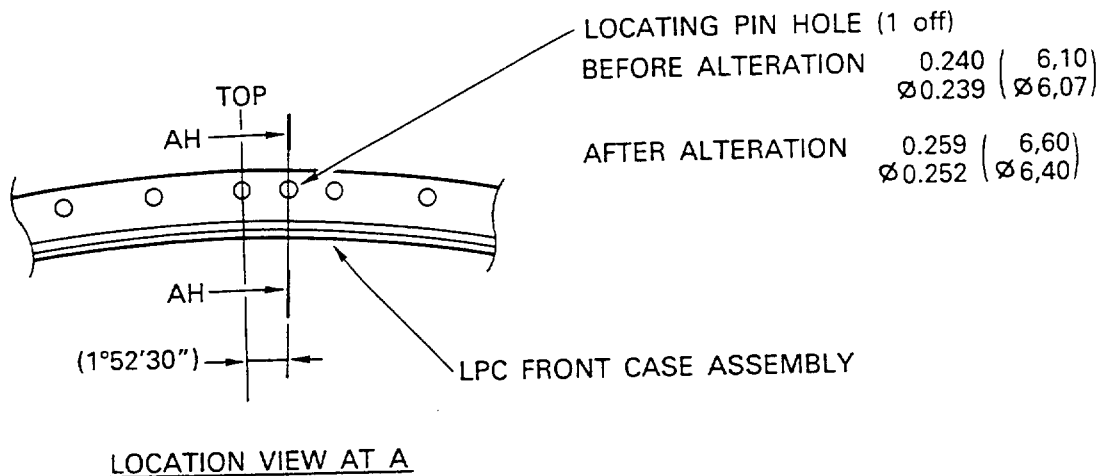
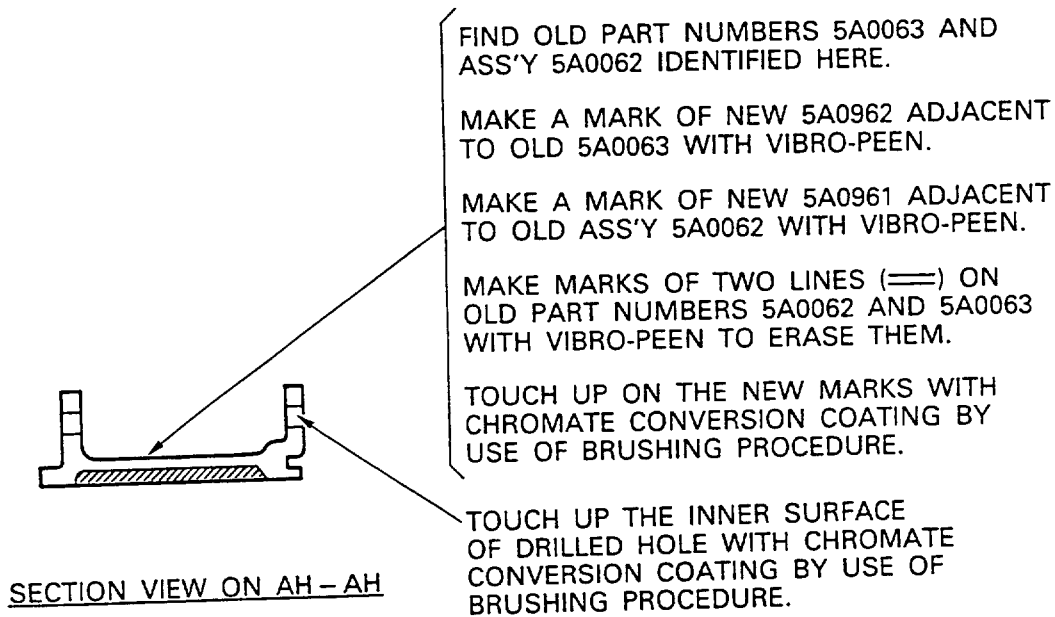
Interference may occur between the locating pin hole on the LPC front case assembly and the locating pin on the LPC rear case assembly depending on the combination of diametral and positional tolerances.

(a) The diameter of the locating pin hole on LPC front case assembly has been enlarged from 0.239 - 0.240 in. (6,07 - 6,10 mm) to 0.252 - 0.259 in. (6,40 - 6,60 mm) (See Figures 1 and 2).

Rework of the LP compressor front case assembly
Figure 2

(a) Do an inspection of the LP compressor front case assembly for a diameter of the locating pin hole

(d) Drill the locating pin hole with 0.256in. (6,50 mm) diameter of drill

(e) Remove the burrs from around the hole

(f) Inspect the hole for cracks

(g) Renumber both of the piece part number and the assembly part number identified on the LP compressor front case assembly by use of the vibration peening method

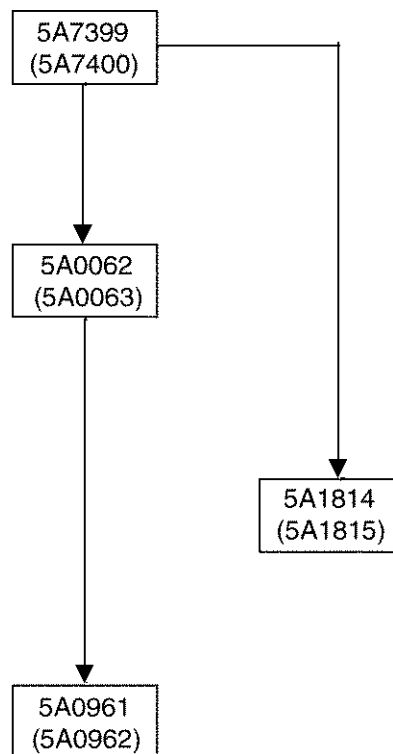
Family tree - LPC front case assembly Ref catalog sequence No. 72-32-83, Fig 01,
Item 350
Fig 3
