ENGINE - MAIN GEARBOX ASSEMBLY - INSPECT THE DEDICATED ALTERNATOR DRIVE GEAR -
CATEGORY CODE 3 - MOD.ENG-72-0043

- (1) Aircraft: Airbus A320
- (2) Engine: A11 V2500-A1 Engines (Pre-SBE 72-0070)

V2500-ENG-72-0043

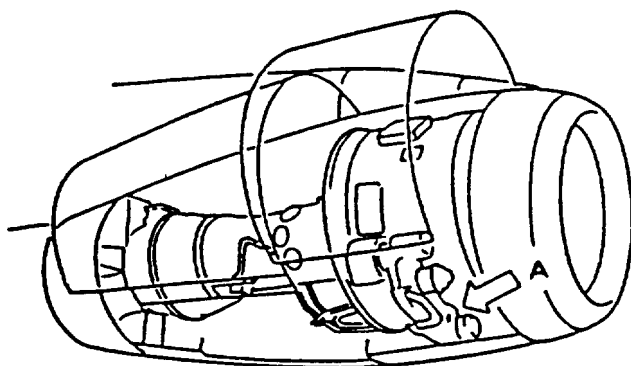
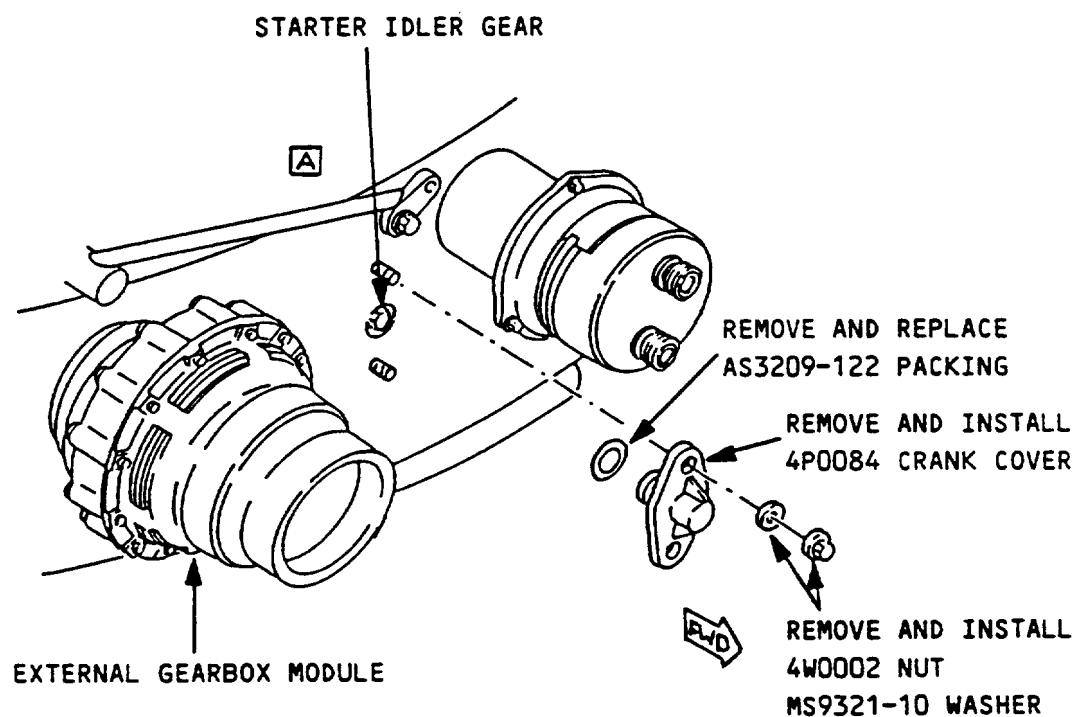
Remove/Install the Crank Cover
Fig.1

- (3) Remove the P.M.A stator, refer to Aircraft Maintenance Manual, 73-22-38.
- (4) Remove the two P/N 4W0002 nuts and P/N MS9321-10 washers. Remove the P/N 4P0084 crank cover from the external gearbox. Remove and discard the P/N AS3209-122 packing, Ref Figure 1.

- (1) Install the P/N 4P0084 crank cover, Ref Figure 1.
 - (a) Install the new P/N AS3209-122 packing on the crank cover.
 - (b) Install the crank cover on the gearbox and safety with the two P/N MS9321-10 washers and P/N 4W0002 nuts.
 - (c) Torque the nuts to 85 to 95 lbfin (9,604 to 10,734 Nm).
- (2) Install the P.M.A. stator, refer to Aircraft Maintenance Manual, 73-22-38.
- (3) Reconnect the power supply
- (4) Prime the engine oil system, refer to Aircraft Maintenance Manual, 12-13-79.
- (5) Close the fan cowl panels, refer to Aircraft Maintenance Manual, 71-13-00.
- (6) Do a leak check of the engine oil system after the first ground run.

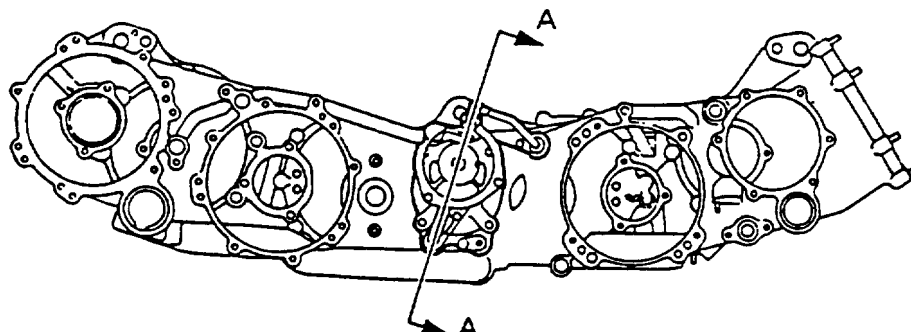
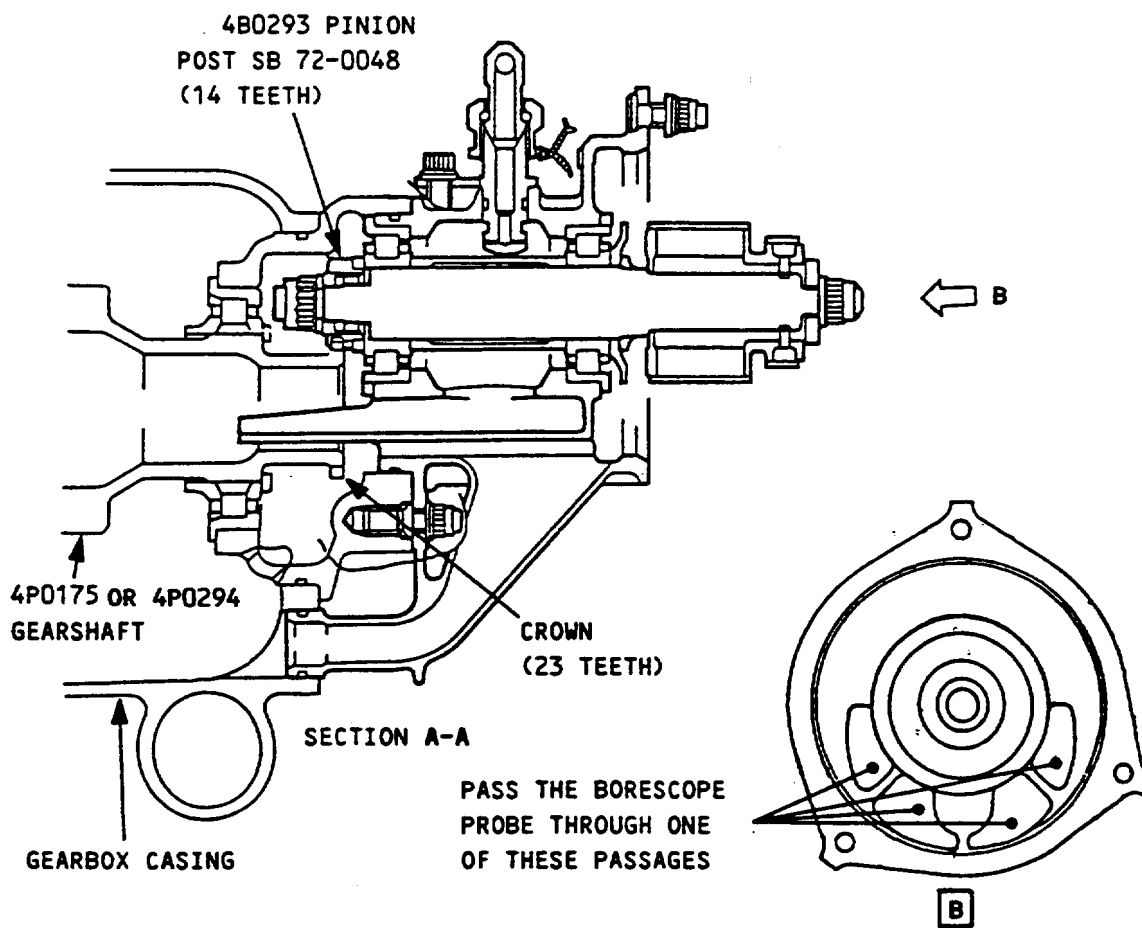
Borescope Access
Fig.2

- (5) Install a standard wrench on the gear starter idler and turn the gear train of the gearbox as required to view the gear teeth in turn.
- (6) Insert IAE1F10056 in to the P.M.A. support through one of the oil passages, Ref Figure 2.

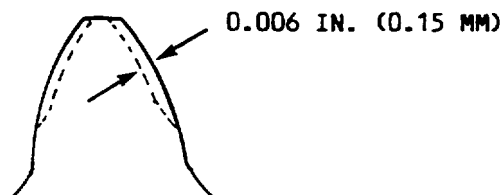
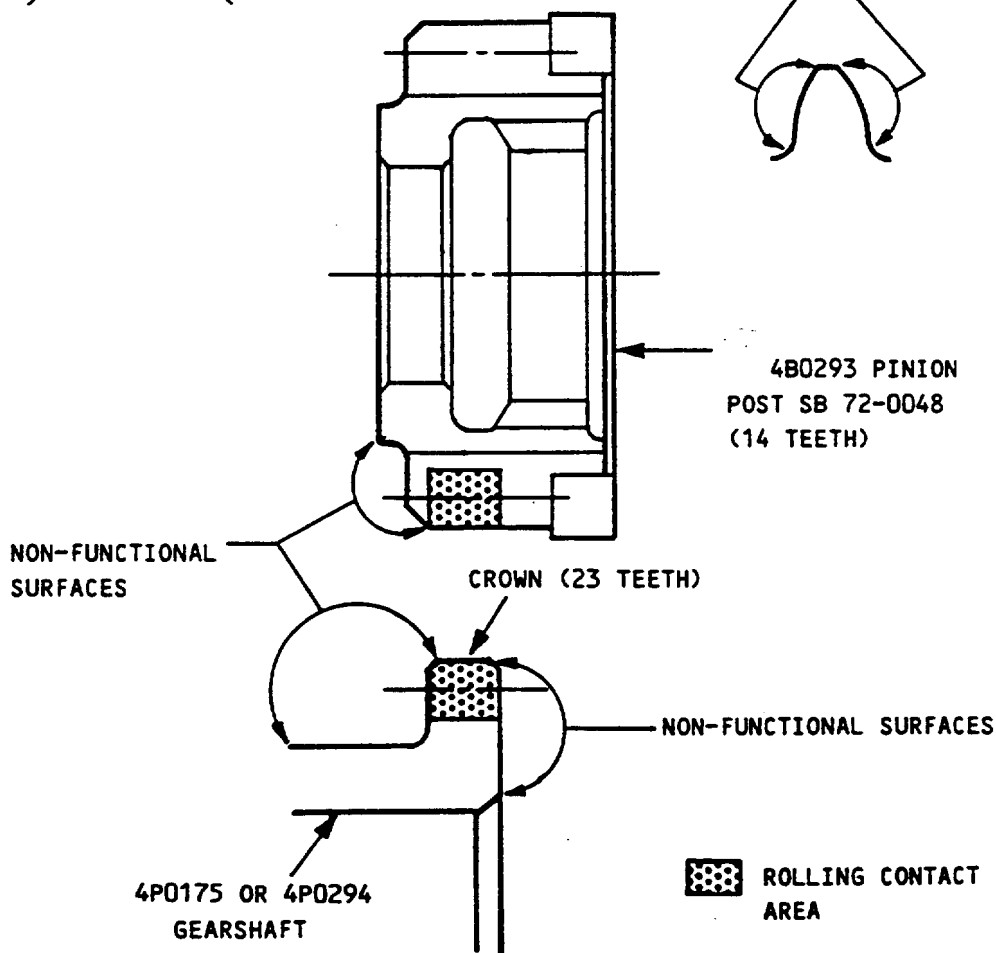
Examine the Dedicated Alternator Drive Gear
Fig.3

- (9) Inspect non-functional surfaces for damage, Ref Figure 3.
 - (a) Dents, nicks and scratches are acceptable.
 - (b) Chipped edges are acceptable.
 - (c) Any damage extending in to the rolling contact area not exceeding 0.03in (0,75 mm) is acceptable.

- (10) Inspect the pinion (14 teeth) P/N 4B0293 (Post SBE 72-0048), Ref Figure 3.

- (a) Abrasive wear at bottom end of the rolling contact area and/or pitting in the rolling contact area
Inspect again within 200 hrs
- (b) Grooves at the bottom end of the contact area more than 0.006in. (0,15 mm) deep
Replace the pinion
- (1) Inspect the crown (23 teeth) P/N 4P0294, Ref Figure 3
- (a) Wear in the contact zone more than 25 per cent of the contact area
Inspect again within 400 hrs
Replace the part in case of pinion replacement
- (b) Material removal leading to alter the tooth profile, Ref Figure 3
Replace the part if material removal exceeds 0.006in. (0.15 mm.)

Note. For any damage above these limits contact the IAE Customer Representative.
