ENGINE - LP COMPRESSOR - LPC BLEED DUCT WITH REDUCED 44 SQUARE INCHES EXIT THROAT AREA
- CATEGORY CODE 7 - MOD.ENG-72-0044

V2500-ENG-72-0044

SERVICE BULLETIN

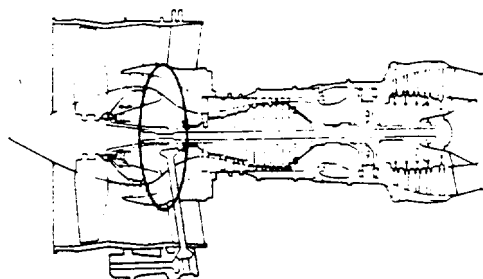
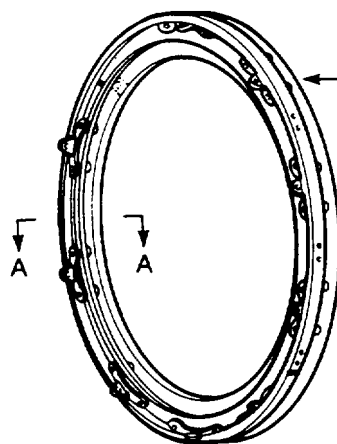
Replacement of LPC bleed duct assembly
Fig.1

REMOVE PN 5W2038 AND
INSTALL PN 5W2080 LPC
BLEED DUCT ASSEMBLY

PN 5W2038

PN 5W2080

- (1) Install the 5W2080 LPC bleed duct assembly by the approved procedure in Reference (2), Chapter/Section 72-32-00 Assembly, Figure 1.
- (2) Reidentify 5W0016 LPC/Intermediate case module as 5W0102 LPC/Intermediate case module by the approved procedures in Reference (4), Chapter/Section 70-09-00, Marking of Parts, Figure 2. Use blank 5A2189 Module identification plate (72-32-85, 03-100) and translate the data from existing Module identification plate except the module part number, if necessary.

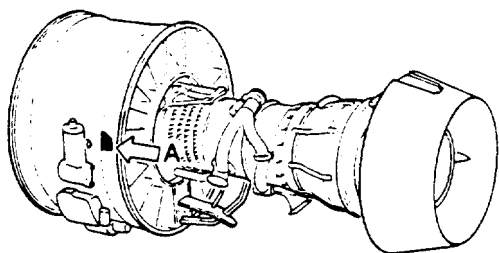
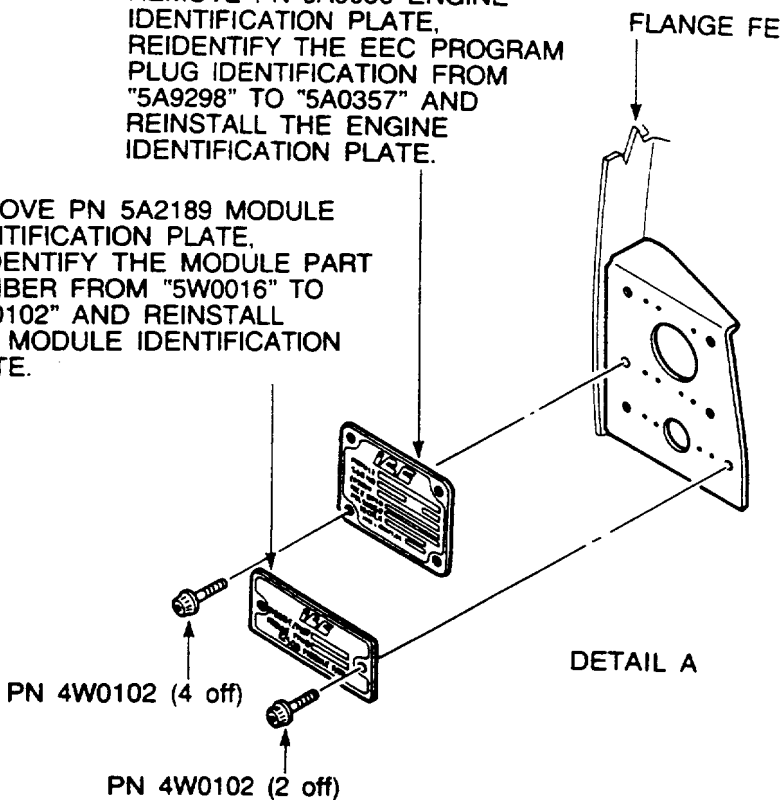
Reidentification of the LPC/intermediate case module and the EEC program plug identification
Fig.2

REMOVE PN 5A9036 ENGINE IDENTIFICATION PLATE, REIDENTIFY THE EEC PROGRAM PLUG IDENTIFICATION FROM "5A9298" TO "5A0357" AND REINSTALL THE ENGINE IDENTIFICATION PLATE.

REMOVE PN 5A2189 MODULE IDENTIFICATION PLATE, REIDENTIFY THE MODULE PART NUMBER FROM "5W0016" TO "5W0102" AND REINSTALL THE MODULE IDENTIFICATION PLATE.

- (3) Reidentify the EEC program plug identification on 5A9036 Engine identification plate (72-32-85, 03-120).
 - (a) Reidentify the EEC program plug identification from "5A9298" to "5A0357" by the approved procedures in Reference (4), Chapter/Section 70-09-00, Marking of Parts, Figure 2. Use blank 5A9036 Engine identification plate (72-32-85, 03-120) and translate the data from existing Engine identification plate except the EEC program plug identification number, if necessary.
