ENGINE - INCORPORATE DRY FILM LUBRICANT TO THE NO.2 AND NO.10 STRUTS THRUST MOUNT
BRACKETS - CATEGORY CODE 5 - MOD.ENG-72-0045

V2500-ENG-72-0045

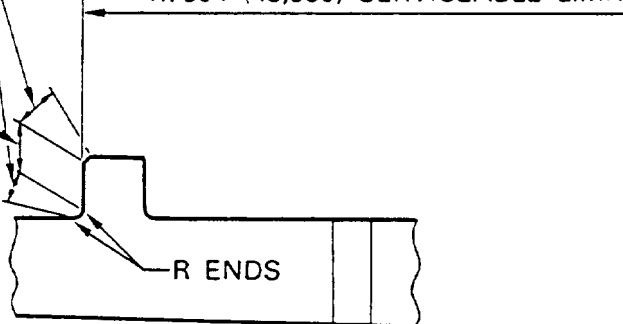
Rework of the No.2 and No.10 Struts Thrust Mount Brackets
Fig.2 Sheet 1 of 3

5A8695 No. 2 STRUT THRUST MOUNT BRACKET
APPLY THE DRY FILM LUBRICANT

OVERCOATING OF THE DRY
FILM LUBRICANT IS
PERMITTED ALL ROUNDS.

APPLY THE DRY FILM
LUBRICANT ALL ROUNDS
WITH 0.0002 - 0.0005
in. (0,003 - 0,015 mm)
OF THE COATING
THICKNESS.

DIAMETER BEFORE COATING

1.7319 (43,991)
 \varnothing 1.7313 (43,975)
 \varnothing 1.7304 (43,950) SERVICEABLE LIMIT

(a) A Dry Film Lubricant with the thickness between 0.0002 and 0.0005in. (0,003 and 0,015 mm.) is coated to the spigot outer surfaces of the No.2 and No.10 Struts Thrust Mount Brackets to prevent the wear during engine operation. (See Figures 1 and 2).

- (e) Remove the grease with CoMat 01-124, Isopropyl Alcohol, and a clean cloth to clean the coating area
- (2) Apply the Dry Film Lubricant to 5A8695, and 5A8696, No.2 and No.10 Struts Thrust Mount Brackets
- Refer to Figure 2, Sheets 1 and 2, and 1.K.(2), 70-38-03, Surface Treating, and 1.K.(3)
- (a) Apply CoMat 02-019, Heat resistant paper Masking Tape, to the area which is not to be given a layer of the Dry Film Lubricant
- (b) Apply CoMat 10-004, Dry Film Lubricant, and CoMat 07-009, Thinners, to each spigot outside diameter of the Brackets

NOTE: The coating thickness must be between 0.0002 and 0.0005in. (0,003 and 0,015 mm.) all rounds.

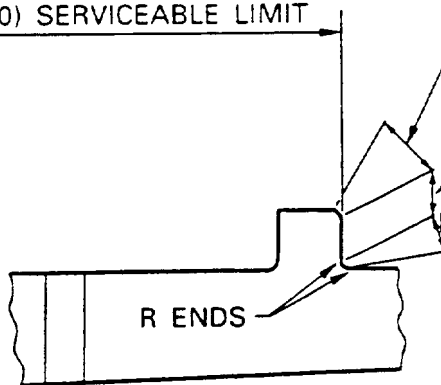
Rework of the No.2 and No.10 Struts Thrust Mount Brackets
Fig.2 Sheet 2 of 3

5A8696 No. 10 STRUT THRUST MOUNT BRACKET
APPLY THE DRY FILM LUBRICANT

DIAMETER BEFORE COATING

1.7319 (43,991)

Ø1.7313 (43,975)

Ø1.7304 (43,950) SERVICEABLE LIMIT
