## SERVICE BULLETIN

ENGINE – HP TURBINE ROTOR AND STATOR ASSEMBLY – PROVIDE A NEW FIRST STAGE HPT BLADE AND FIRST STAGE HPT COOLING DUCT ASSEMBLY – CATEGORY CODE 6 – MOD.ENG-72-0046

# V2500-ENG-72-0046

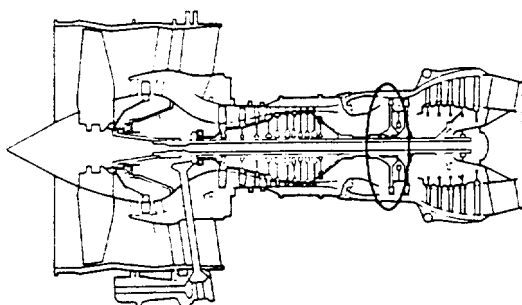
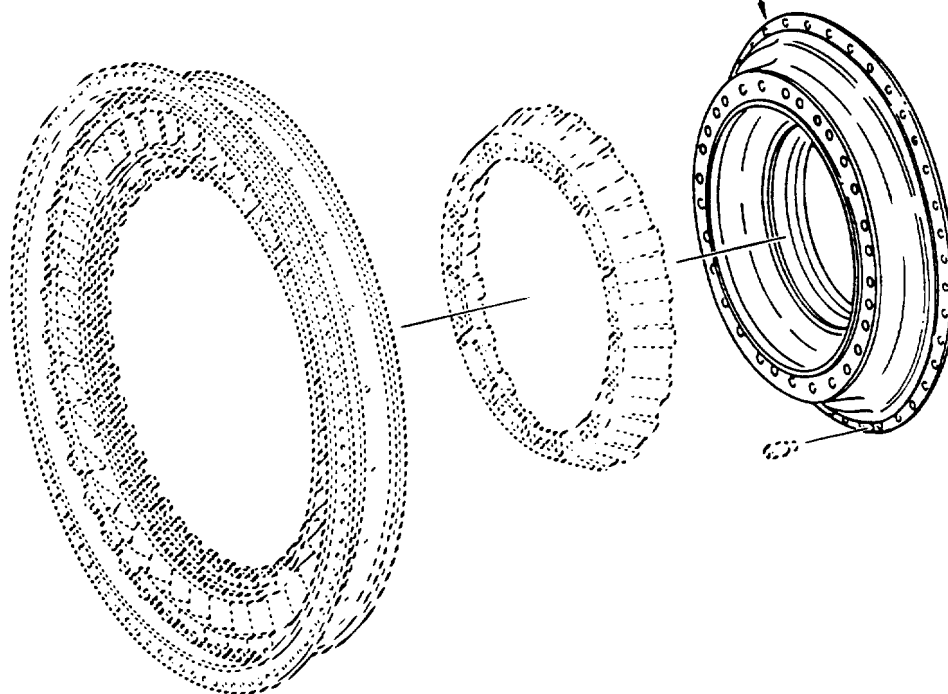
Location of stage 1 HPT cooling duct assembly  
Fig.1

REPLACE PN 2A0008-01  
STAGE 1 HPT COOLING  
DUCT ASSEMBLY (1 Off)  
WITH PN 2A1997-01 STAGE 1  
HPT COOLING DUCT  
ASSEMBLY (1 Off)

- (ii) Use the vibration peen method.
- (4) Replace the 2A0008-01 Stage 1 HPT Cooling Duct Assembly (1 off) with 2A1997-01 Stage 1 HPT Cooling Duct Assembly, by the approved procedure in Reference (3), Chapter/Section 72-44-00, Assembly. Refer to Figure 1.

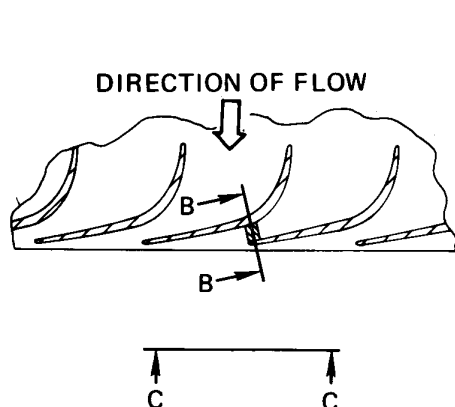
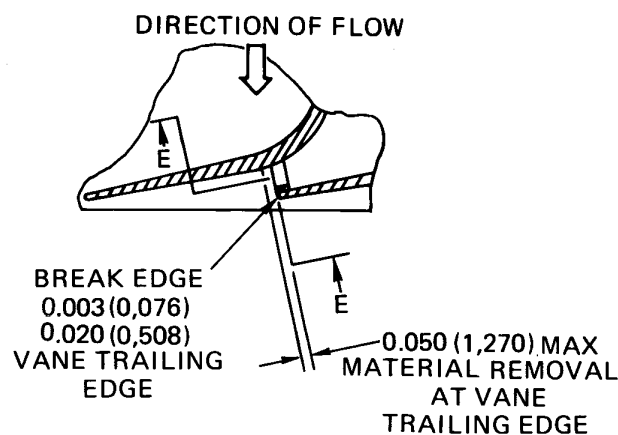
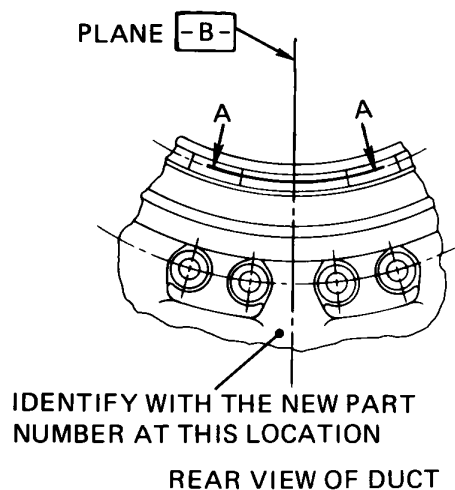
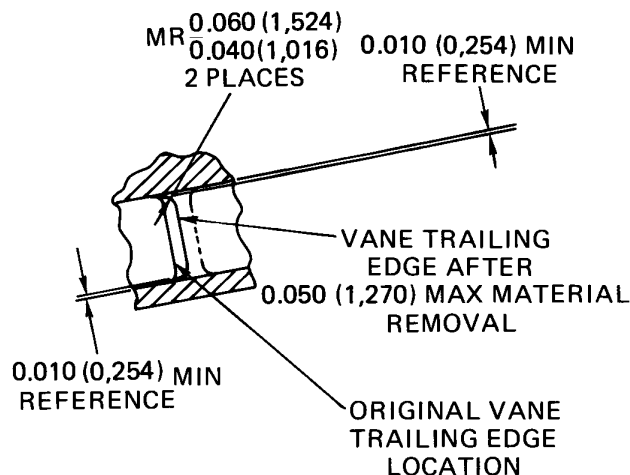
Modification of stage 1 HPT cooling duct assembly  
Fig.2 Sheet 2

NOTE: THE FLOW TEST DATA IS AS FOLLOWS:

$$\frac{W \sqrt{T_3}}{P_{AMB}} = 1.040 \text{ \& } \left( \frac{P_3}{P_{AMB}} \right)_{MIN} = 1.527, \left( \frac{P_3}{P_{AMB}} \right)_{MAX} = 1.577$$

Procedure	Supplementary Information
(a) Flow test the vane passages collectively in the direction shown by the procedure specified	See Figure 1 and Figure 2, Sheets 1 and 2, requirements. Use the procedure in Reference (3) Control No./Task No. 72-44-50-990-009 through 72-44-50-990-011
(i) Make sure that the flow is in the limit specified	
(ii) To get the specified flow rate add or make larger 1 to 15 openings, as necessary, to increase flow

- (c) Do the flow test given in step (a) again      See Figure 2, Sheets 1 and 2, requirements. Use the procedure in Reference (3) Control No./Task No. 72-44-50-990-009 through 72-44-50-990-011.

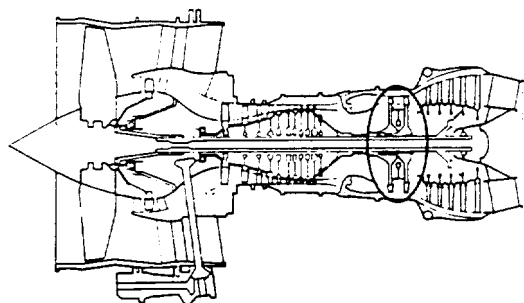
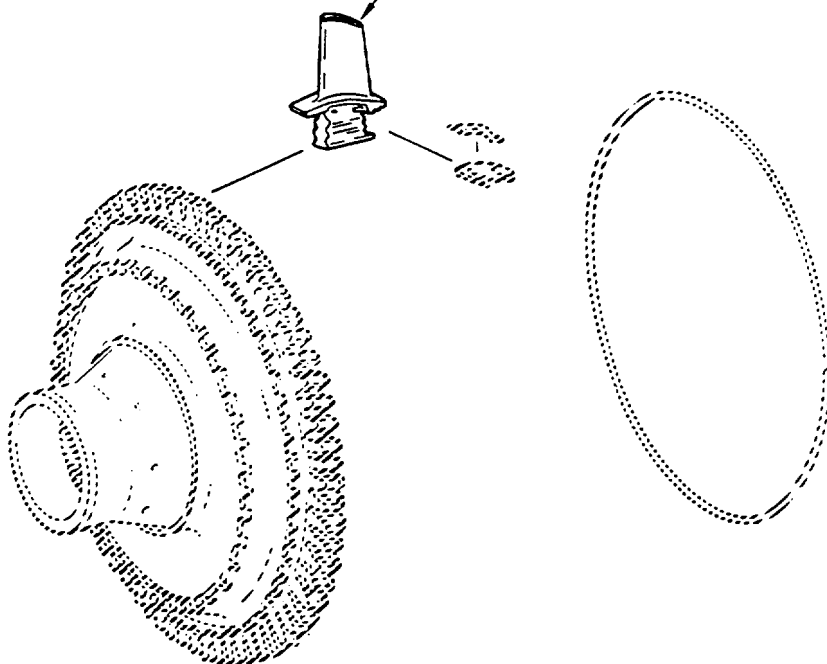
Location of stage 1 HPT blades  
Fig.3

REPLACE PN 2A1721 STAGE 1  
HPT BLADES (64 Off) WITH  
PN 2A2421 STAGE 1 HPT  
BLADES (64 Off)

- (2) Send the 2A1721 Stage 1 HPT Blades (see Reference (2), 72-45-14, Figure/Item No.01-010) to the approved vendor given in the Material Information Section for a modification and identification to 2A2421 Stage 1 HPT Blades. See Figure 3.

- (1) Replace the 2A1721 Stage 1 HPT Blades (64 off) with 2A2421 Stage 1 HPT Blades, by the approved procedure in Reference (3), Chapter/Section 72-45-10, Assembly. See Figure 3.
- (2) Identify the new Stage 1 Turbine Rotor Assemblies as follows:
- (a) Identify the 2A2321 Stage 1 Turbine Rotor Assembly as 2A2521.
- (i) Use the approved procedure given in Reference (4), Control No./TASK No.70-09-00-400-501, Marking of Parts.
- (ii) Use the vibration peen method.
- (b) Identify the 2A1621 Stage 1 Turbine Rotor Assembly as 2A2721.
