ENGINE - LP TURBINE MODULE AND EXHAUST GAS TEMPERATURE (EGT) INDICATING SYSTEM -
PROVIDE RECONTOURED EGT BRACKETS AND DOUBLE HEXAGONAL HEADED NUTS - CATEGORY CODE 5 -
MOD.ENG-72-0050

V2500-ENG-72-0050

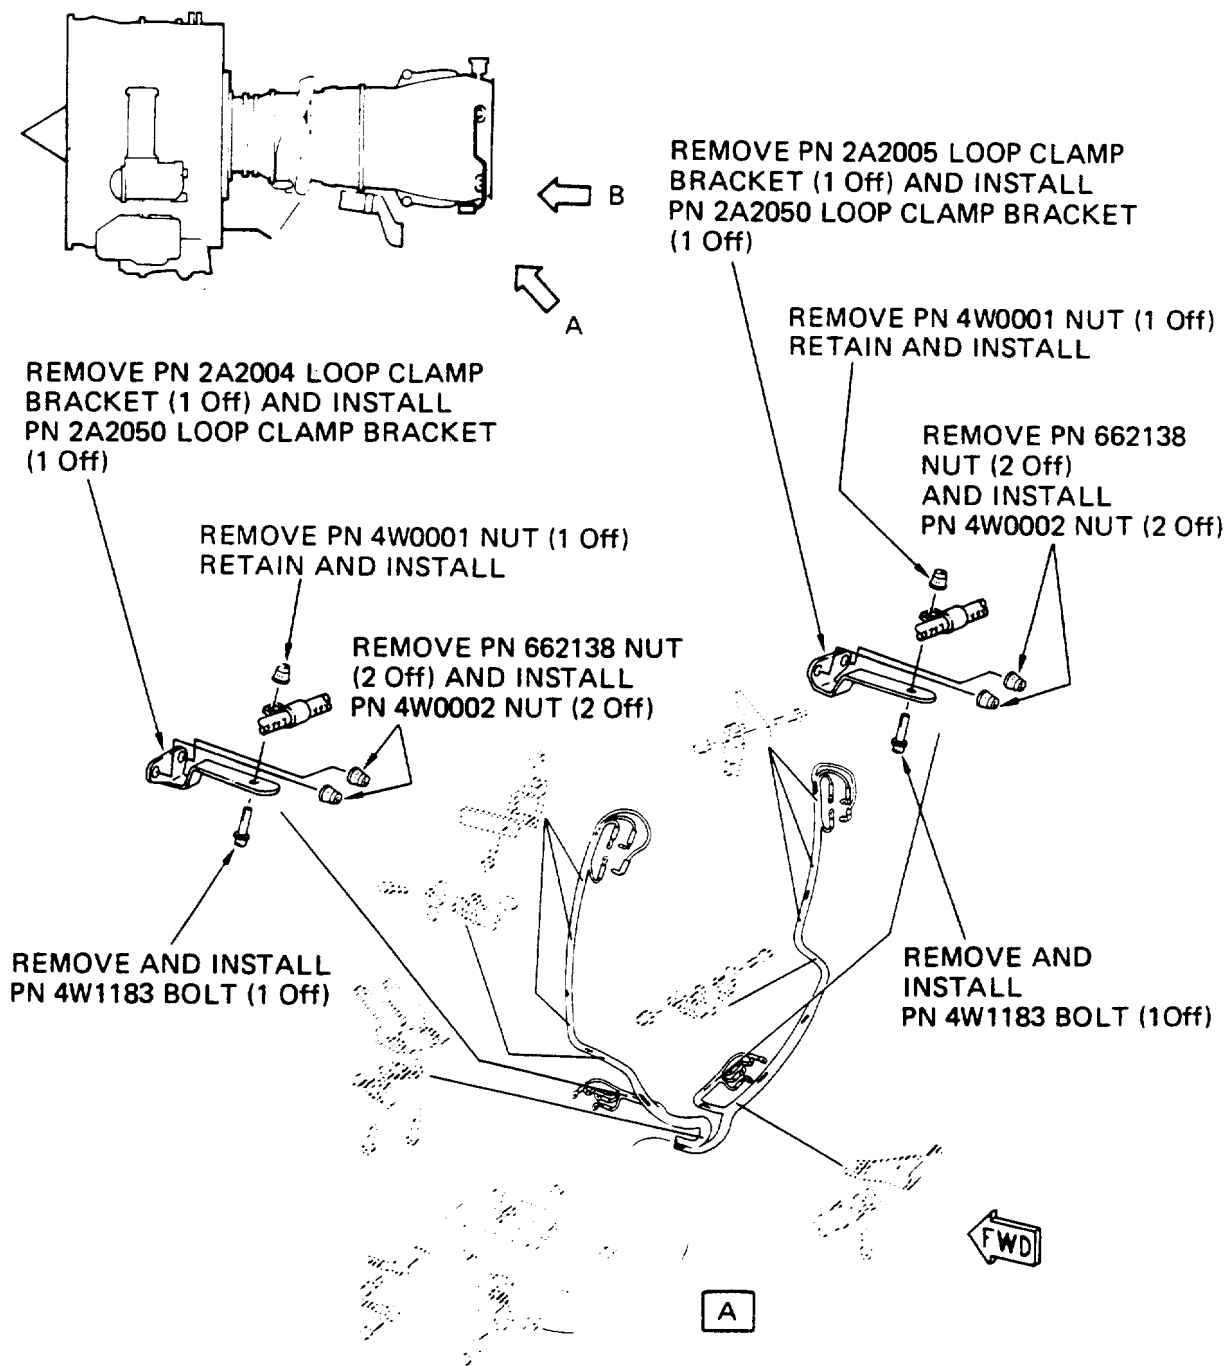
Replacement of loop clamp brackets and attaching nuts
Fig.1 (Sheet 1 of 2)

The present configuration EGT Brackets on Flange P at hole location 52, 53, 62 and 63 has contact with the Hold-Open Rod Brackets for the C-Ducts.

- (5) Put the 2A2050 Loop Clamp Bracket (1 off) at the location of holes 62 and 63. Refer to Figure 1.
 - (a) Make sure that the bracket mount flange is forward of Flange P.

- (6) Install the Nuts and Bolts and tighten them with your hand.
- (7) Put the 2A2050 Loop Clamp Bracket (1 off) at the location of holes 52 and 53. Refer to Figure 1.

- (a) Make sure that the bracket mount flange is forward of flange P.
- (8) Install the Nuts and Bolts and tighten them with your hand.
- (9) Torque the Bolts to between 85 to 105 lbfin (9,60 to 11,86 Nm). See Reference (2) Chapter/Section 70-41-00, Torque Tightening Technique.
