DATE ~~R~~ Sep.15/01**V2500-A1 PROPULSION SYSTEMS SERVICE BULLETIN**

**V2500-ENG-72-0051**  
 Transmittal - Page 1 of 2

ENGINE – LP COMPRESSOR – INCORPORATE A FUEL DRAIN TUBE IN THE FAN FRAME ASSEMBLY

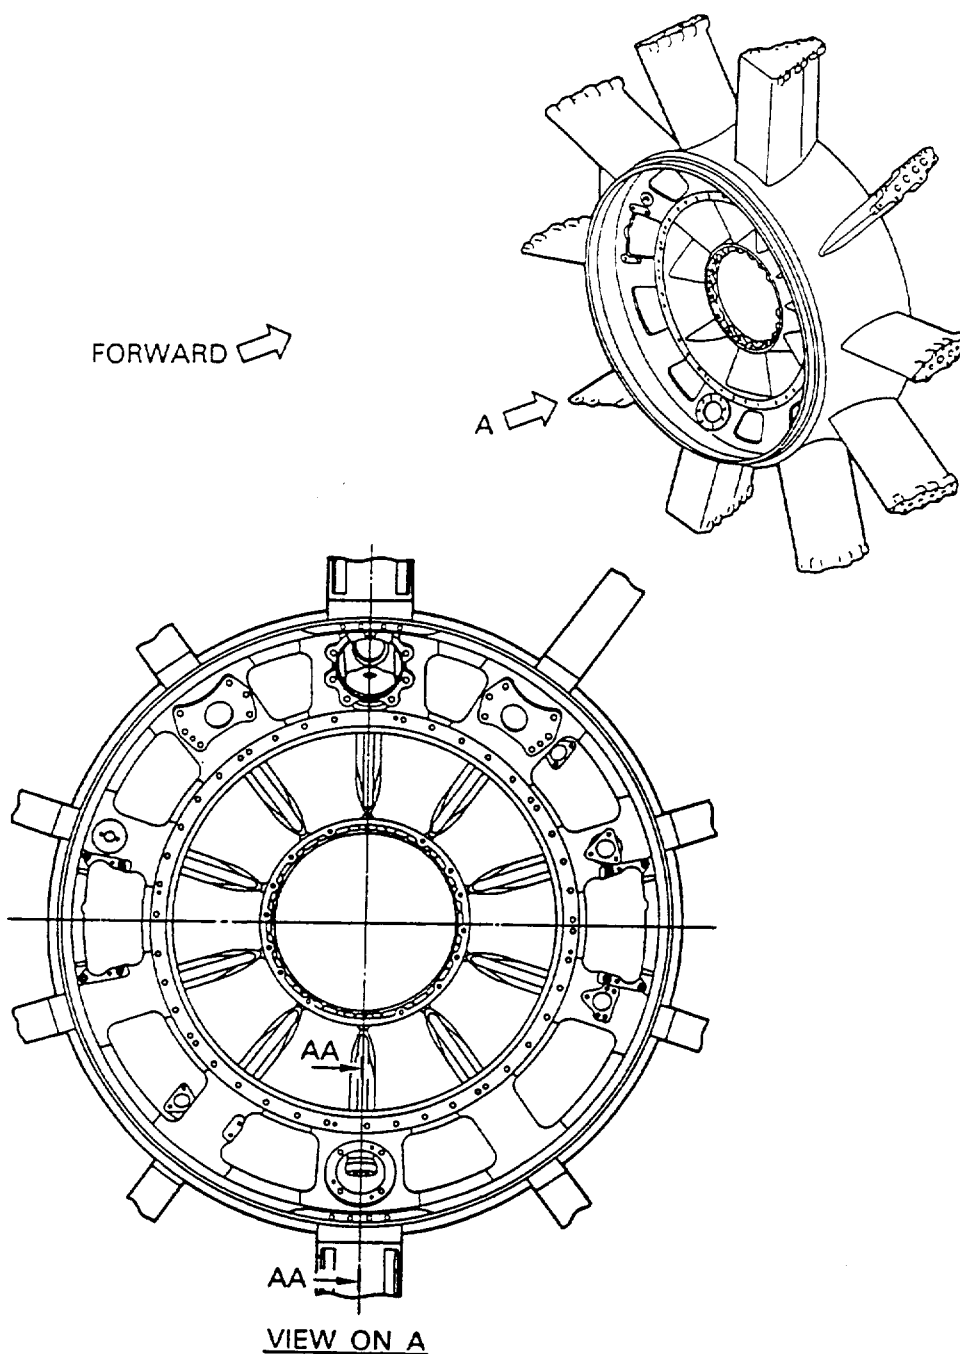
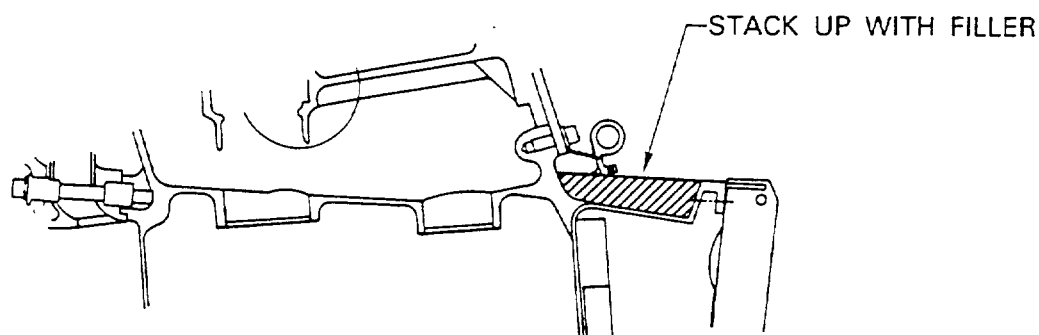
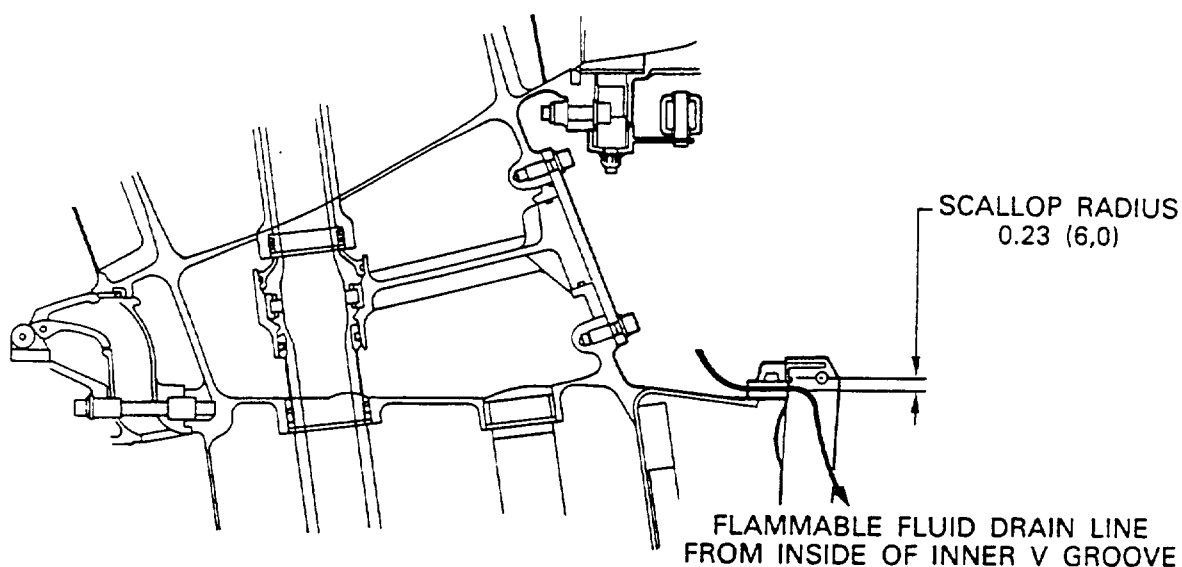
Fan Frame Assembly - Before and after alteration  
Figure 2 (Sheet 1 of 2)

Existing Fan Frame Assembly does not incorporate the drain tube to drain the fluid in the rear inner flange area.

A review for the existing Fan Assembly has shown that a drain tube is desirable rather than existing filler compound included in the rear inner flange area to prevent an accumulation of the fluid.

- (a) The existing filler compound which is included in the Fan Frame rear inner flange area has been removed. (See Fig. 1 and 2).
- (b) An additional drain tube is installed to the Fan Frame rear inner flange bottom through the additional hole in No. 6 Strut Fairing Panel A/O to drain out the fluid in the rear inner flange area. (See Fig. 1 and 2).
