ENGINE - GENERAL - PROVIDE BOLTS OF INCREASED LENGTH AT CLIPPING POINTS CP0577, CP0560
AND CP0537 - CATEGORY CODE 5 - MOD.ENG-72-0052

V2500-ENG-72-0052

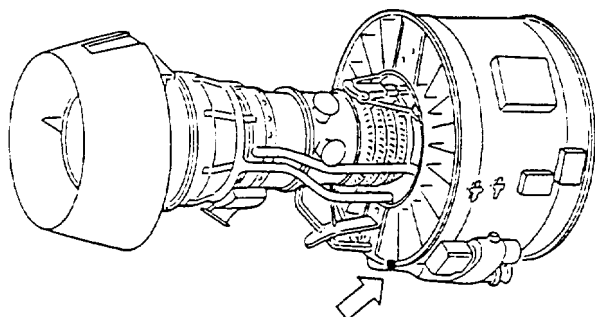
View showing clipping points CP0537, 0560 and 0577
Fig.1

The bolts used at clipping points CP0577, CP0560 and CP0537 may not be of sufficient length. This could cause a looseness of the clipping nuts.

The existing bolts at CP0577, CP0560 and CP0537 may not protrude an acceptable protrusion amount.

(a) The bolts at CP0577, CP0560 and CP0537 have been changed to increase the bolt length (See Figure 1).

- (1) At CP0577 and CP0560, remove each 4W0106, Bolt, by the procedure given in the Engine Manual (Refer to Figure 1, and Engine Manual, 72-00-32, LP Compressor/Intermediate Case Module - Removal, TASK 72-00-32-020-003).
- (2) At CP0537, remove 4W0115, Bolt, by the procedures given in the Engine Manual (Refer to Figure 1 and the Engine Manual, 72-00-32, LP Compressor/Intermediate Case Module - Removal, TASK 72-00-32-020-003).
- (3) At CP0577 and CP0560, install each new 4W0108, Bolt, by the procedures given in the Engine Manual (Refer to Figure 1 and the Engine Manual, 72-00-32, LP Compressor/Intermediate Case Module - Installation, TASK 72-00-32-420-003).
- (4) At CP0537, install new 4W0116, Bolt, by the procedures given in the Engine Manual (Refer to Figure 1 and the Engine Manual, 72-00-32, LP Compressor/Intermediate Case Module - Installation, TASK 72-0032-430-003).

CP0560
REMOVE 4W0106 BOLT
AND
INSTALL 4W0108 BOLT

CP0537
REMOVE 4W0115 BOLT
AND
INSTALL 4W0116 BOLT

CP0577
REMOVE 4W0106 BOLT
AND
INSTALL 4W0108 BOLT
