ENGINE – ENGINE HP TURBINE ROTOR AND STATOR ASSEMBLY – REMOVAL OF THE ORIFICE PLATES  
AND RELATED HARDWARE FROM THE HPT CASE ASSEMBLY – CATEGORY CODE 3 – MOD.ENG-72-0058

V2500-ENG-72-0058

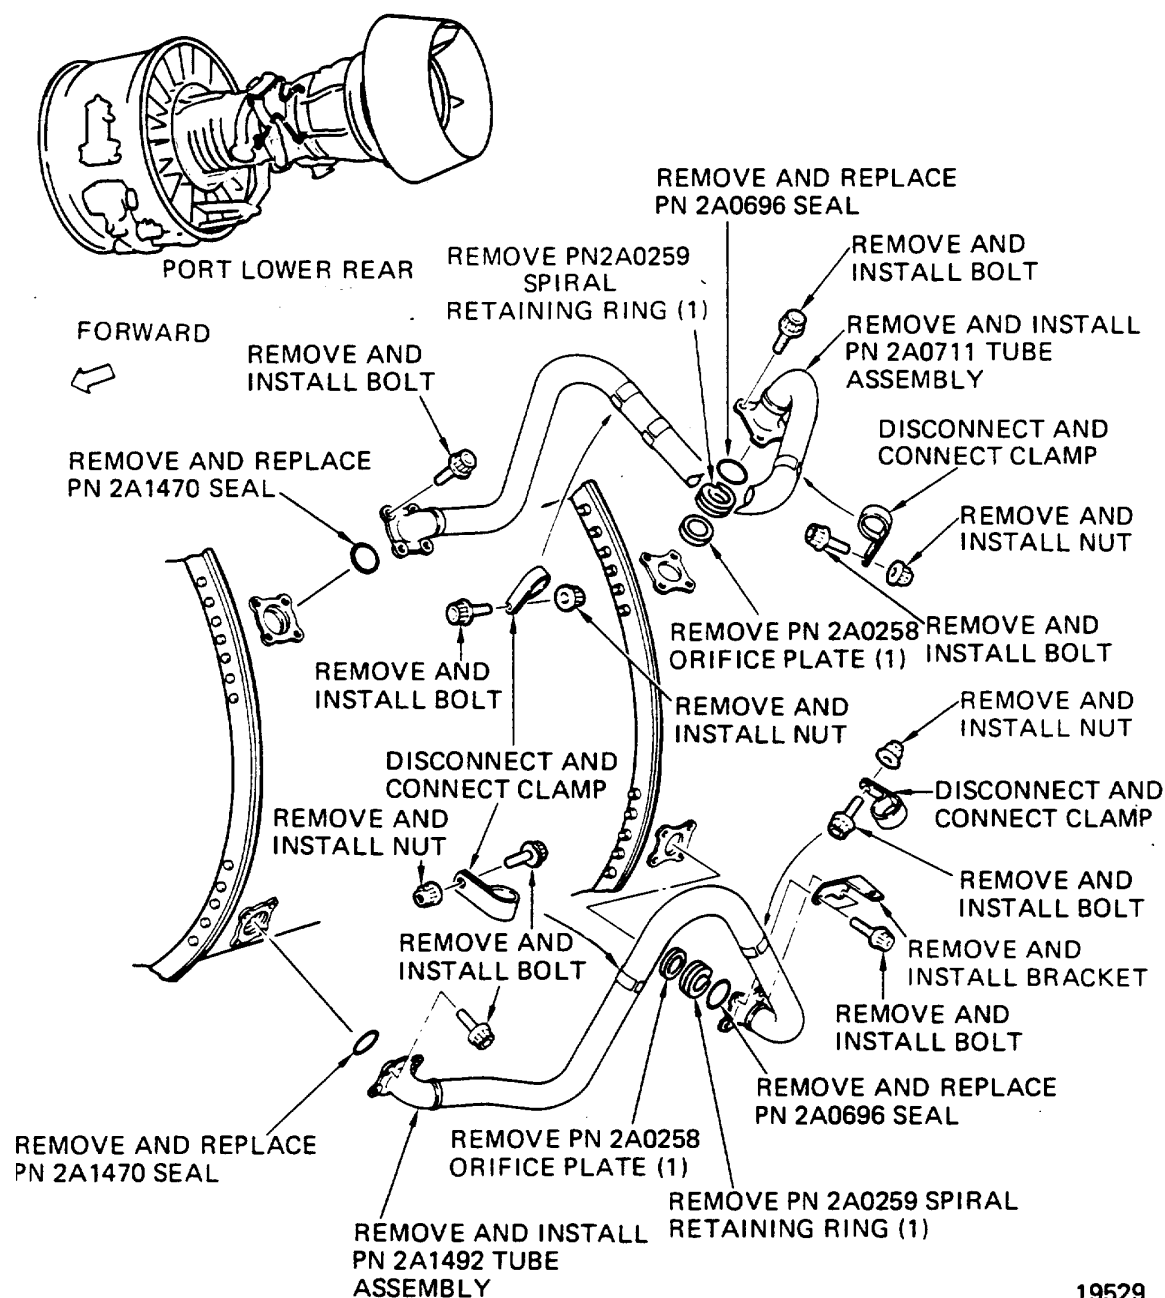
Removal of Orifice Plate  
Fig.1 (Sheet 1 of 2)

During the Flight Test Program the Turbine showed indications of deterioration before the usual time.

The deterioration was caused by an air supply to the HP Turbine which was not sufficient.

- (1) Deterioration of Turbine, before the usual time, is decreased by removal of the orifice plates at both ends of the Turbine Cooling Air Tubes.

- (1) Remove the Turbine Cooling Air Tubes by the approved procedure in Reference (1) Chapter/Section 72-00-50, Removal-01. Refer to Figure 1.
- (2) Remove the Spiral Retaining Rings and the Orifice Plates from the Turbine Case Assembly as follows:
  - (a) Remove the 2A0259 Spiral Retaining Ring from the groove in the Case Boss (four locations). Refer to Figure 1.
  - (b) Remove the 2A0258 Orifice Plate from the Case Boss (four locations). Refer to Figure 1.
- (3) Install the Turbine Cooling Air Tubes by the approved procedure in Reference (1), Chapter/Section 72-00-50, Installation-07. Refer to Figure 1.
- (4) Make sure that the New Part Number 2A1600A is shown on the Turbine Exhaust Case Assembly.
