SERVICE BULLETIN

ENGINE - L.P. COMPRESSOR - REPLACE THE NO.3 BEARING HOUSING ASSEMBLY SHOULDER STUDS WHICH HAVE BEEN SHOT PEENED - CATEGORY CODE 5 - MOD.ENG-72-0059

V2500-ENG-72-0059

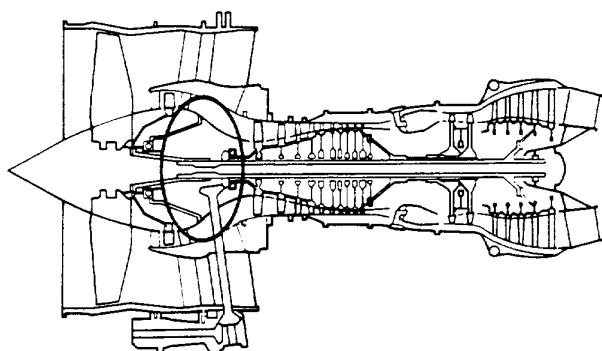
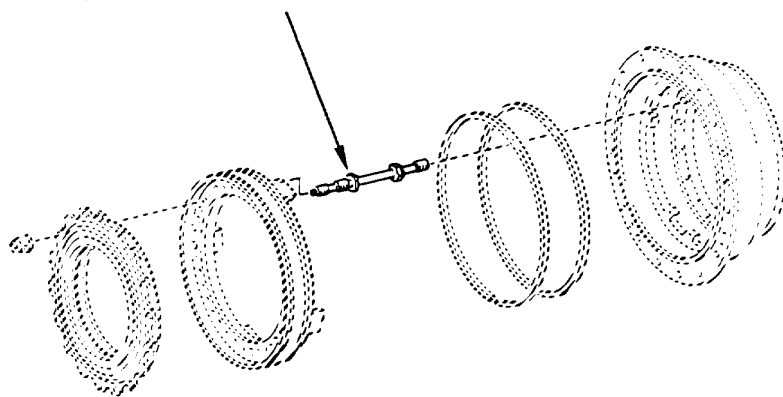
Location of No.3 bearing housing assembly shoulder stud
Fig.1

The existing 2A0422 No.3 Bearing Housing Assembly Shoulder Studs were not shot peened.

During a engine hardware review, it was found that the shot peen requirement was not incorporated.

To improve the high cycle fatigue life of the No.3 Bearing Housing Assembly Shoulder Studs.

- (1) Remove the 2A0422 No.3 Bearing Housing Assembly Shoulder Studs by the instructions given in Reference (2), Chapter/Section, 72-32-20 Removal. Refer to Figure 1.

- (1) Install the 2A1667 No.3 Bearing Housing Assembly Shoulder Studs (18 off) by the instructions given in Reference (2), Chapter/Section, 72-32-20 Assembly.

REMOVE THE PN 2A0422
SHOULDER STUD AND INSTALL
PN 2A1667 SHOULDER STUD (18 Off)
